## DAVID DUNLAP OBSERVATORY & ADMINISTRATION BUILDING CONSERVATION PLAN

City of Richmond Hill  
+VG Architects (Toronto) Ltd.

September 12<sup>th</sup>, 2019

**PROJECT:** David Dunlap Observatory & Administration Building  
CONSERVATION PLAN

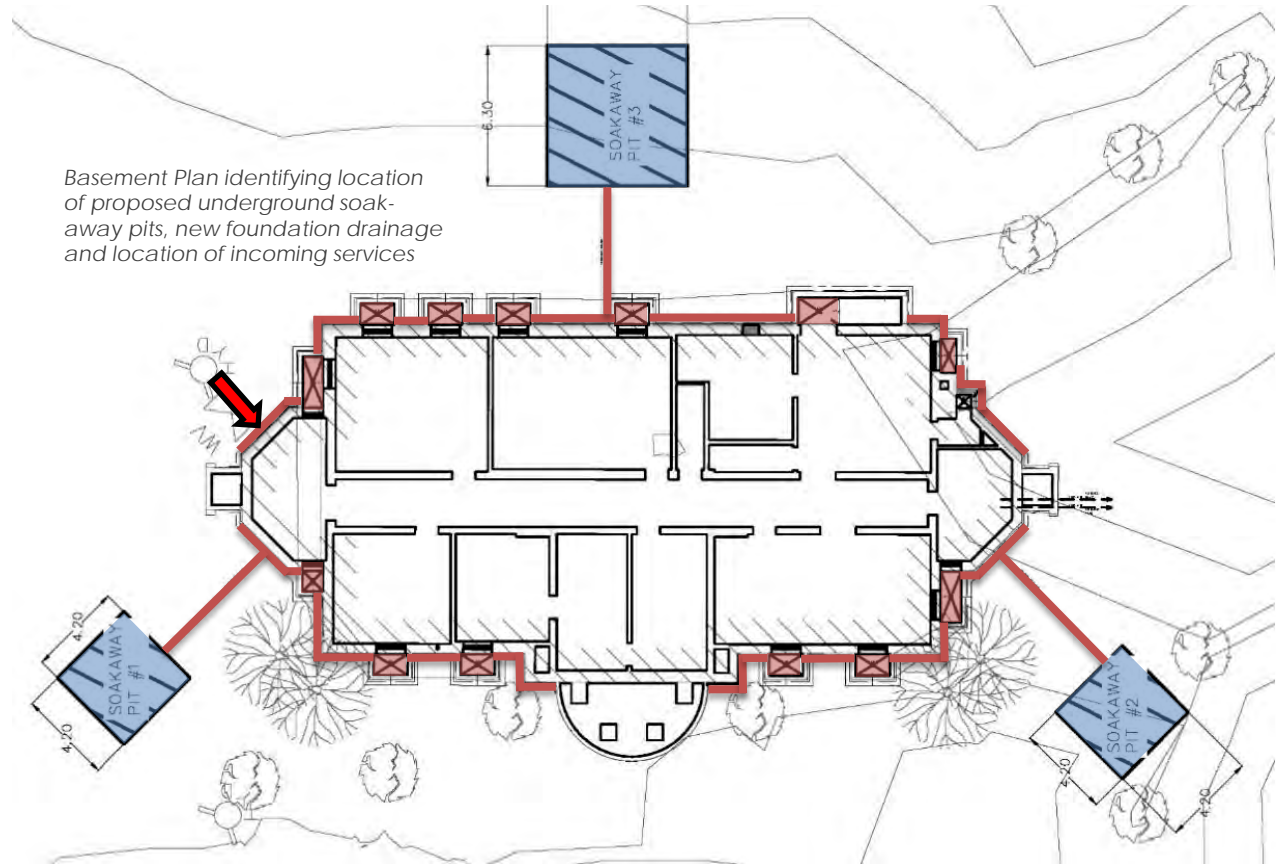
- Water infiltration and moisture at base of interior walls around the perimeter of basement level
- Connections of incoming services (domestic water and fire main) are past useful life and require replacement

*Basement Plan identifying location of proposed underground soak-away pits, new foundation drainage and location of incoming services*

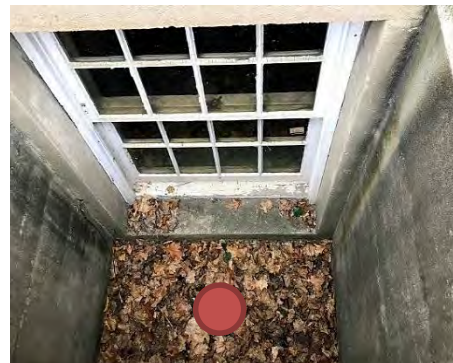
Poor & inefficient drainage in window wells

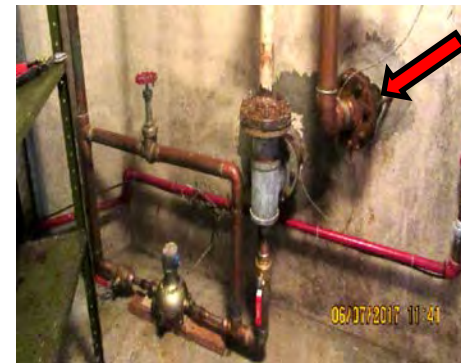
Old and deteriorated services connection

<b><i>Municipal Services</i></b>	Complete replacement of old and deteriorated incoming municipal services (domestic water and fire main) where services are penetrating through the exterior basement walls.
<b><i>Structure and Foundations</i></b>	It is anticipated that a limited number of localized interventions to the concrete surfaces of foundation walls, such as crack and patch repairs, will be required following excavation and prior to the installation of the new foundation wall drainage system. Repairs will be carried out with specialty concrete mixes suitable for the specific application and nature of existing material.
<b><i>Wood Windows and Doors</i></b>	<p>Intent of this work is to undertake repair activities and refinishing work as necessary to ensure the ongoing preservation of wood windows and doors, including sashes and muntins, frames, jamb, casing, sill, apron, trim and all other components associated with the window and door assembly. At completion of the conservation work establish an effective and comprehensive programme of maintenance to ensure window systems and doors including hardware are checked and maintained/lubricated regularly.</p> <p>It is assumed that refurbishment and refinishing of wood windows (sashes) and doors is to be carried out in the shop and refurbishment/refinishing of wood surfaces including (but not limited to) jambs, frames, casings, sills, aprons, trims, etc. – is to be carried out in-situ.</p> <p>Removal and reinstallation of all sashes and doors will require provision for temporary plugs and doors. Doors are part of required exits and exits shall not be obstructed or made un-accessible at any time during the work.</p>

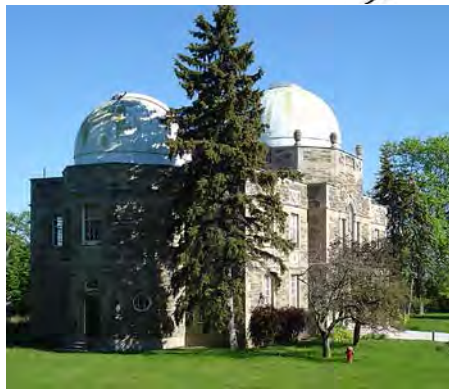
T1 (left)

- Several non-native trees has grown close to the building face and will impact on the new drainage system around the perimeter of foundations
- Planting beds along the west façade are encroaching onto the anticipated excavation zone for the proposed foundation drainage system.

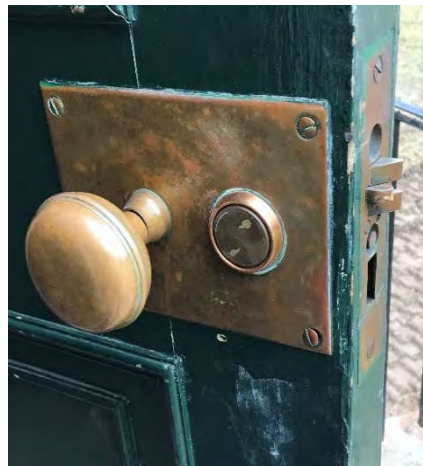
*Heritage hardware requires cleaning and lubrication*

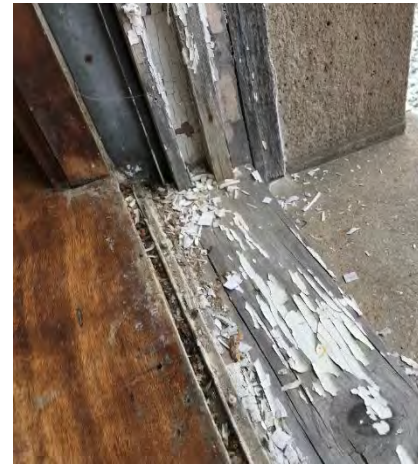
The peeling of paint finish and general deterioration of exterior wood surfaces is extensive. Deterioration is more pronounced for the windows on the south and west elevations that are exposed to direct sunlight and weather. Most of the damage is noted at horizontal sills, wood stops, and the bottom portions of the frames in direct contact to the sills where water and snow has the chance to sit and pond for longer times. The condition of the putty is typically dry and cracked. Sealant at all exterior joints between frames and masonry is old and deteriorated.

*Extensive deterioration of finishes and weatherstripping at windows*

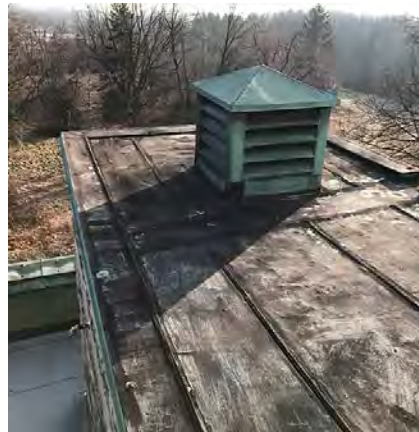
The flat seamed joints between larger sheets of copper cladding show unevenness and deterioration. There are numerous evident signs of old repairs (face fastened nails and abundance of caulking) aimed at keeping joints weathertight and cladding/flashing secured to the substrates that are now failing.

*Old and deteriorated asphalt repairs over flat-seamed copper roofing.*

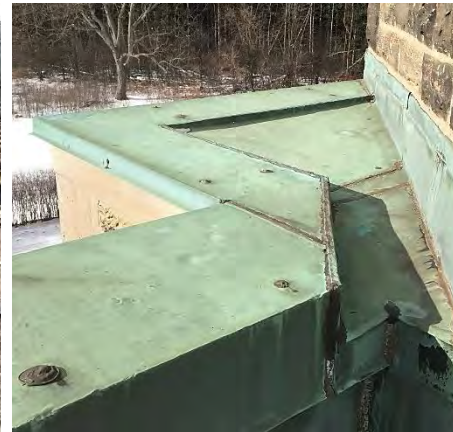
Open joints noted at reglets and starting strips. Sheet metal flashing and caps is not always, and positively, secured in reglets, but face fastened with material that is generally found loose due to poor adherence to the substrates. The condition of the existing roof concrete deck and walls should be thoroughly reviewed for signs of damage following the removal of the old cladding/flashing, prior to carrying out any replacement work.

*Old and deteriorated cap-flashing and joints between dif. materials*

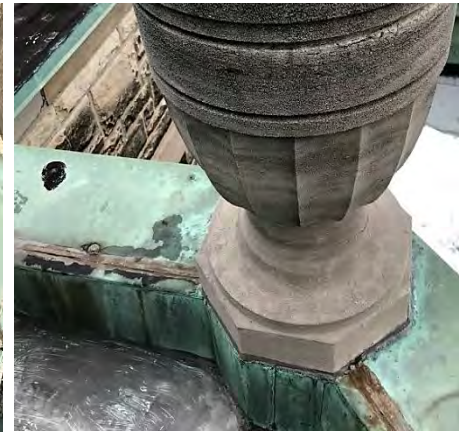
*Deteriorated cap flashing and thru wall flashing*

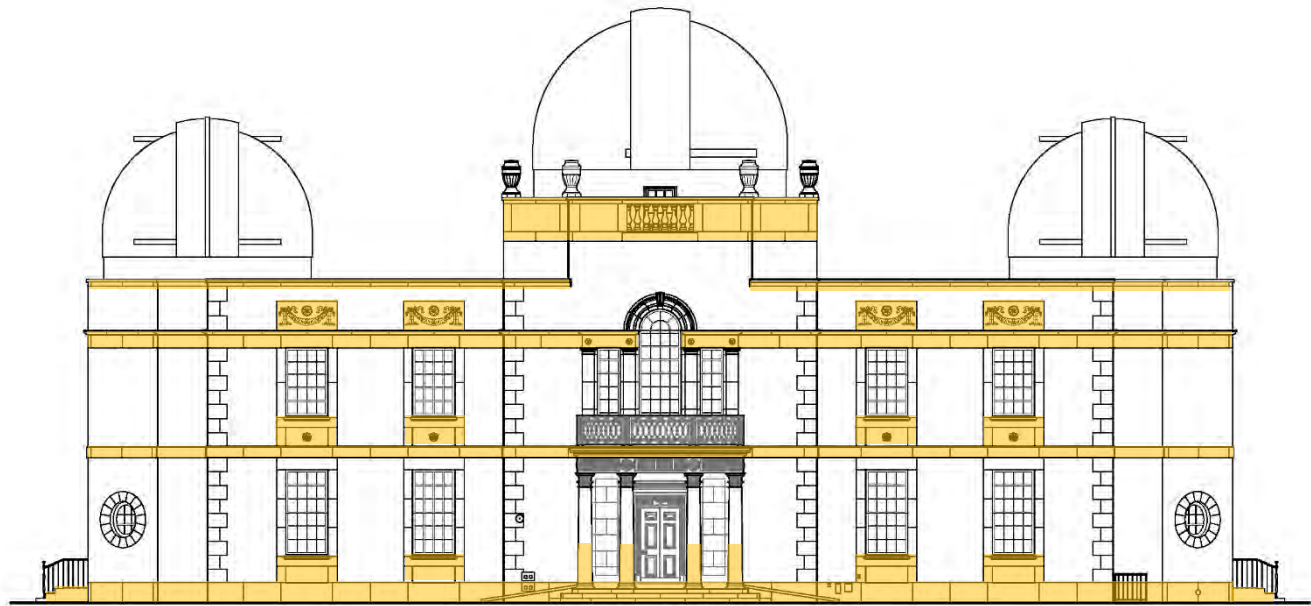
- Masonry walls and concrete surfaces require cleaning, repairs and selective replacements.

*West elevation identifying areas where masonry deterioration is most pronounced. Other building's facades exhibit similar conditions.*

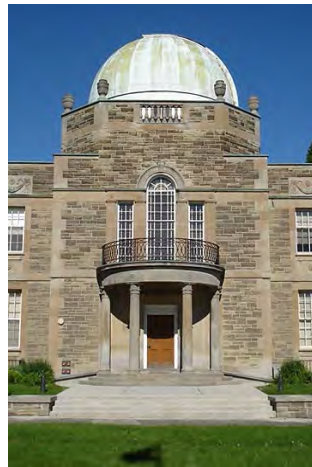
The concrete steps and apron connecting the drop-off area to the main entrance are in good condition. The three semi-circular stone steps and landing of the covered portico are in fair condition except for most mortar joints which are typically open and exposed to weather with missing or deteriorated mortar or sealant.

*Main portico and entry steps with atmospheric soiling*

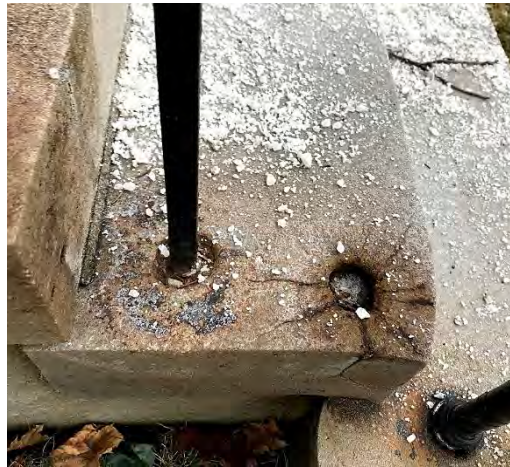
Particularly evident is the wear at the steps and bottom landings of the east and west stairs. In the worst cases the stone material is spalled or cracked particularly at the joints between steps and metal pickets.

*Cracks at stone threads of entry stairs and rust staining*

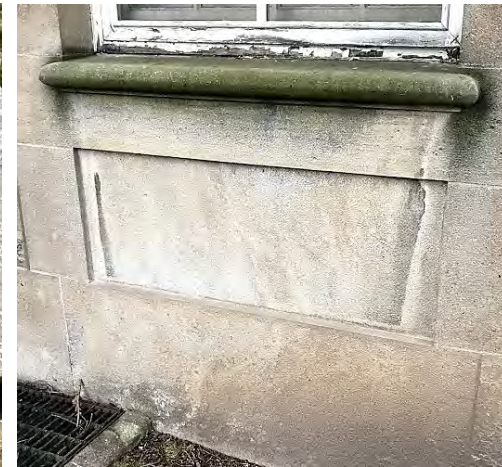
Water courses (locations where the wall thickness changes) have weathered joints that show accelerated water damage. This is also noted at horizontal surfaces that are exposed to continuous action of rainwater such as sills and curbs where sills and curbs are not protected by cap flashing as well as at the underside of exposed lintels where water is not effectively diverted by drip edges.

*Stained sills and weather courses*

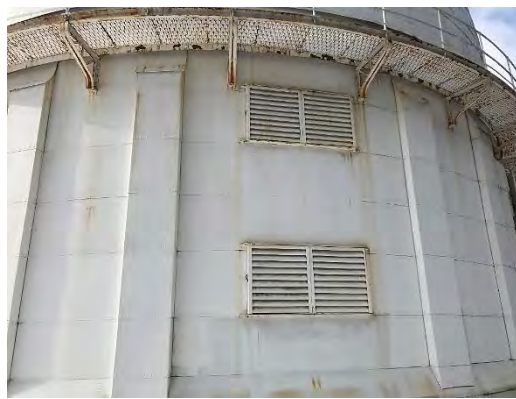
*Corrosion and staining of exterior metal surfaces*

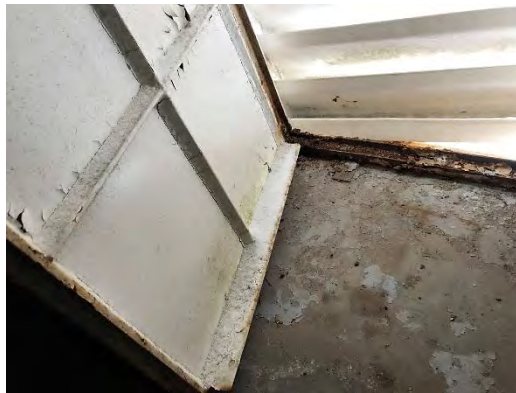
*Rusting of windows and deterioration of putty*

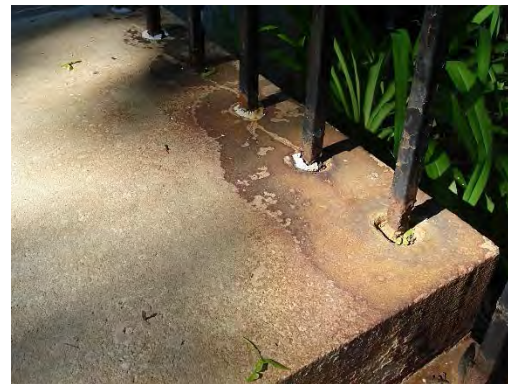
Metal guards, handrails and balustrades installed at the two north/south stairs, around the window wells and atop the front circular portico as well as the metal grating covering window wells are typically deteriorated and rusted. In the worst cases the metal is corroded to the point of structural failure and no longer positively supported.

*Advanced corrosion at base of metal pickets*

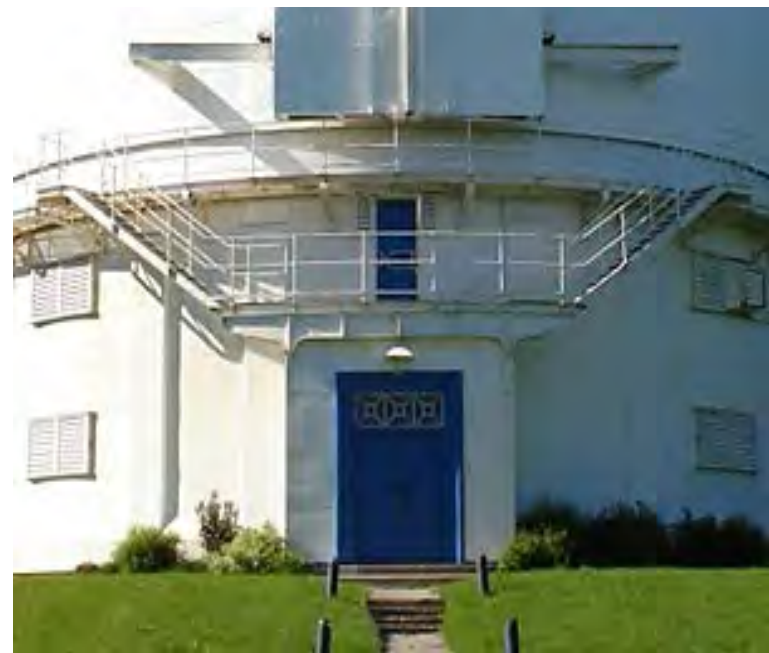
The main entry double door to the building, including all windows and sashes are constructed entirely in metal and set within metal frames. Conditions are generally consistent to the condition of metal surfaces described above. The area with most deterioration is localized to the roof over the main entrance vestibule, where active water leaks and visible signs of past repairs are noted. Repairs were carried out with a coating of asphaltic material applied to the metal roof surfaces in the effort of stopping or preventing the leaks.

*Observatory's entry vestibule where damage to metal is most evident*

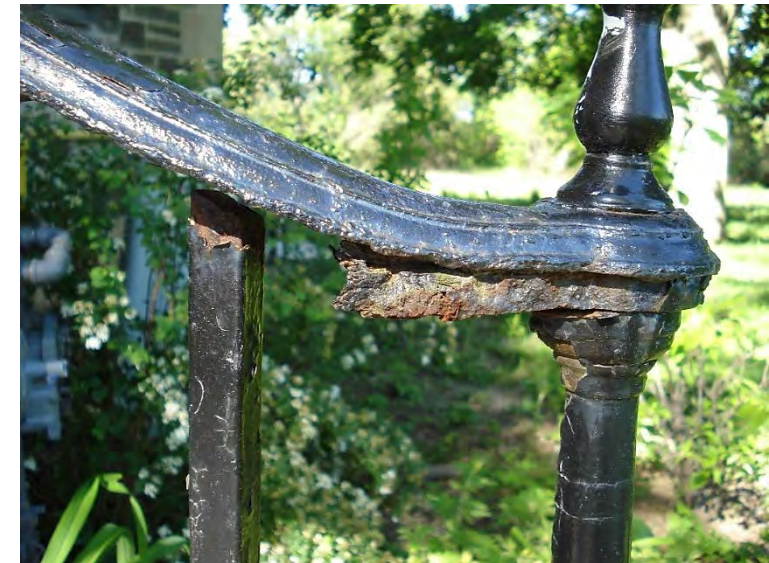
*Loss of material due to corrosion at handrails*

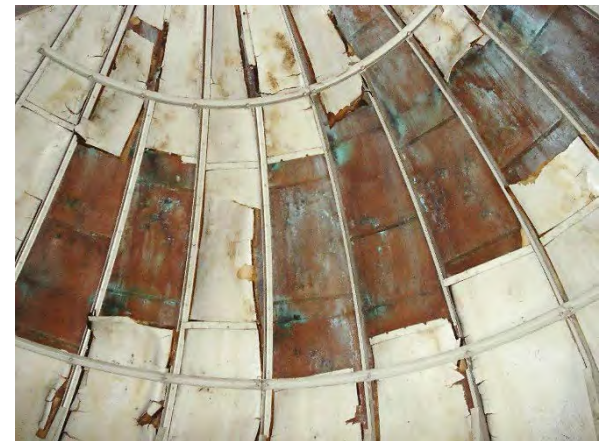
*Deteriorated "Agasote" insulation*
