10027 YONGE STREET, RICHMOND HILL EXISTING CONDITIONS STUDY

OCTOBER, 2011

+VG ARCHITECTS
THE VENTIN GROUP LTD

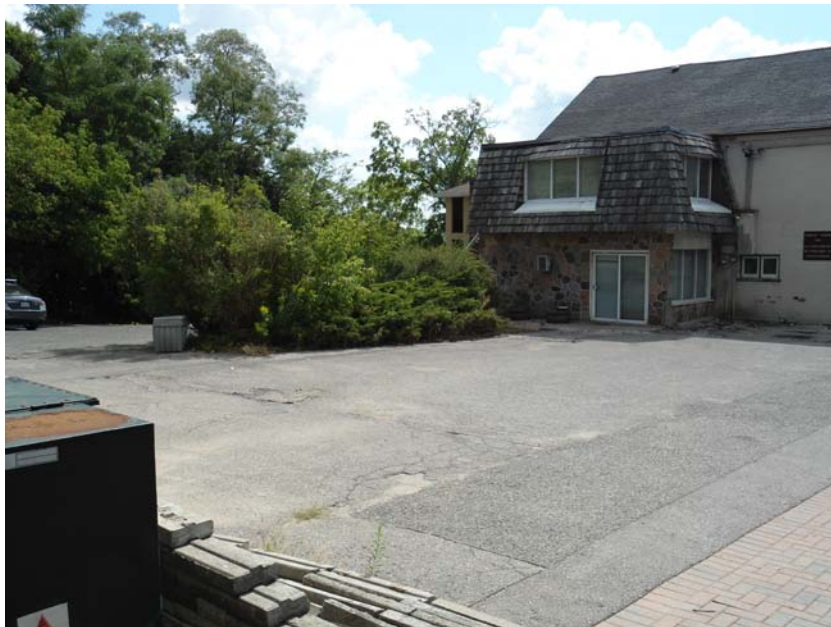
Figure 1: Overall view of property from northwest looking southeast

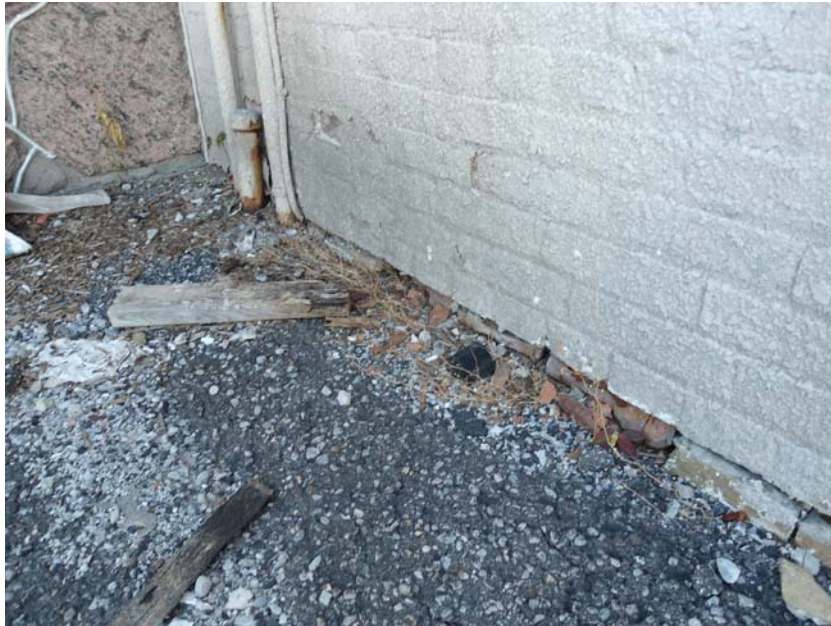
The general topography has the property draining mainly to the south in conformance with the surrounding properties with some sloping away from the property along the east and west property lines. Generally the grade slopes away from the building at its' perimeter except for the area adjacent to the east wall of the 2 storey 1960's addition where the grade appears to be contributing to water collection. This condition has caused excessive deterioration of the hard-surfacing at this area. It was observed at the time of this review that all downspouts were terminating well above grade. This condition not only exposes the building face to excessive moisture but impedes the immediate directing of water away from the building at ground level.

Figure 2: Low point adjacent to north wall of original building

Summary: removal and replacement of all exterior hard-surface areas, extension of all downspouts to ground level and directed away from the building.

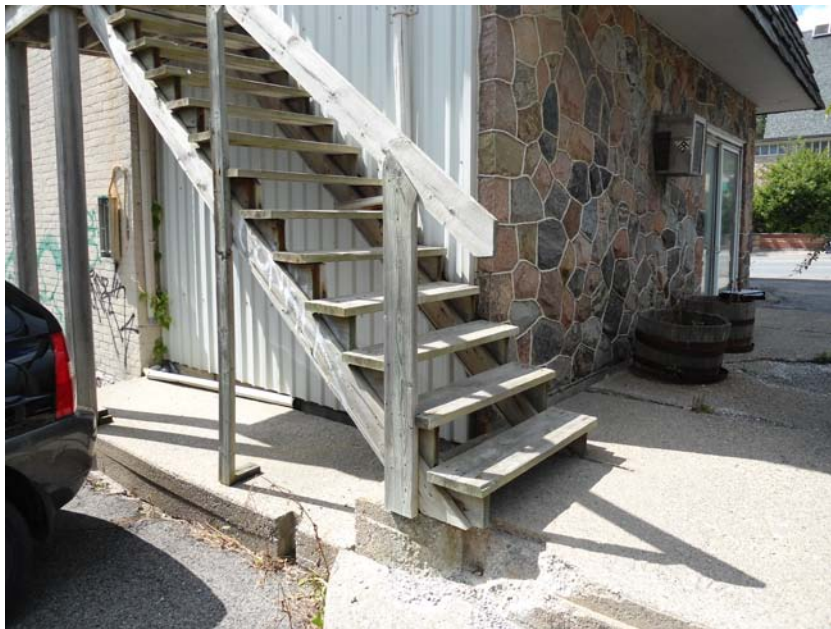
The property is completely hard-surfaces with a mixture of asphalt and concrete surfacing with little or no soft-surface or landscape areas to speak of. The asphalt surface is found to be in poor condition with excessive breaking and cracking throughout the property. The concrete surfacing is also found to be in poor condition with cracking and deterioration occurring throughout the majority of these areas. Hard surfacing at the main entrance to the building is broken and crumbling presenting a danger to pedestrian traffic.

Figure 3: Broken and cracked concrete surfacing. Uneven settlement.

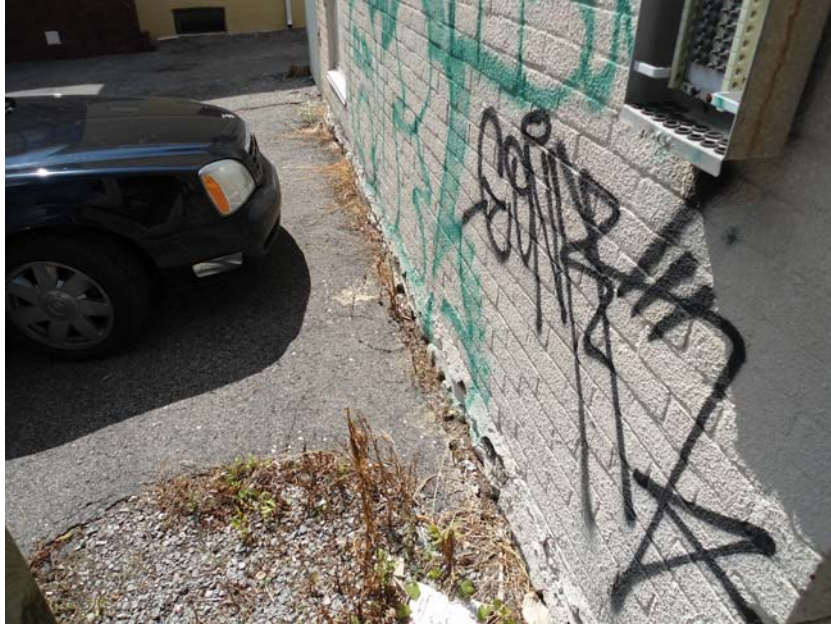
Figure 4: Gap between asphalt and stone foundation at west wall

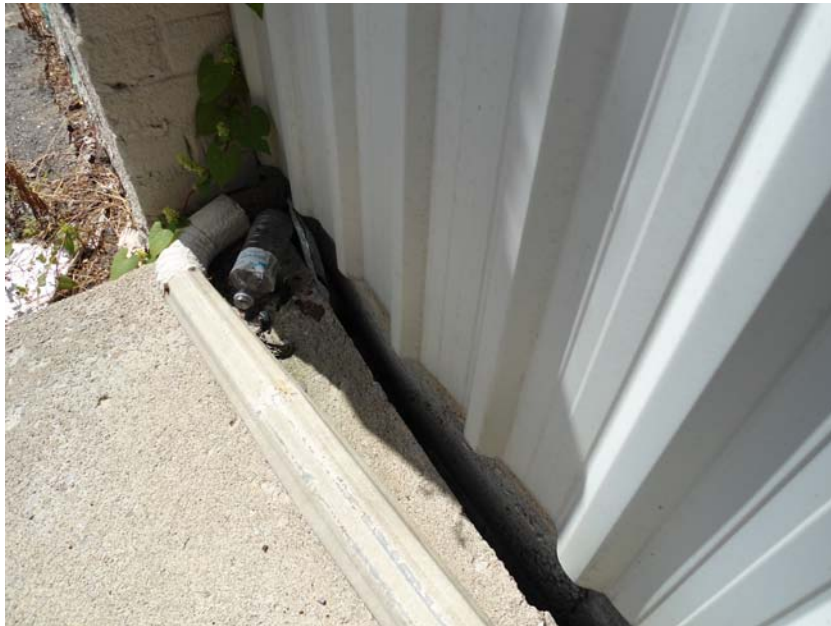
Figure 5: Gap between concrete surface and building. Disconnected downspout

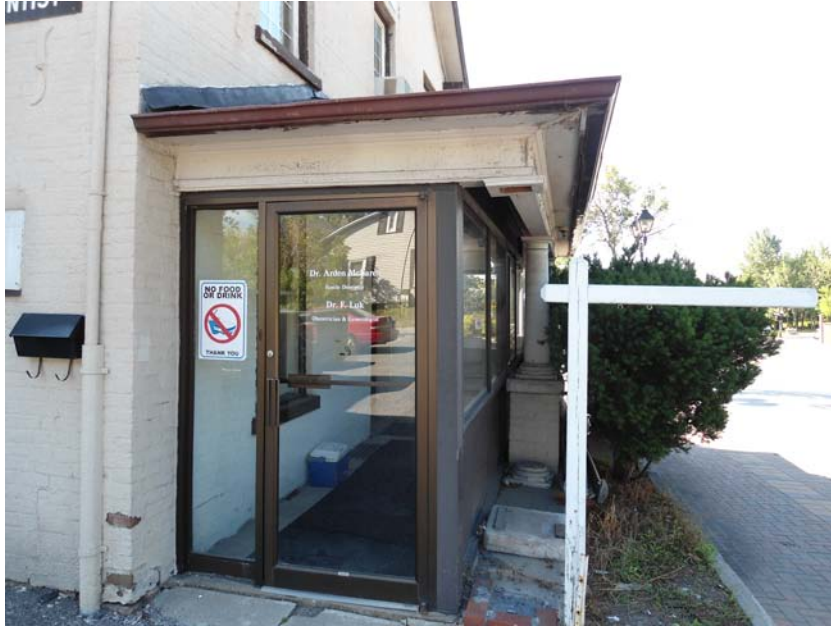
The front porch which was a later addition to the original building is found to be in a state of decay. The wood fascia, soffit and trims at the roof eave show signs of rot and peeling paint. The wood columns also indicate signs of decay as well as peeling paint. The northern-most column along with its' masonry pier base has been removed. The masonry piers for the porch columns were previously covered with a stucco finish which is now peeling and cracking. The concrete pier caps at these locations were also previously stuccoed over. This finish has all but peeled away to reveal the eroded and porous surface of the concrete cap beneath. The brick masonry and mortar exposed at these piers by the shedding stucco finish is observed to be severely deteriorated and spalling. Severe disintegration was noted at the perimeter of the poured concrete porch. Fragments of which were falling onto the adjacent public sidewalk. An aluminium framed, glass enclosure has been installed under the existing porch roof and appears to be in fair condition. This enclosure is now the structural support for the porch roof. It was also observed that the porch is pulling away from the main building. This matter should be investigated further to ensure the roof is properly supported. It was noted that two existing window wells and two existing vents leading from the basement have been filled in with concrete by the current Owner. The flashing installed from the face of the gable end wall onto the porch roof is comprised of bent galvanized metal secured to the face of the brick with an asphaltic membrane over which is mechanically fastened to the face of the brick and caulked. Proper step flashing tied into the mortar joints of the brick should be used here.

Figure 6: View front porch from the north. missing column, broken concrete at entrance.

A support post has been removed and at this location the porch roof is supported by the glazing framing. The remaining post supports are badly deteriorated. The porch also appears to be leaning outward from the main building wall.

We believe the porch in its current condition is unsafe.

Summary: The aluminium frame glass enclosure is the only sound portion of the porch and appears to be the structural support for the porch roof. It is noted that this enclosure is not designed for this purpose and is compromised by the loading of the porch. The condition of the remaining porch elements pose a hazard to pedestrian traffic as it is directly adjacent to the public sidewalk along Yonge Street.

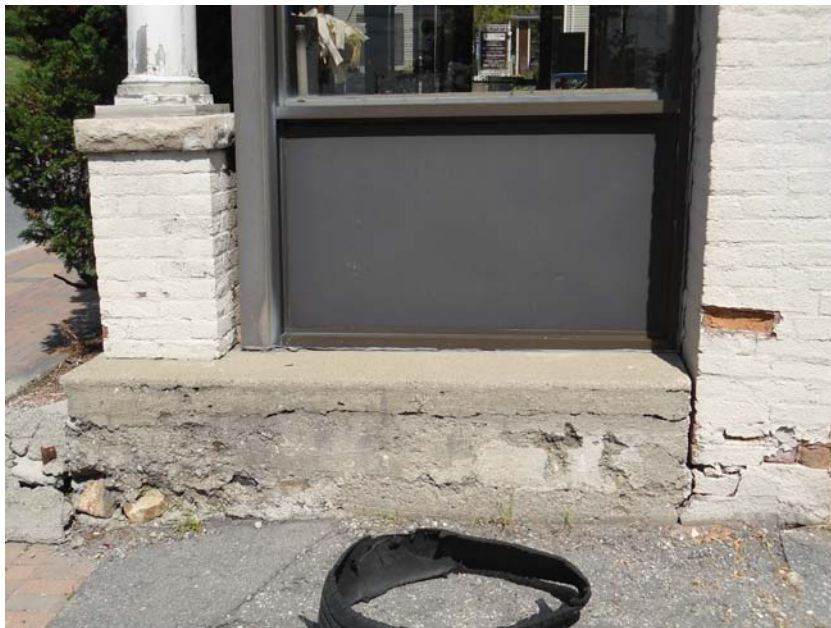
Figure 7: South view of front porch. Concrete disintegrating.

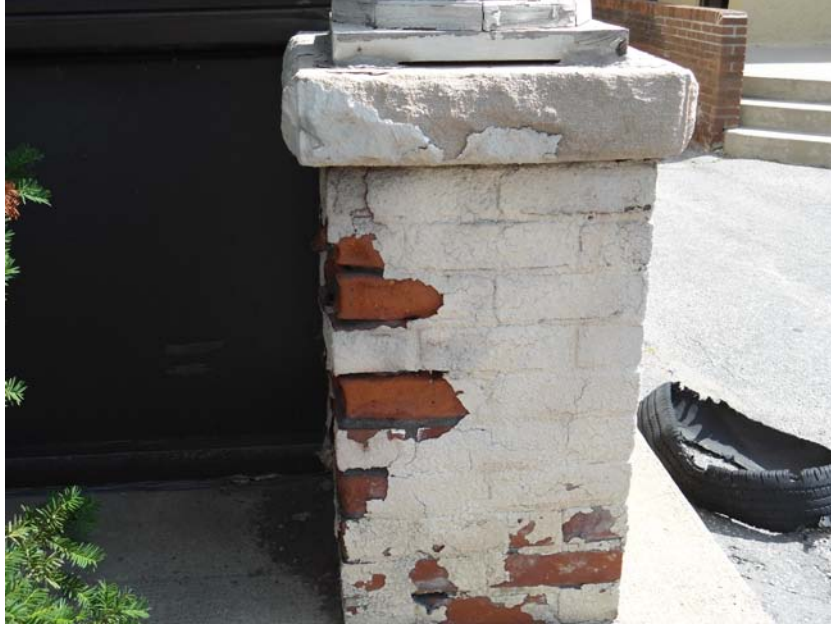
Figure 8: Masonry pier at porch column. Peeling stucco, deterioration of brick and mortar.

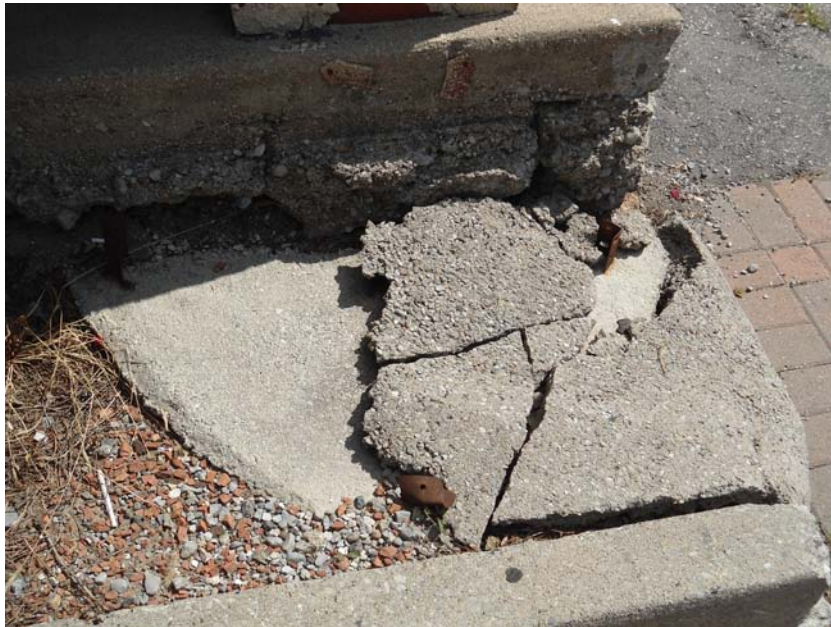
Figure 9: Deterioration of concrete at porch and curb adjacent to public sidewalk.

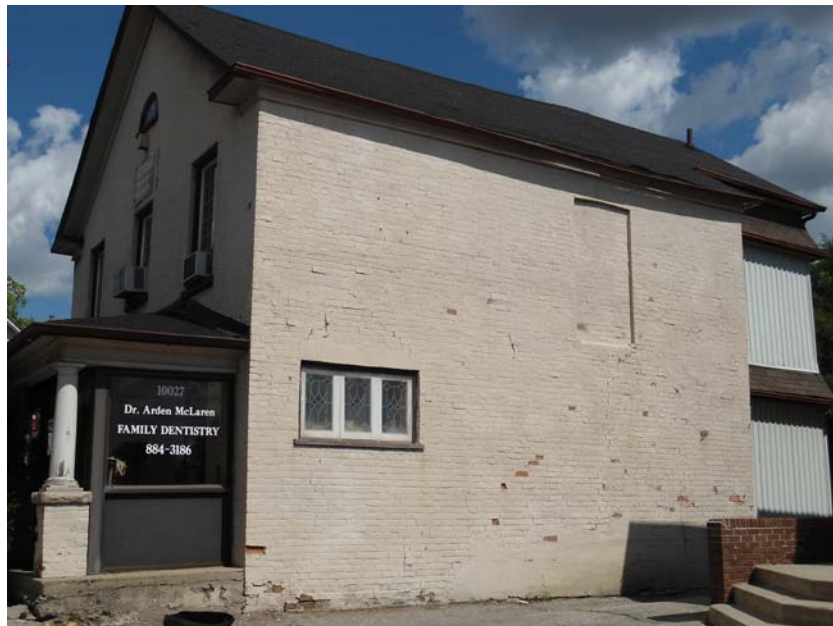
This is a gable roof with asphalt shingles and aluminium gutters and downspouts. The asphalt shingles have recently been replaced and are in fair condition. The roof shows a prominent sag in the sloped planes. This is likely due to;

- 1860's roof rafters exposed to ongoing variation in moisture content of the wood due to inadequate attic ventilation. Currently only two small vents on the north face of the roof.
- Periodic heavy snow loading will add to the sagging once the above mentioned condition exists.

There is also a sag in the ridge of the roof although less noticeable than in the sloped plane. This condition would also contribute to the more noticeable sag in the sloped plane of the roof. The sag is more prominent on the south facing plane of the roof than the north. The eaves trough along the south eave is severely sagging and bent.

Figure 10: Pronounced sag at roof. Eaves trough bent.

There is a noticeable sag in the roof structure and this should be further investigated structurally.

Summary: A more thorough investigation of the roof structure should be conducted by a licensed Engineer. The sagging of the roof rafters applies a lateral load to the top of the exterior wall structure. The wall is not designed to manage this type of loading and the existing deteriorated condition of the north and south walls only compounds this concern.

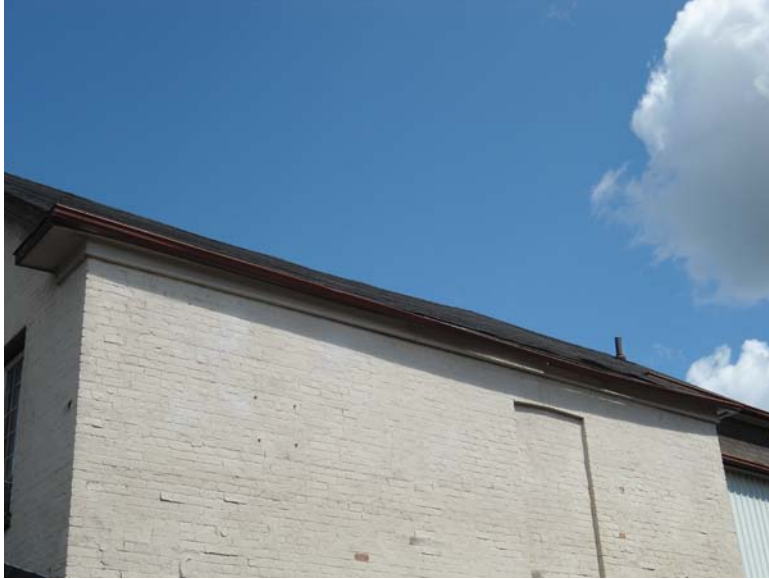
Figure 11: Pronounced sag at roof.

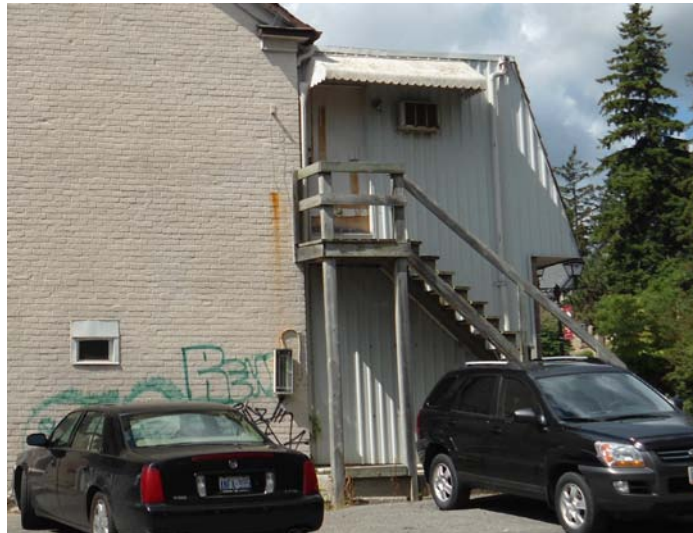
This existing wood frame stair does not meet the current OBC requirements to be considered an exit stair. The wood is weathered and its' strength compromised. The handrails and guardrails do not meet the code requirement both for loading and climbability. The vertical support at mid-span is broken and is currently not supporting any load. The concrete surfacing supporting the stringers at grade level is broken and there is currently no support under the east stringer.

Figure 12: 2nd floor non-conforming wood exit stair east elevation

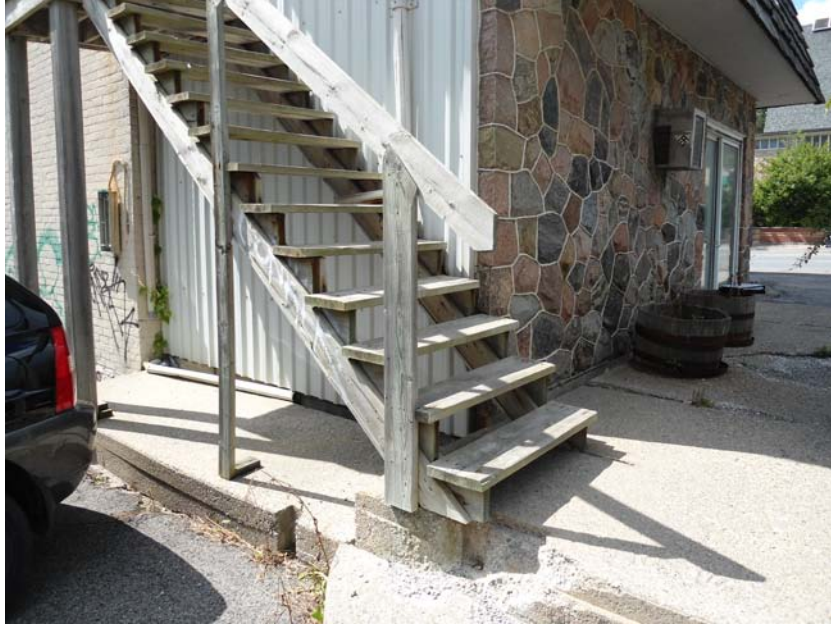
Figure 13: Non-conforming wood exit stair bearing on broken concrete walk

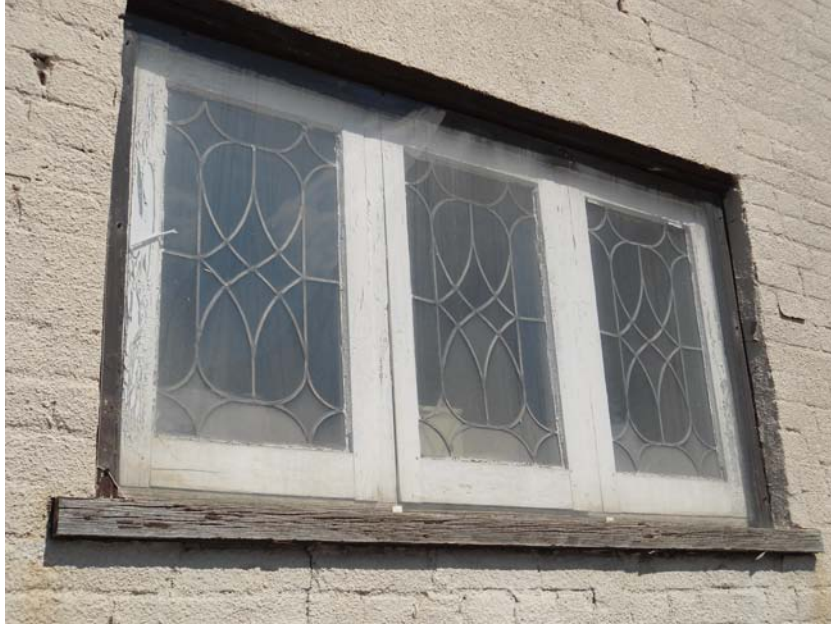
The majority of the windows have been replaced in the 1970's and 1980's with double pane windows which are found to be in satisfactory condition. The original wood casings appear to be intact and are found to be in fair condition requiring minor repair and re-finishing. The two leaded glass transom style windows on the north and south face of the building are not original to the building but were likely installed as part of the Lucy Nicholls renovations. These windows are single pane leaded glass with plexi-glass secured over top. The frames are unfinished wood which is decayed from exposure to the elements. It is understood that the only window original to the building is the demi-lune in the front gable end.

Figure 14: Leaded glass window added at north and south elevation circa early 1900's. Exposed wood sill rotted, plexi-glass fastened over window.

Summary: Although the windows have been replaced, the newest of these is 25 years old. It is recommended that all windows except for the demi-lune window in the front gable and the leaded glass transom style windows be replaced with new, insulated glass windows for improved energy efficiency. It is recommended that exterior "sull" sashes be installed over the demi-lune and transom windows described above.

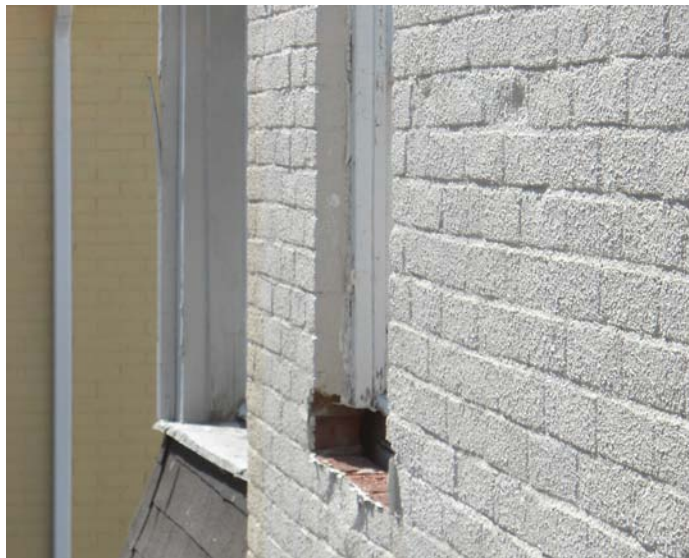
Figure 15: Missing sill allowing water into wall

The second floor window at the rear (east) wall is missing its' sill. This leaves the brick exposed to the elements and allows water to freely migrate into the wall. The exterior lapped sheathing behind the brick is exposed at this location and clearly shows a small cavity between the sheathing and the brick which is exposed to the elements.

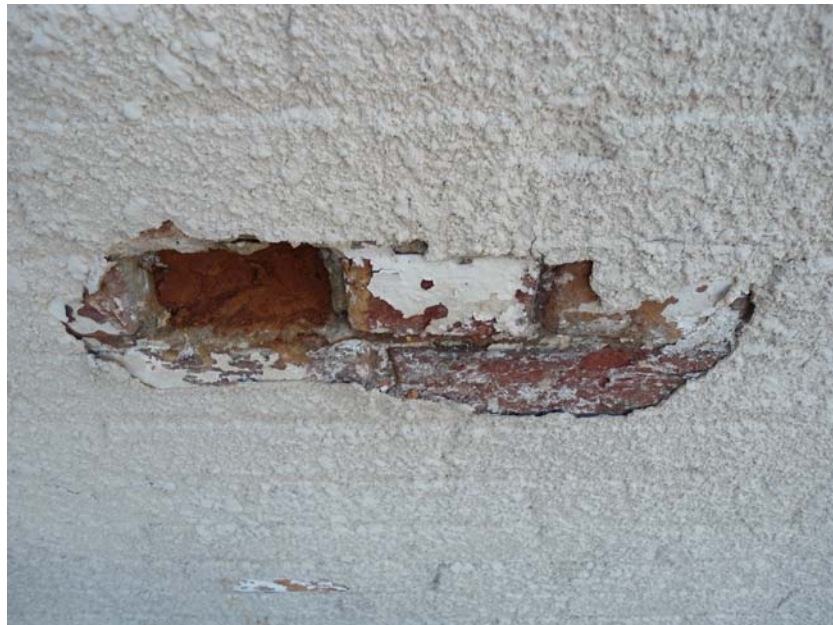
The exterior walls are constructed of non-reinforced brick masonry bearing walls which have been covered with a stucco finish. The stucco finish is found to be peeling and cracking over the entire surface of the exterior face of the building. Where this finish has peeled off to expose the brick beneath, the condition of the brick and mortar are found to be in extremely poor condition. Spalling of the brick and deterioration of the mortar is evident over the entire building face. This is especially prevalent at the base of the wall.

As the installation of a vapour barrier was not an aspect of construction practices at the time this building was constructed, no vapour barrier is present. This allows the warm moist air inside the building to escape through the exterior walls and into the brick. The brick has had non-breathable finishes such as paint and stucco applied to the exterior surface as far back as the 1970's. These finishes do not allow the vapour inside the building to escape and therefore remains trapped within the brick. During freezing cycles this moisture freezes, expands and causes the brick to spall. The same is true of the mortar. Moisture trapped within the mortar expands and causes deterioration. The ongoing occurrence of this process causes both the brick and the mortar to become more and more porous which in turn makes it more susceptible to this destructive cycle. Another contributing factor would be the brick used in the construction of the building would likely have been "soft brick" which is more porous by nature than modern brick and therefore more prone to the effects of moisture infiltration and the freeze/thaw cycle described above.

Figure 16: Spalling brick. Previous paint finish exposed by peeling stucco.

Summary: As the exterior masonry wall of this building is the major above grade structural component, it is strongly recommended that a thorough structural analysis be performed by a licensed Engineer. The present condition of the brick and mortar which are visible indicate a widespread degradation of the exterior brick wythe. Visually noticeable movement has occurred at the south wall. The wall is noticeably bowed outward at the second floor level and the base of the wall at the southeast corner has noticeably shifted to the south. Structural connections at the roof, second floor and foundation should be thoroughly inspected as these are the points of lateral support for this wall. The movement of the wall suggests that the lateral support has been compromised at one or all of these points.

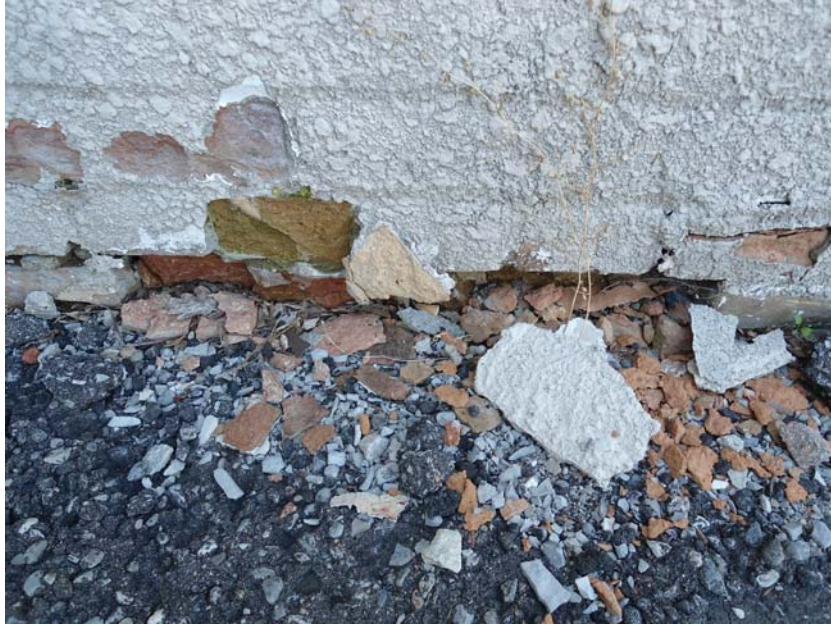
Figure 17: Spalling brick under stucco finish at base of exterior wall

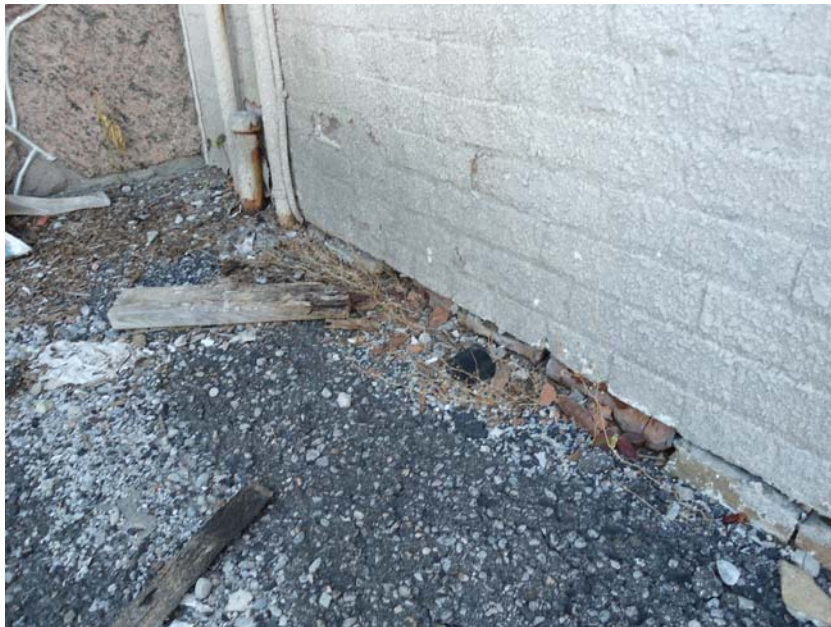
Figure 18: Spalled brick and deteriorated mortar at base of exterior wall. Mortar has completely disintegrated.

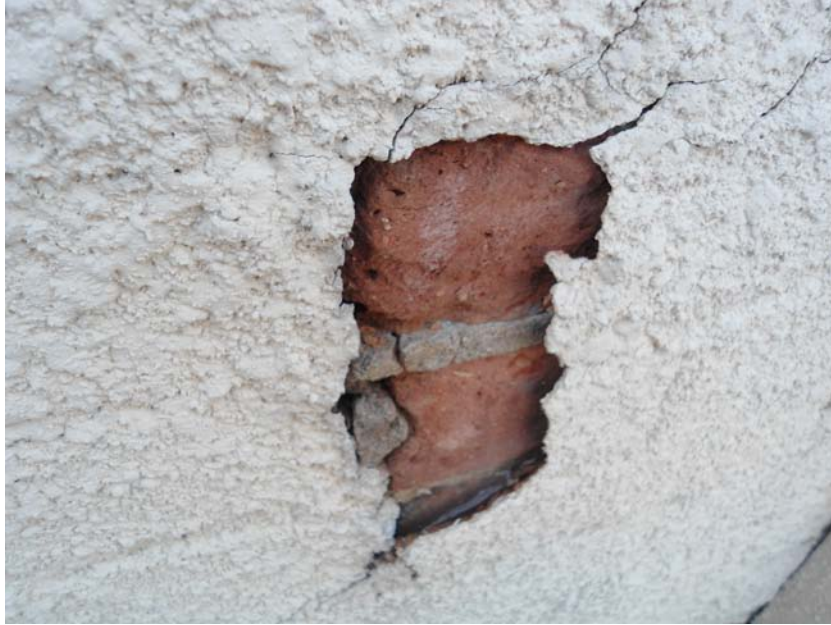
Figure 19: Spalled brick and mortar. Note porousness of bric face.

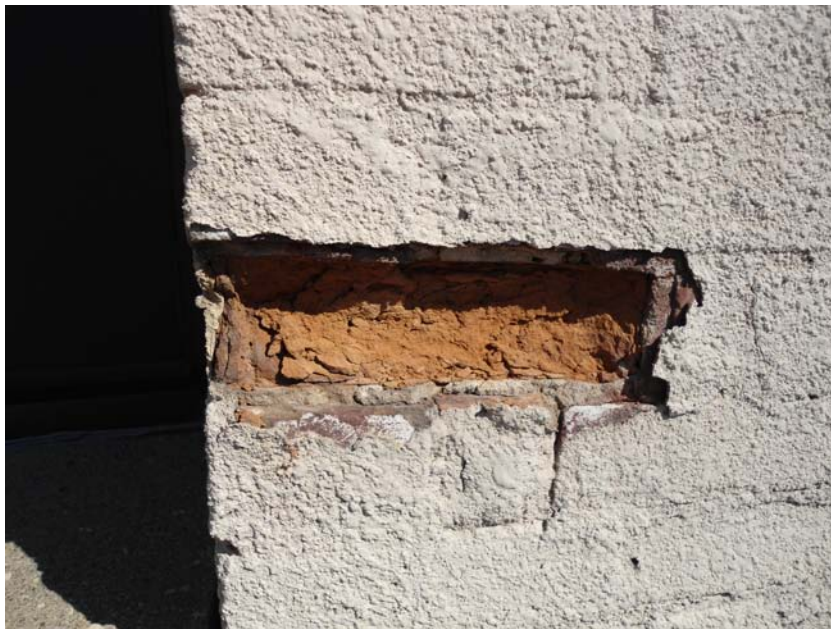
Figure 20: Spalled brick

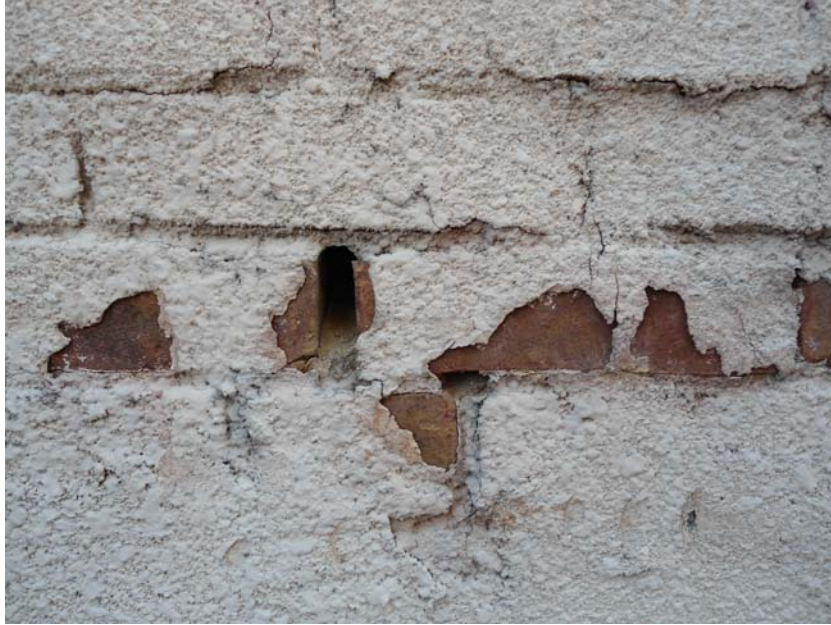
Figure 21: Mortar deteriorated. Remaining dust visible.

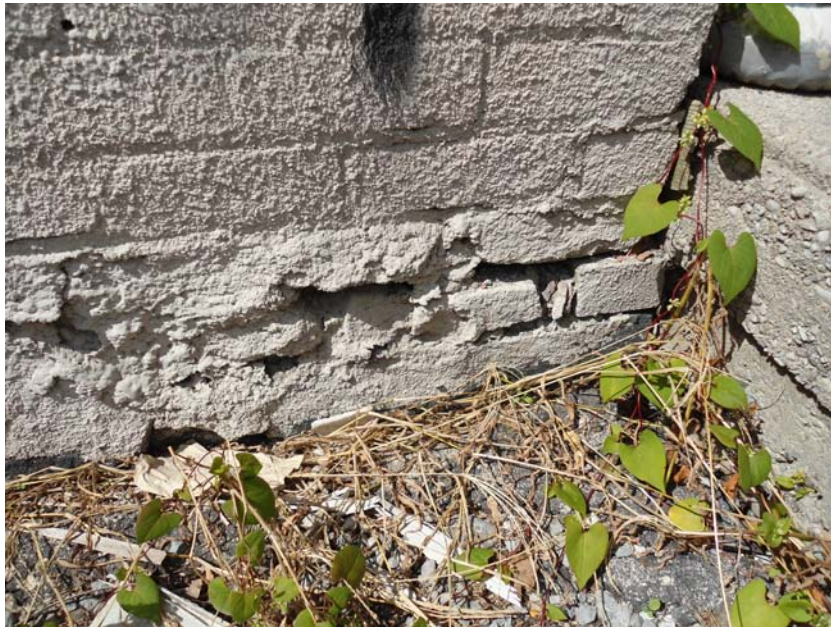
Figure 22: Mortar disintegrated at top of foundation wall

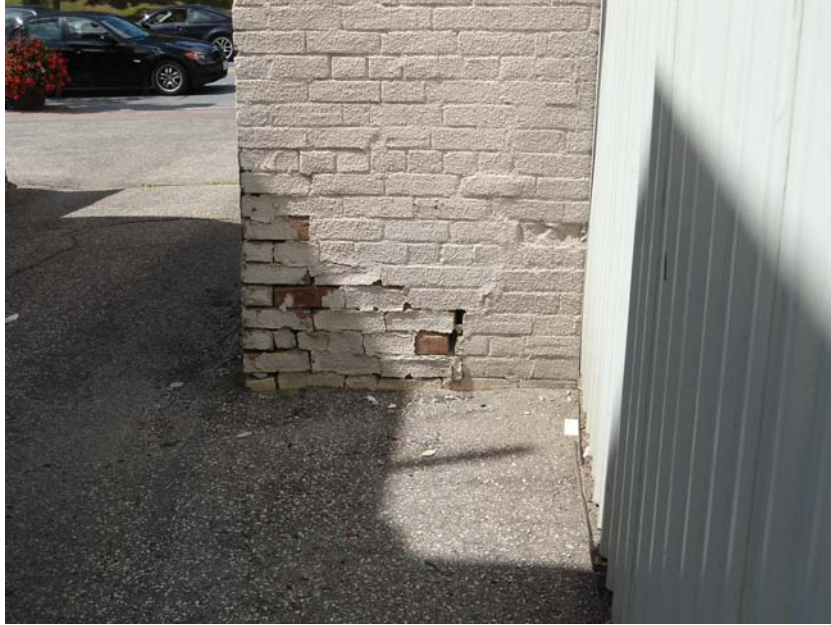
The base of the wall at the southeast corner of the existing building shows major deterioration of the brick and mortar with mortar missing entirely from some joints. The wall at this location has shifted noticeably to the south at its' base.

Figure 23: Spalling and missing mortar at base of southeast corner of original building. Base of wall has shifted to the south.

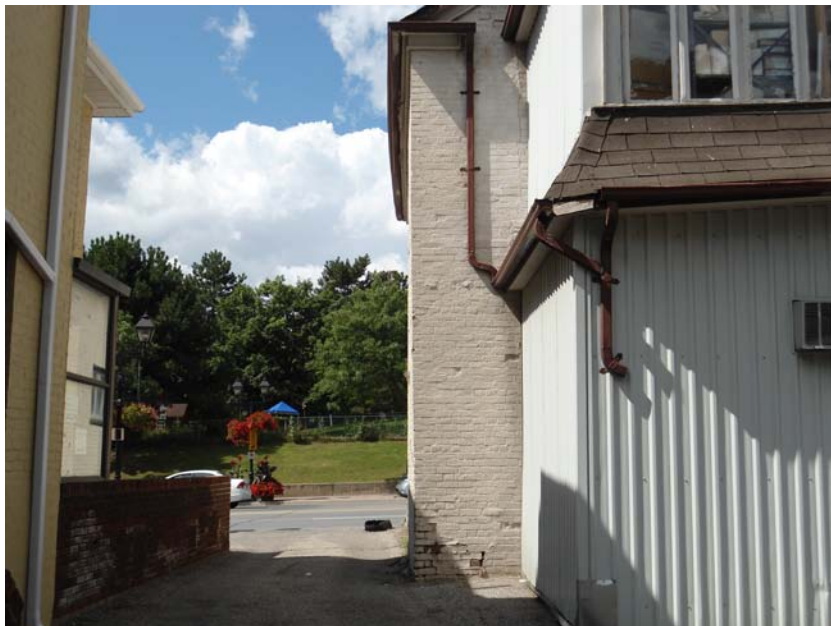
The south wall exhibits a pronounced bow or bulge. Possible causes for this would be;

- Freeze/thaw cycles deteriorating and diminishing the bearing capacity of the brick and mortar.
- Deterioration of ties or lack of ties at second floor level which tie the exterior wall to the floor structure.
- Movement at the base of the wall has displaced the loading on the wall out of vertical plane
- Sagging of the roof structure has implied loads to the exterior wall for which it has not been designed.

Figure 24: South wall of original building bowed outward.

The south wall is bowed outward and it has significant deterioration at the outer brick wythe. At numerous locations the mortar was a powder and flowed readily from the joints and there was a considerable quantity of spalled brick. There were numerous cracks in the brick and in some locations the brick was loose and could be pulled out by hand.

If the inner wythes are of a similar condition, in addition to the bowed wall, we would consider the wall unsafe in particular when subjected to lateral loading such as wind or earthquake.

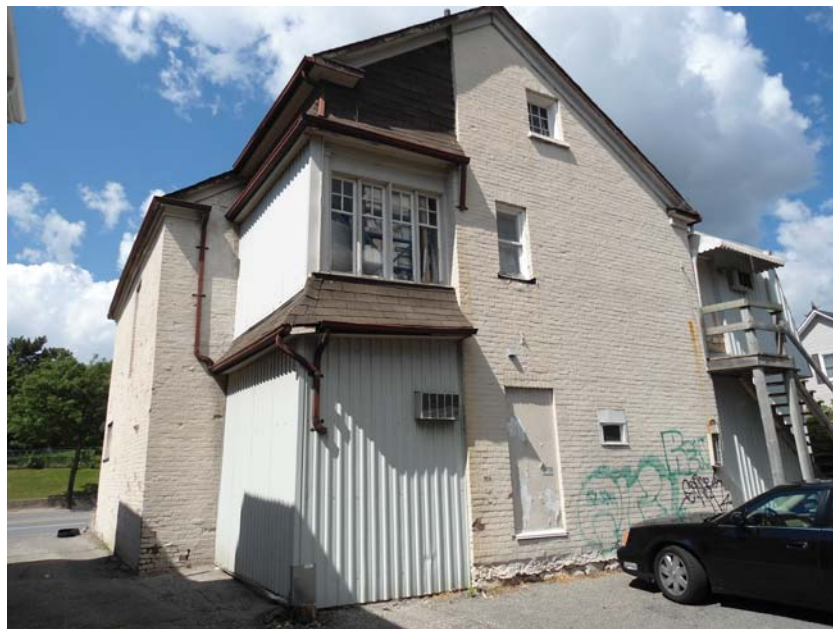
Figure 25: View of 2 storey sun room addition at southeast corner.

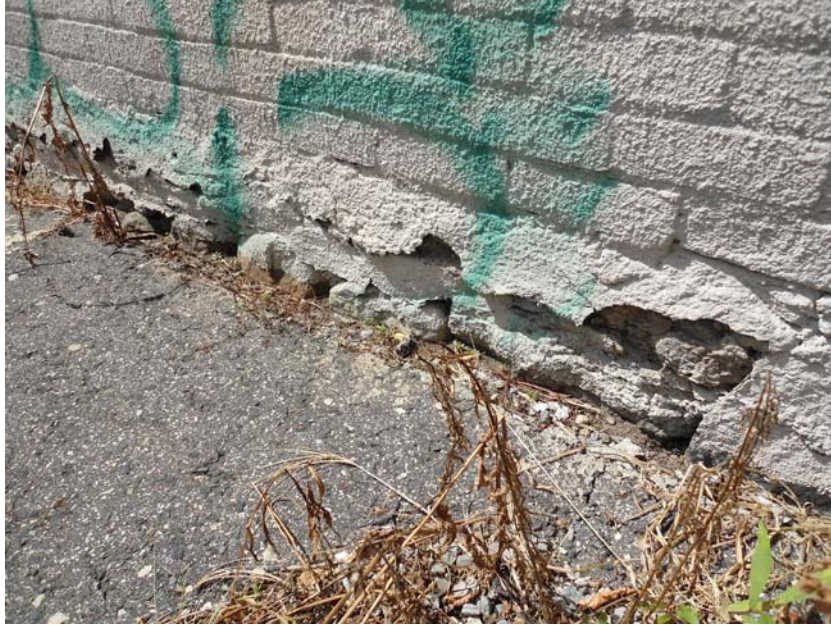
The basement is a partial basement which extends beneath the central portion of the original building and is a full basement under the 2 storey brick addition to the west. The remainder of the footprint is comprised of shallow crawl spaces. The foundation of the original building and rear addition are of rubble stone construction with a parged interior face. Portions of this foundation wall show efflorescence while localized areas of mortar have deteriorated, leaving breaches in the mortar joints. There are two interior brick masonry bearing walls running east/west beneath the original building and are found to be in fair condition. The majority of the interior face of the foundation has a parged coating. The upper portion of the north foundation wall of the original building is of brick construction. A later poured concrete wall has been constructed adjacent to the north and east foundation of the original structure. The poured concrete wall adjacent to the east foundation wall of the original building is a tapered monolithic pour approximately 4'-0" thick at the base and 2'-0" thick at the top. It is supposed that this was poured to hold the foundation in place while the basement was being excavated for the 2 storey brick addition to the east. Evidence of moisture on the face of the foundation wall was observed at the southeast corner of the rear 2 storey addition.

Figure 28: Exterior foundation at grade

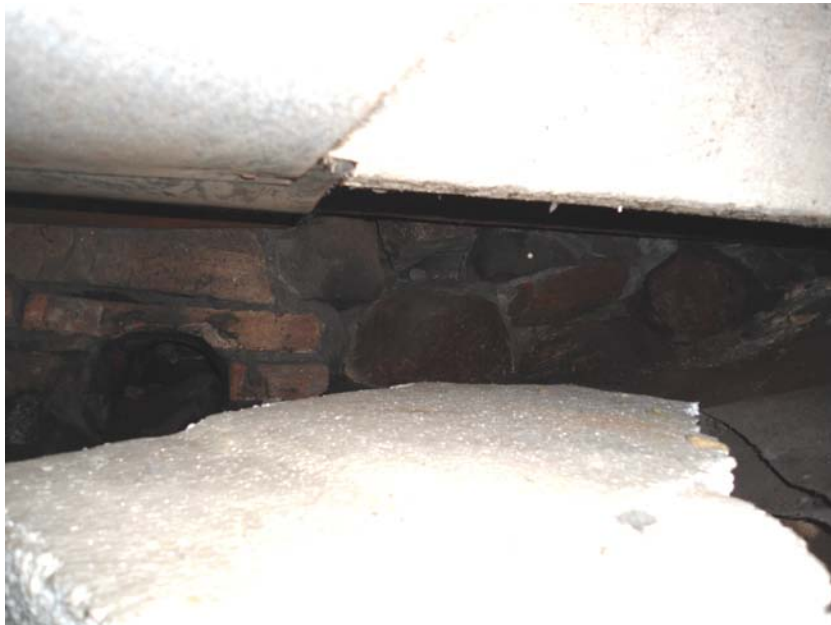
Figure 29: Exterior foundation wall at crawl space

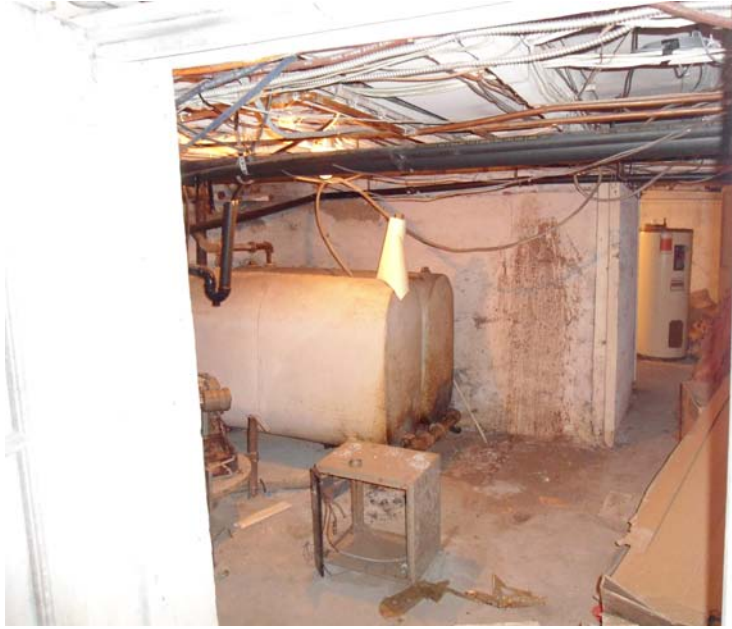
Figure 30: View from original basement through to east addition basement. Note abandoned oil tanks.

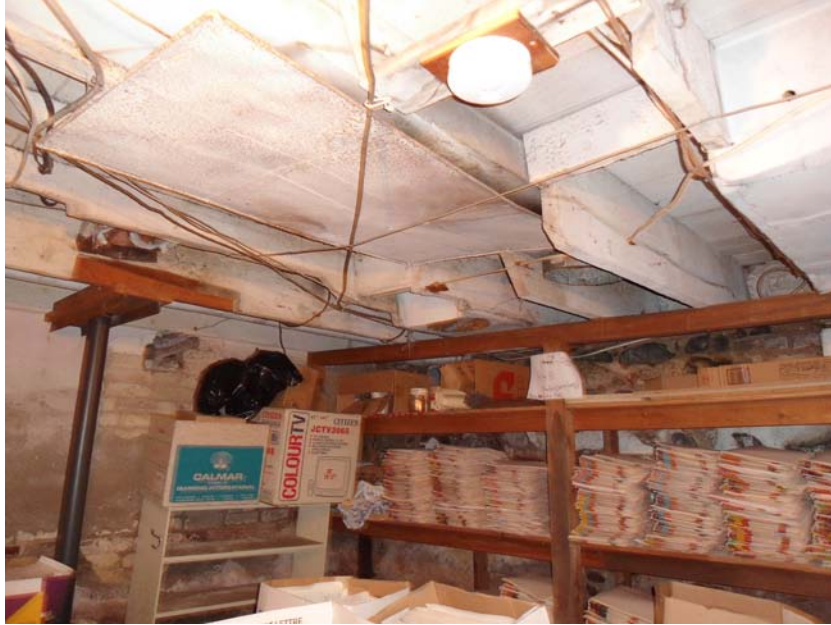
The supporting structure for the main floor is of wood frame construction as viewed from within the basement and adjacent crawl spaces. The wood members are in sound condition with no evidence of rot or deterioration. It was found however that a large number of floor joists have been cut and notched to allow passage of piping, etc. with no offsetting reinforcement of these members. The strength of these members has been greatly compromised by these alterations. One floor joist at the northeast corner of the 2 storey addition basement was completely severed with no compensating reinforcement provided.

Figure 35: Floor joists under original building have been cut. Note temporary steel post and blocking to support weakened floor.

From the basement the floor joists were observed to have numerous defects. Some of the joists were cracked, some notched, and some twisted. There were also joists that were spliced and supported on storage shelving units. This framing should be further reviewed to determine if it complies with the current building code.

Summary: It is strongly recommended that a licensed Engineer be retained to perform a complete analysis of the floor structure and provide the required reinforcement measures to be taken.

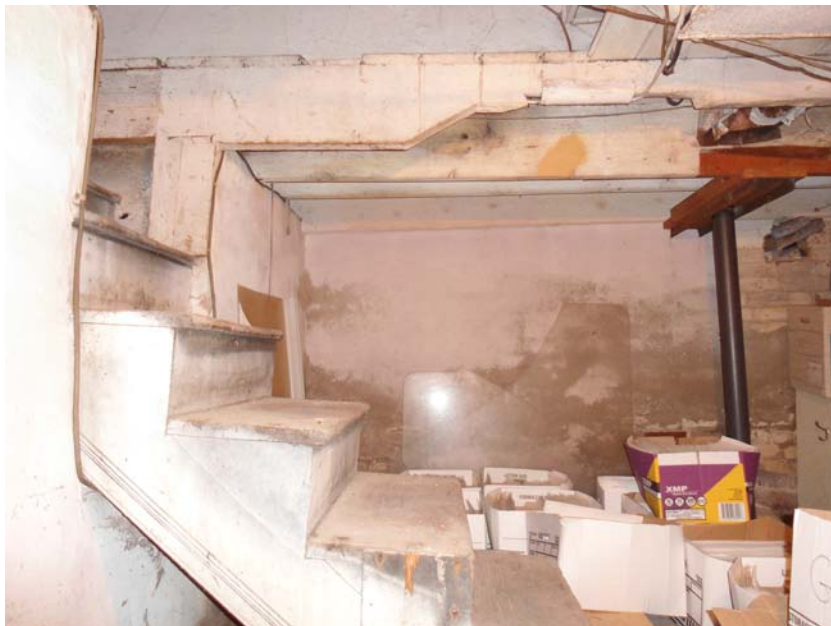
Figure 36: Floor joists cut at stair opening
