christopher l.  
ferguson

**Conservation Plan**  
**Ira D. Ramer House**  
**33 Roseview Avenue, Town of Richmond Hill**

Re-submitted April 25th, 2017

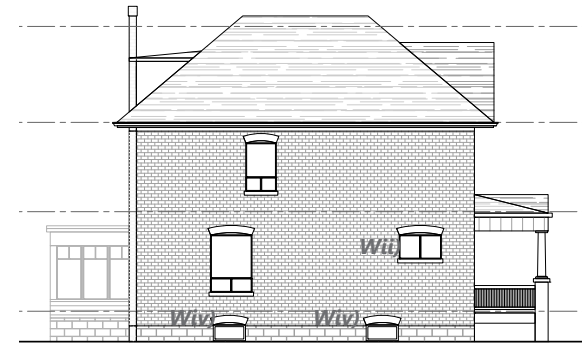
IMAGE 1. File: Existing House 7.pdf - West Elev.

- i) All windows to be replaced.
- 2) Ground floor:
  - Wii) Stained glass window to be kept. Storm to be kept.
  - iii) Window to be replaced.
- 3) Basement
  - Wiv) All windows to be kept.

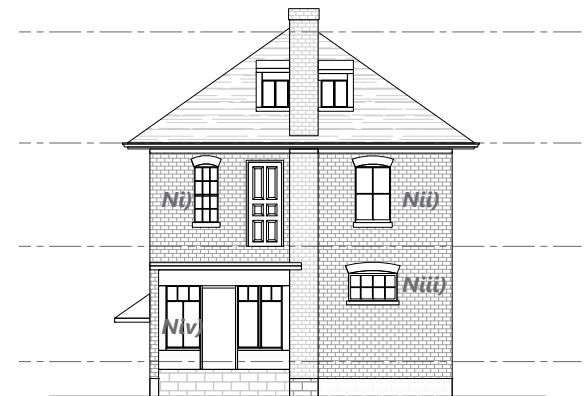
IMAGE 2. File: Existing House 8.pdf - North Elev.

- 1) 3rd floor:
  - i) All windows to be replaced. No heritage value.
- 2) 2nd floor:
  - Ni) Sash window to be replaced. 6-over-6 storm to be kept.
  - Nii) Sash window to be replaced. Storm to be replaced.
- 3) Ground floor:
  - Niii) Stained glass window to be kept. Storm to be kept.
- 4) Sunroom:
  - Niv) All windows to be kept.

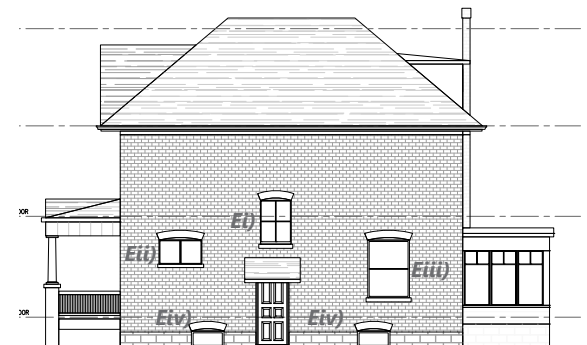
IMAGE 3. File: Existing House 9.pdf - East Elev.

There is a pair of vertical atmospheric stain streaks running down the side of the east elevation, from 3rd floor to ground floor. It is indeterminate what caused the stains. These should be cleaned using a water wash, surfactant detergent cleaner, and hand scrubbing using soft bristle brushes. Abrasive blasting or water jet cleaning should be avoided to minimize surface matrix loss.

- 1) 2nd floor:
  - Ei) Sash window to be replaced. Storm to be kept.
- 2) Ground floor:
  - Eii) Stained glass window to be kept. Storm to be kept.
  - Eiii) Sash window to be replaced. Metal storm to be removed, replaced with wood storm.
- 3) Basement
  - Eiv) All windows to be kept.
