**Re: John Love – Heritage House
Site Visit**

This letter is to report on the observations from our November 19, 2020 site visit to the John Love house on the corner of King Rd. and Greywacke St. in the Town of King. The inspection was performed by our Mr. F.A. Prendergast.

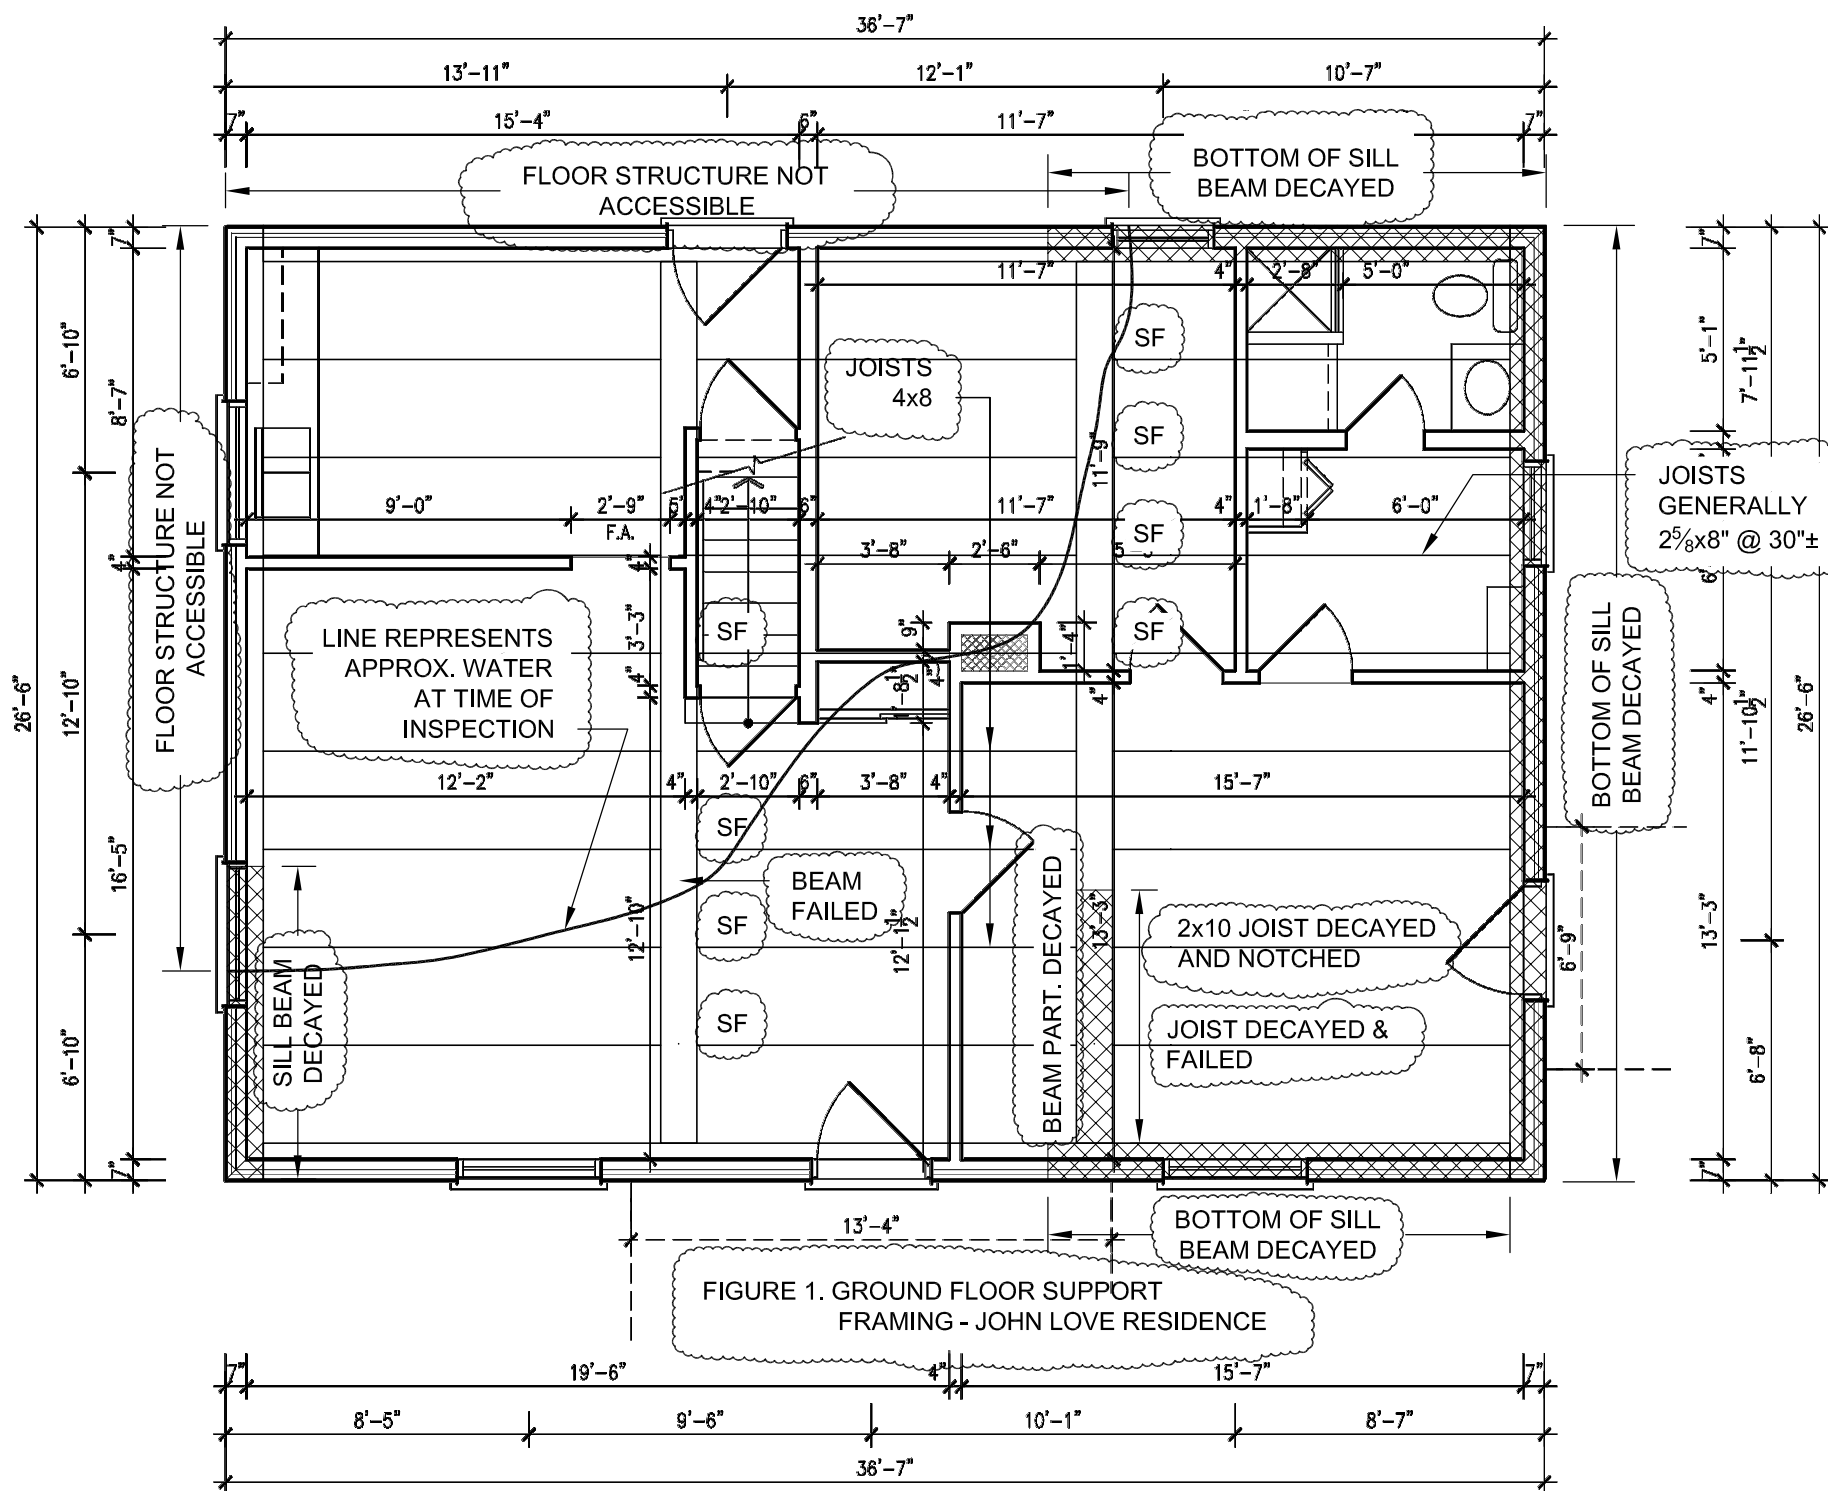
FIGURE 1. GROUND FLOOR SUPPORT FRAMING - JOHN LOVE RESIDENCE

At the time of our inspection there was a large puddle under the house. The house is supported on two steel beams supported on wood cribs (Photo 1). Due to the depth of the water, approximately 25% of the ground floor framing was not accessible. The observations from our inspection are summarized in Figure 1.

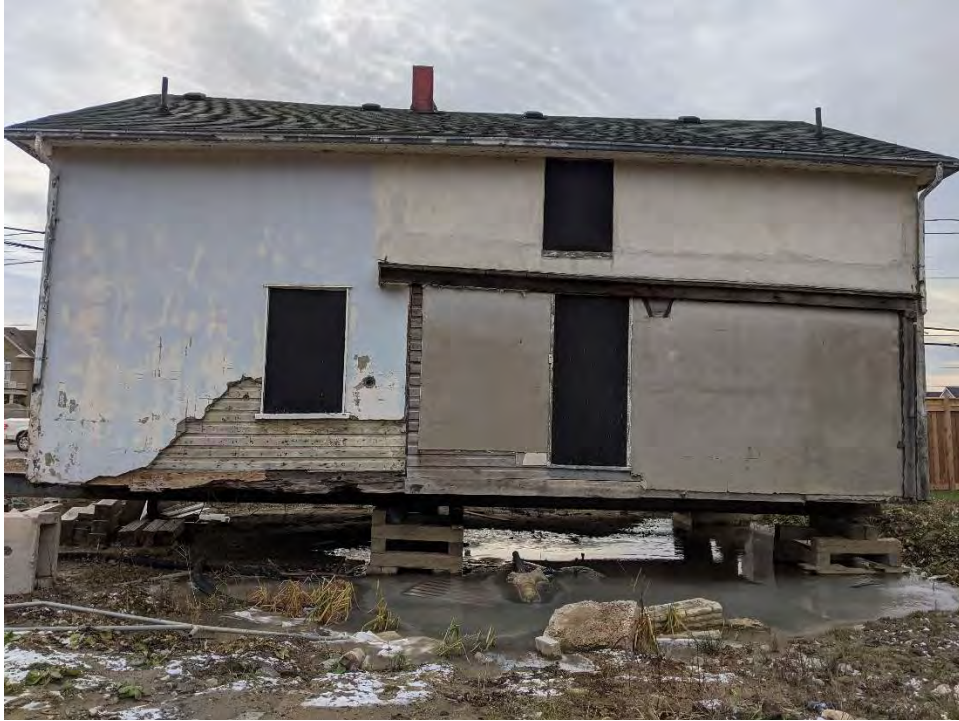
From the exterior it is apparent, Photo 1, that the planks in the vicinity of the bathroom have been cut off at the ground floor level since the side of the sill beam is visible. Therefore, the roof and second floor are no longer supported by the planks. In other areas the planks are deteriorated along with the sill beams. Deformation is visible on the north side of the structure, which is likely due to the poor connections and deterioration of the planks.

As shown in Photo 1, the roof ridge is sagging indicating that the roof rafters have been overstressed for some time.

Photo 1. North elevation of John Love house.

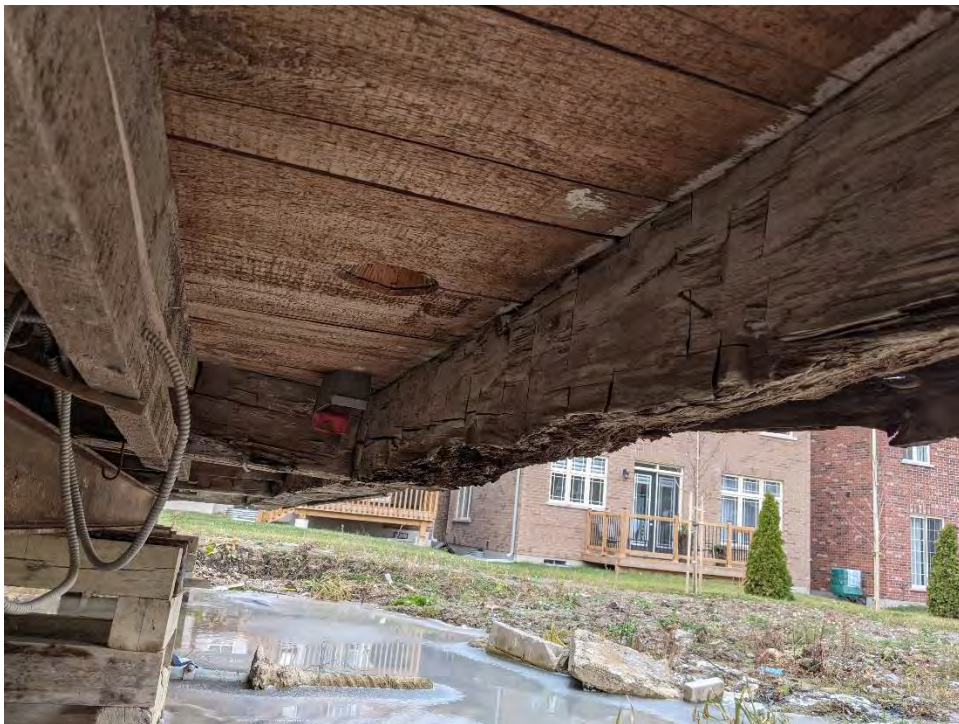
1. Sill Beams – The sill beams are generally in poor condition. The undersides of the north, south and west sill beams are partially decayed (Photo 2, 3 & 4). The section losses due to the decay is approximately 50% of the members. The underside of the east sill plate is decayed along the full length of this member (Photo 5). There is 40 to 50% loss of section on this member. The section losses have also resulted in the mortise and tenon connections, that tie the building together, being compromised (Photo 6).

Photo 2. Decayed north sill beam and failed adjacent floor joist.

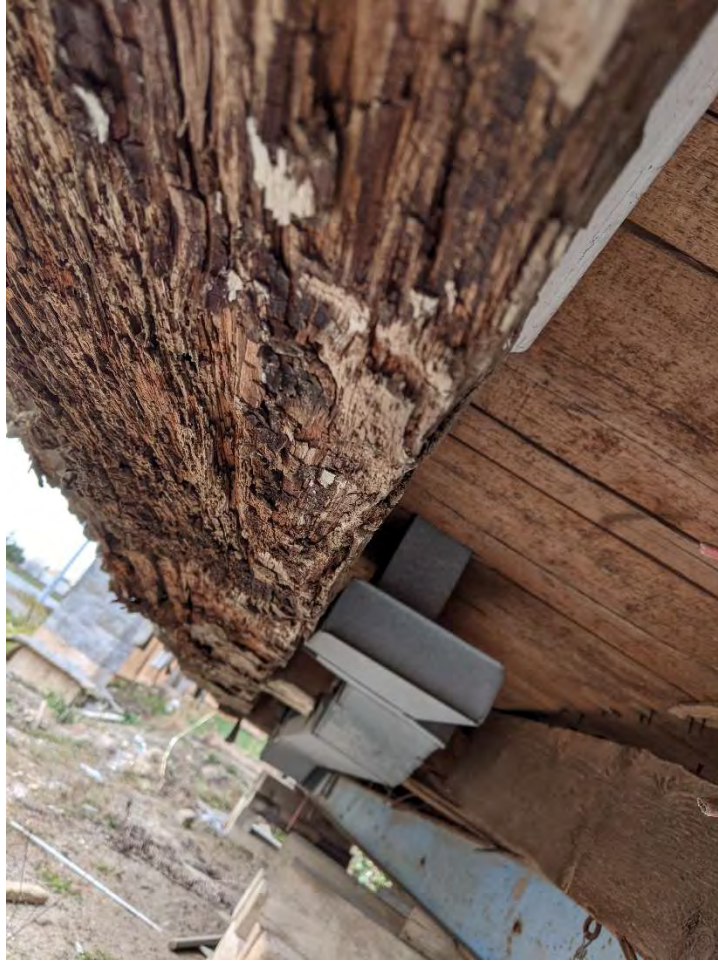
Photo 3. Decayed south sill beam and failed adjacent floor joist.

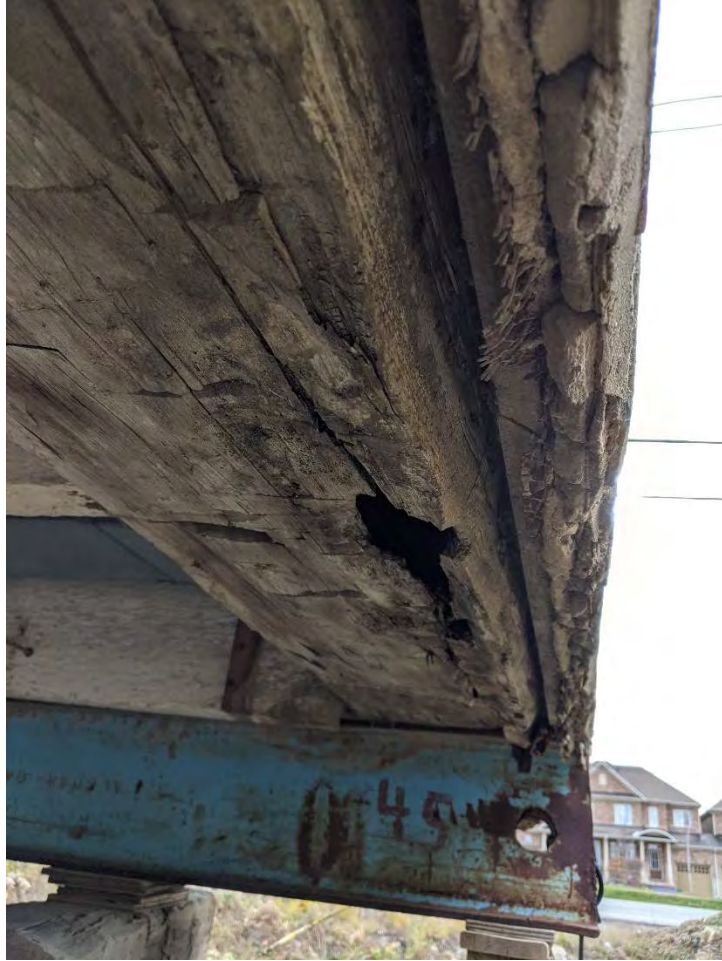
Photo 4. Decayed sill beam at south-west corner of the house.

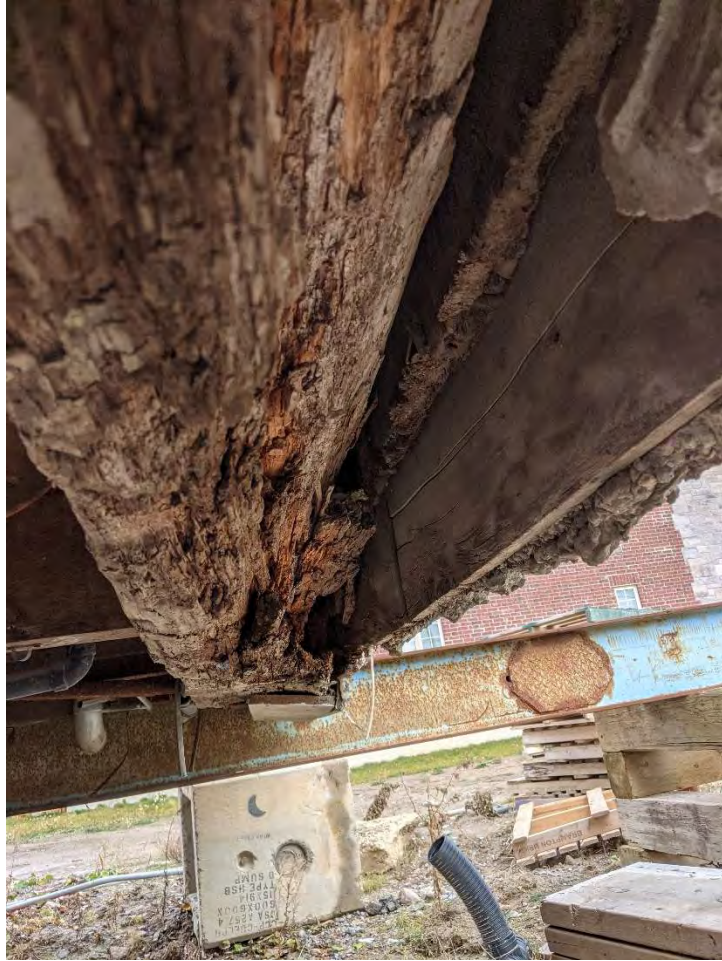
Photo 5. Decayed east sill beam.

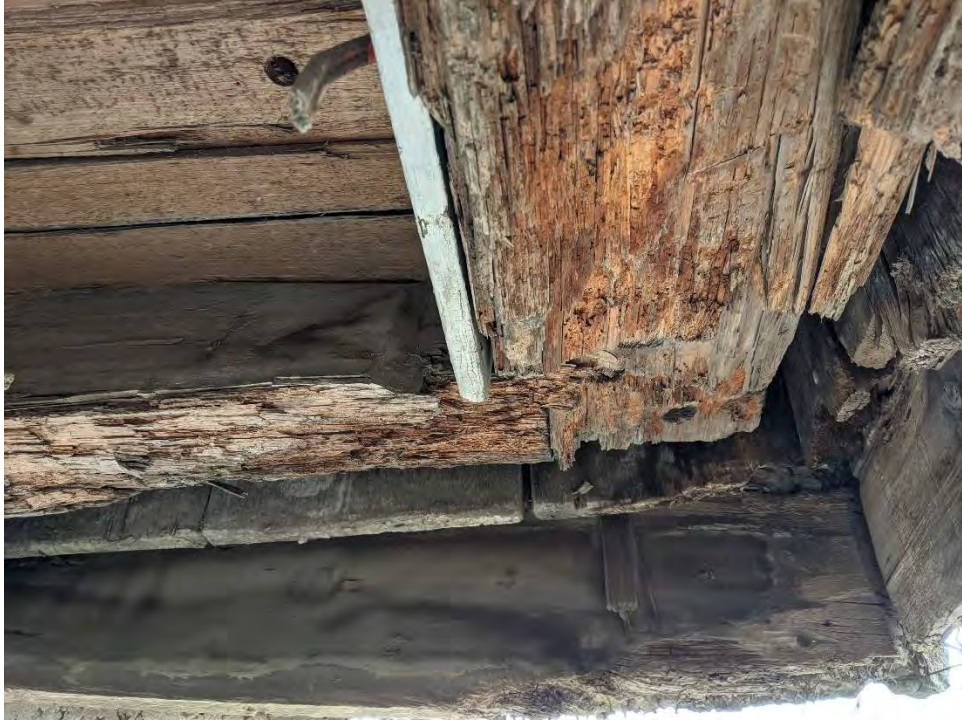
Photo 6. Compromised connection at south-east corner.

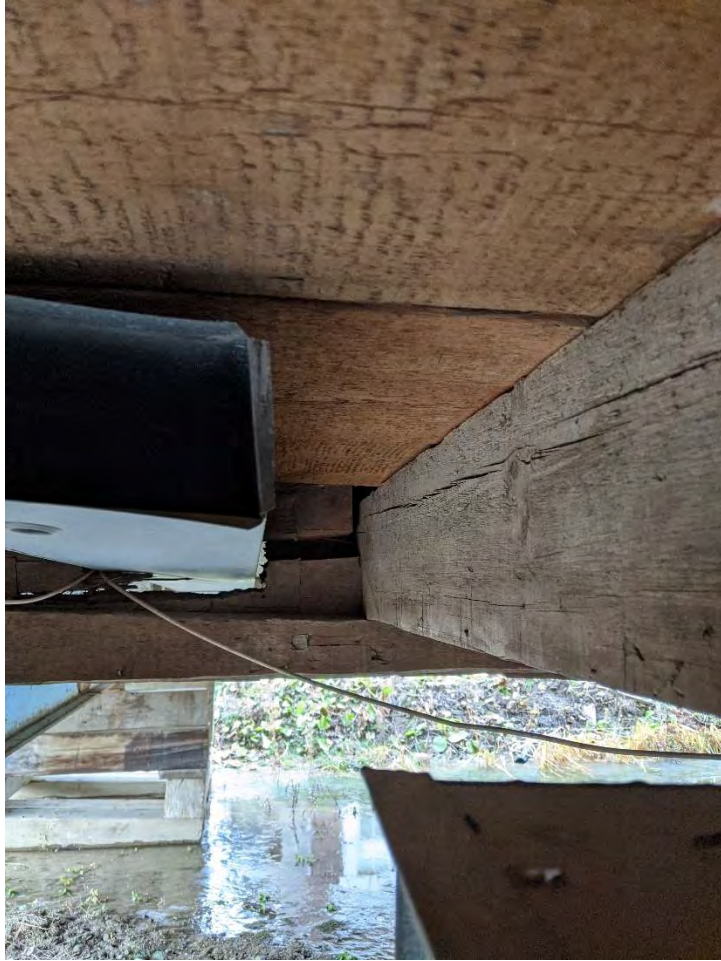
2. Intermediate Floor Beams – The ground floor structure has two intermediate 12x12 floor beams. The western beam, closer to the back of the house, has failed in bending and needs to be replaced or reinforced (Photo 7). The eastern floor beam is partially decayed on the underside of the beam (Photo 8). The mortise and tenon connection at the north and south sill beam have been compromised due to decay.

Photo 7. Failed western intermediate beam. Failed at duct.

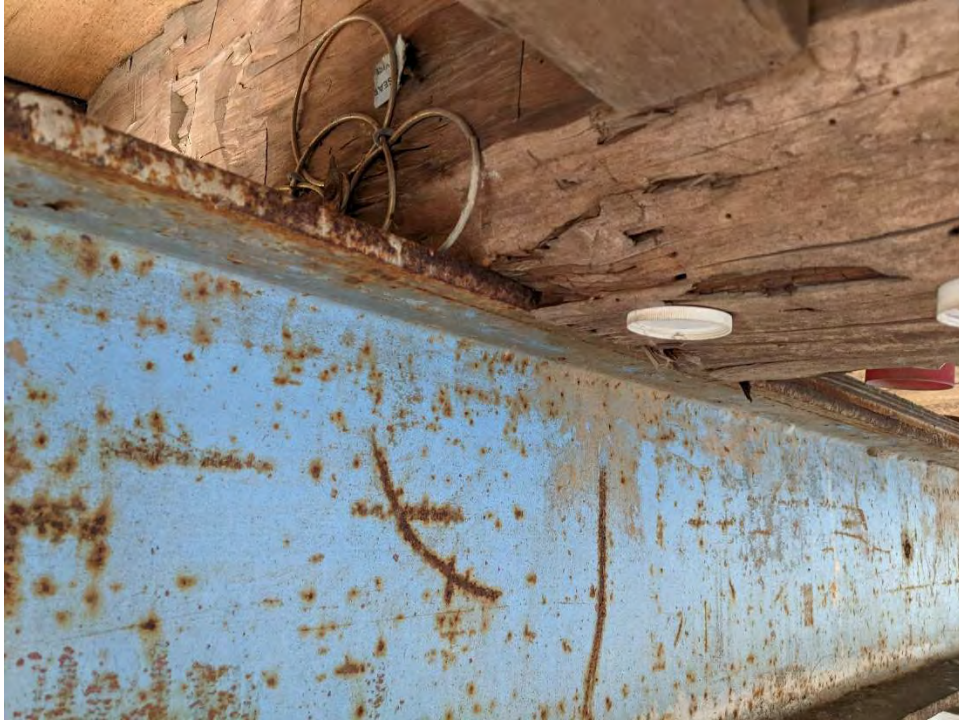
Photo 8. Decayed eastern intermediate beam at south support beam.

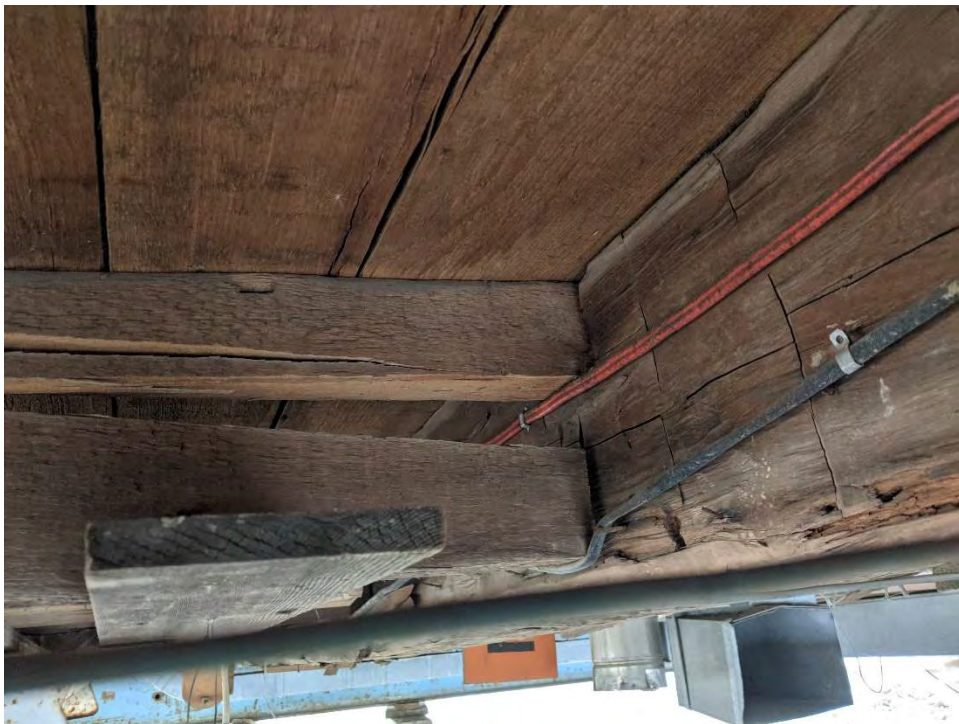
3. Ground Floor Joists – The floor joists are variable in sizes. They consist generally of solid 2x8 spaced at 30", but within the mix there are 4x8's and some 2x10's. The joists are notched to fit into the mortise and tenon connections at the sill and intermediate beams. A large number of the floor joists having shear failures at the notches (Photo 9).

Photo 9. Typical shear failure in floor joist at support. Note decay on underside of intermediate 12x12 beam.

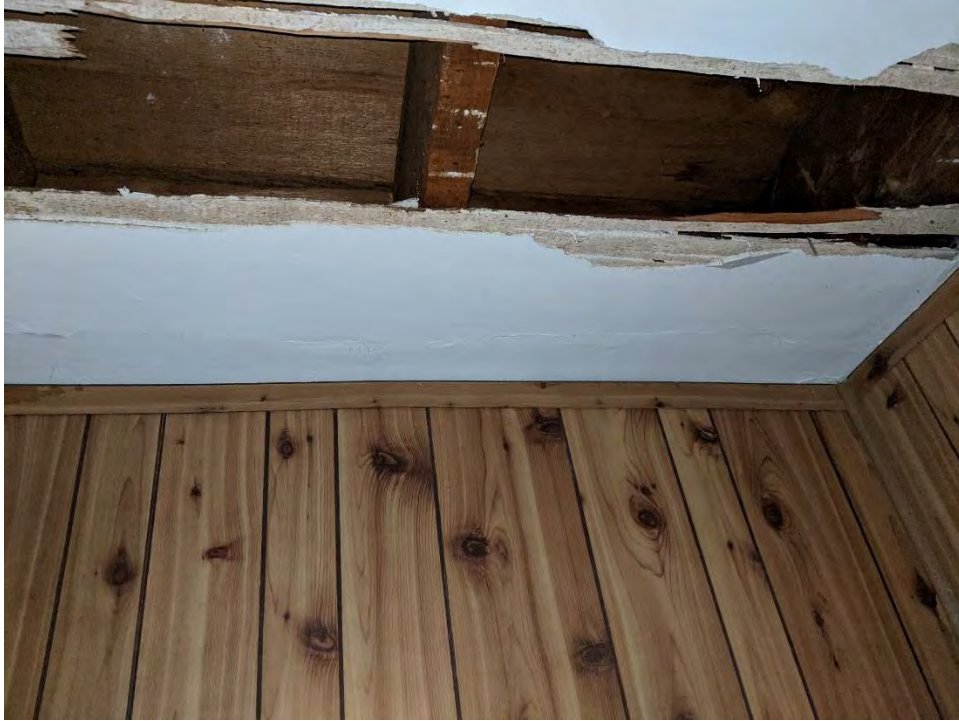
Generally, the condition of the second-floor support framing could not be inspected as it is concealed by the lathe and plaster and drywall. There was a small opening in the ceiling over the ground floor bathroom. The opening revealed the 2 ½"x10" ground floor joists, which are spaced at 24", frame into a 10x10 perimeter beam (Photo 10). Based on the literature the 10x10 beams would be supported by nails from driven through the planks. Thus, the joists are hanging from the beams that are hanging from the sides of the 2 ½"x14" planks.

Photo 10. Second floor support structure at north-east corner of ground floor bathroom.

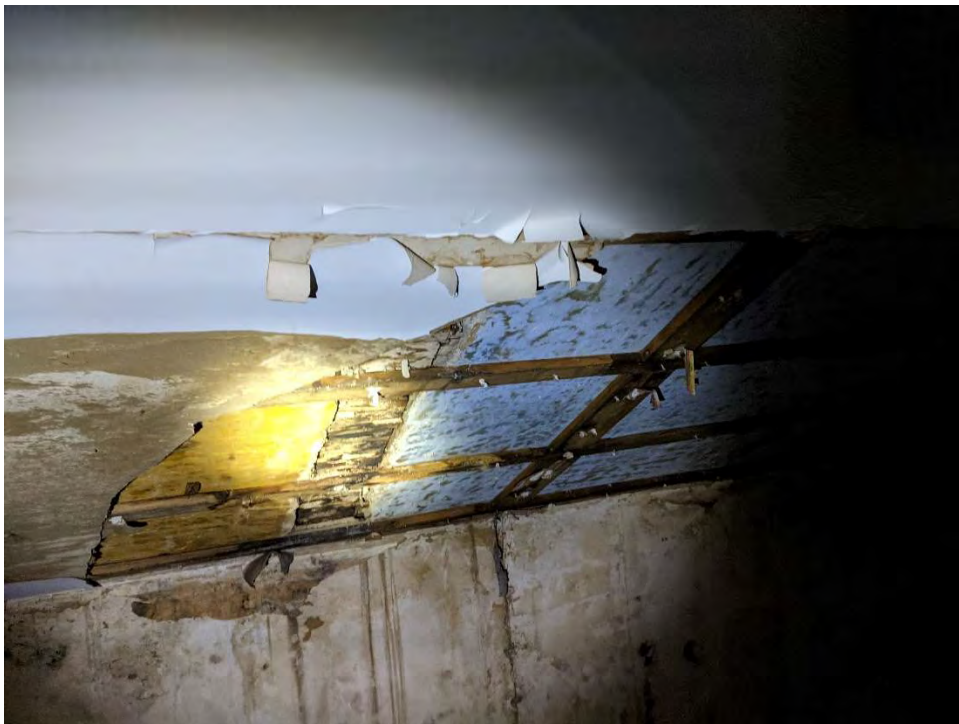
Like the ground floor, the second floor is generally finished and therefore the roof support structure was not visible. There are some locations where the plaster has failed and there was a small hole in the exterior wall of bedroom 4. From the failed plaster on the ceiling it is assumed there is moisture damage to the roof structure due to the presence of mold (Photo 11).

Photo 11. Water damage and mold on lath in bedroom 4.

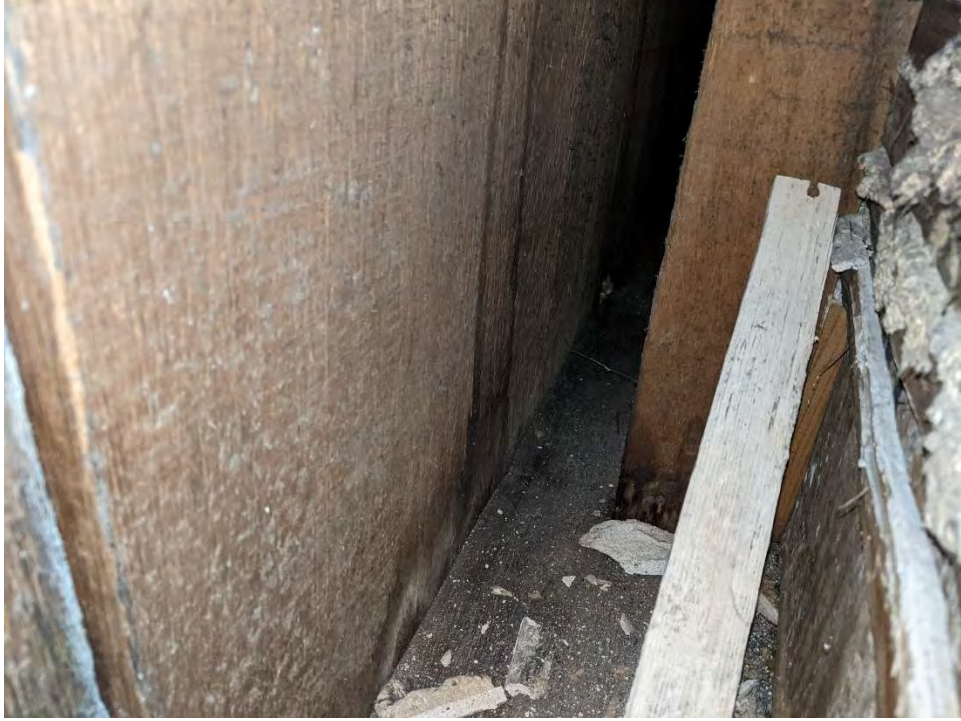
From the hole in the exterior wall of the bedroom, we noted there is a 2x4 stud wall adjacent to the plank wall on the second floor only (Photo 12). The stud wall stands off the plank wall by approximately 2". Based on the literature we suspect there is a perimeter member fastened to the inside face of the planks that supports the roof rafters. The stud wall may have been erected to assist in the support of the roof rafters as the wall has not been insulated.

Photo 12. 2x4 stud wall in exterior wall of bedroom 4.
