BUILDING CONDITION ASSESSMENT

1577 Major Mackenzie Drive East

Richmond Hill, Ontario

Project number 20 – 101

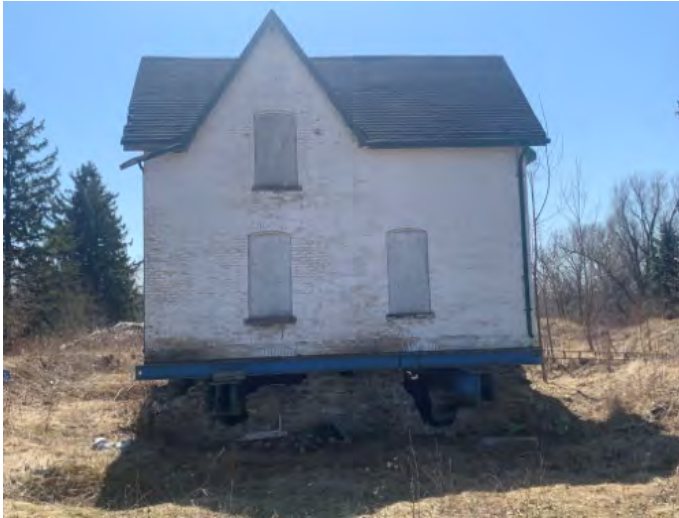
2 storey building.

Exterior walls are of load bearing masonry.

Face sealed wall system allow water diffusion and moisture into the building.

Cracking at high stress corner apparent.

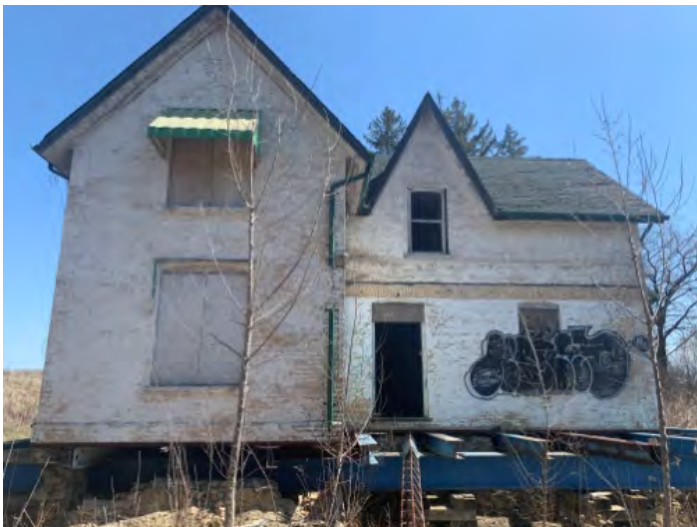
Roof, soffit and eave damage is apparent.

Deteriorated shingles and sheathing allows precipitation in the building.

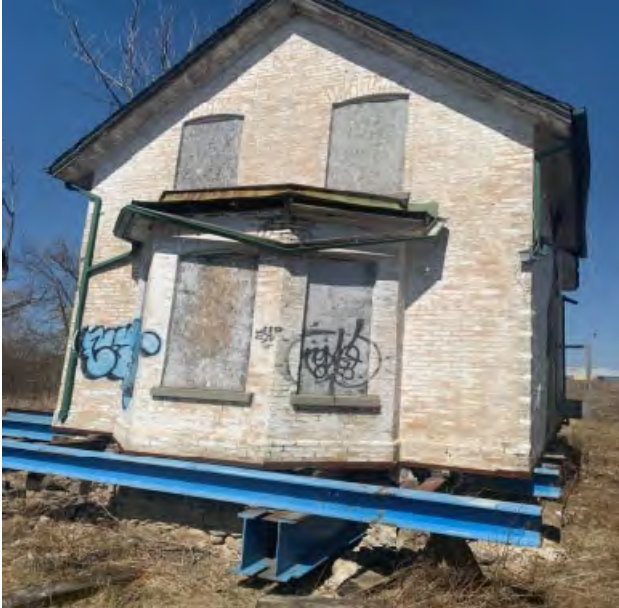
Damaged soffit

Fallen eave trough

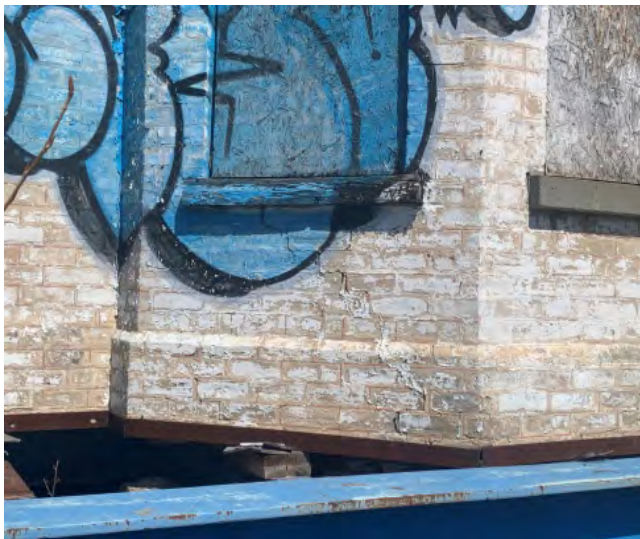
3. The perimeter 3"x3"x3/16" angle at the base of the exterior carries a the entire load of the 8" exterior wall and part of the ground floor, second floor framing and the part of the roof framing as well. The angles are tack welded together. The angle is an unsafe condition.

Cracked masonry at high stress location

The perimeter 3"x3"x3/16" angle which carries the outside wall is in adequate and unsafe.

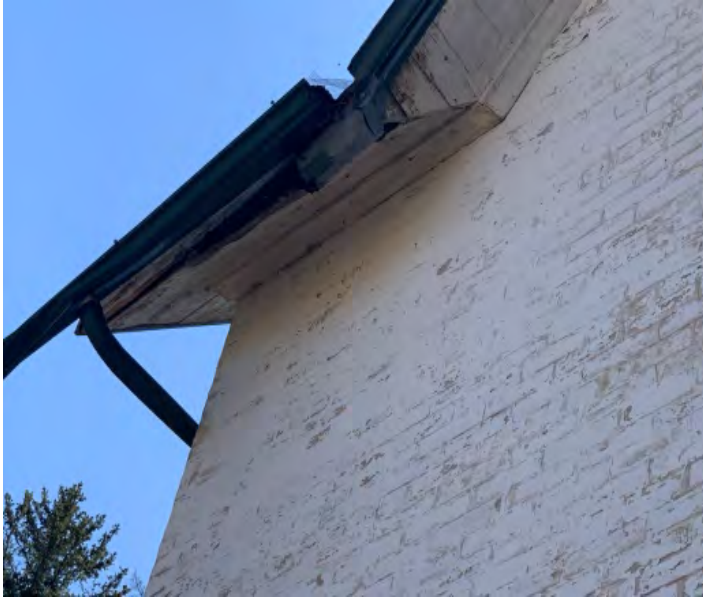
Rotting and deteriorating soffit and eaves.

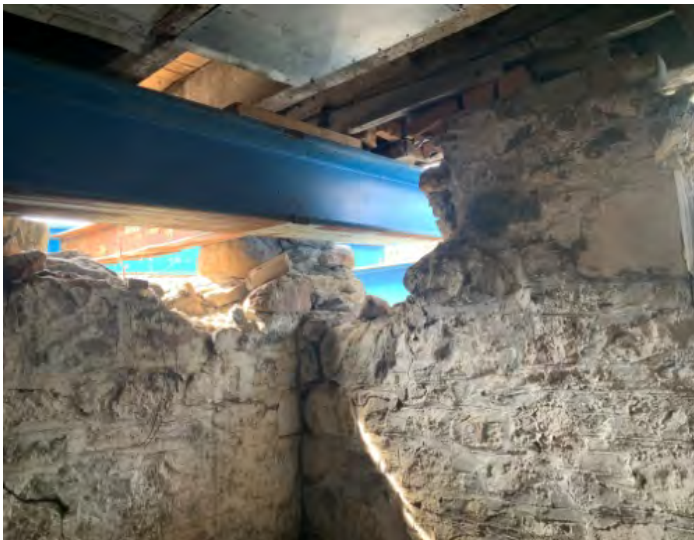
The lifting operations comprised the structural integrity of the building structural system.

Lifting operation significantly damaged the structural integrity of the load bearing walls around the entire perimeter of the building.

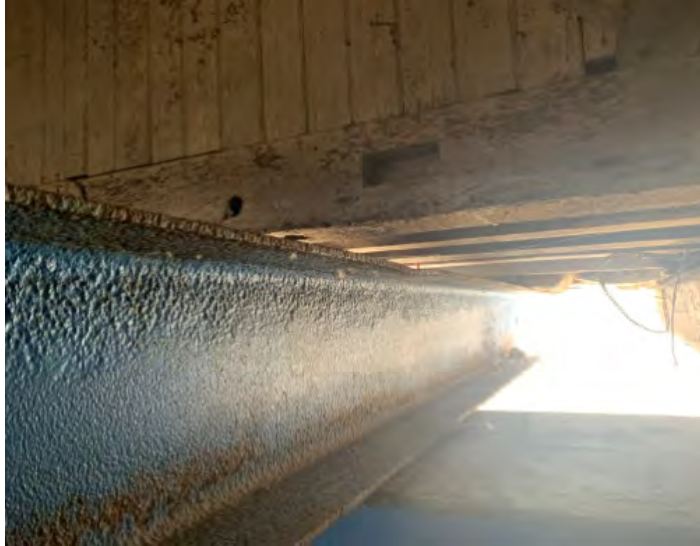
The structure is not being fully supported, contravention of both the OBC and OHSA.

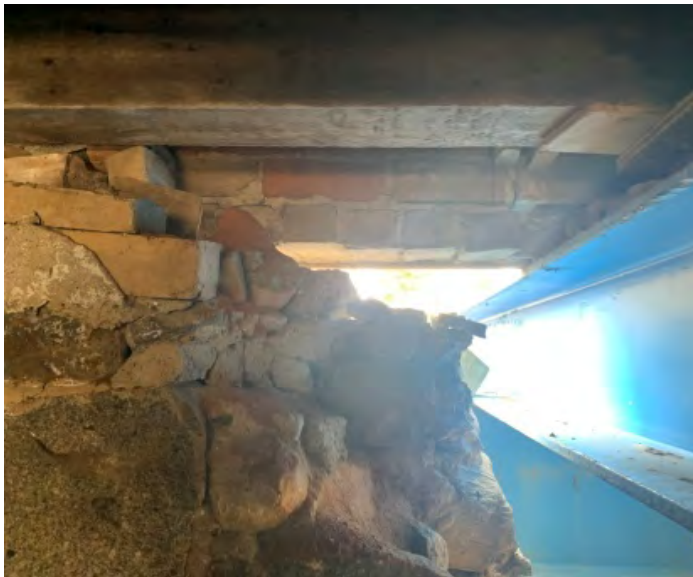
5. The connection of the ground floor framing to the exterior walls has been structurally compromised.

The exterior load bearing wall is not fully supported. The existing support is comprised of a 3"x3"x3"/16" angle which carries the 8" outside wall.

There is in adequate connection of the ground floor framing to the exterior wall. There are no sill plate or anchor and the perimeter walls are structurally comprised.

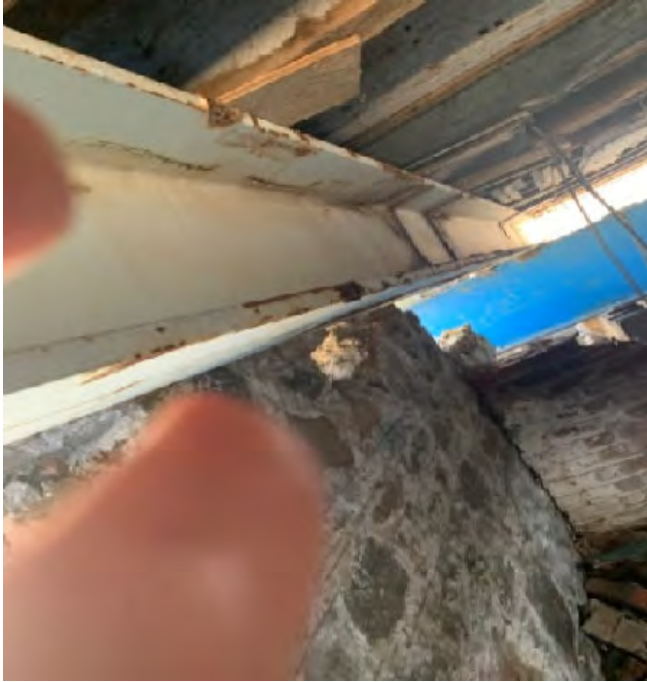
4. The ground floor joist are not provided with full support / bearing. In some areas the joists have been wedged to provide suitable bearing and allow leveling of the floor.

Where full bearing is not provided wedges are used to provide full bearing and floor leveling.

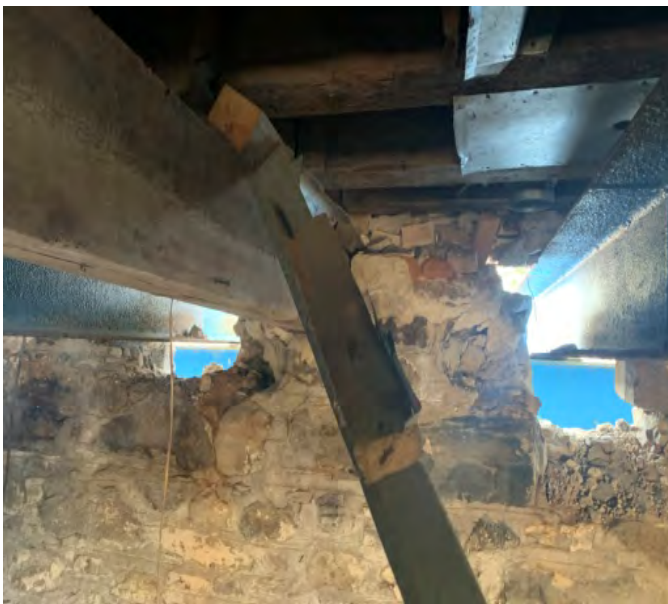
Ground floor framing, unsafe condition. Planking above has no partial structural support.

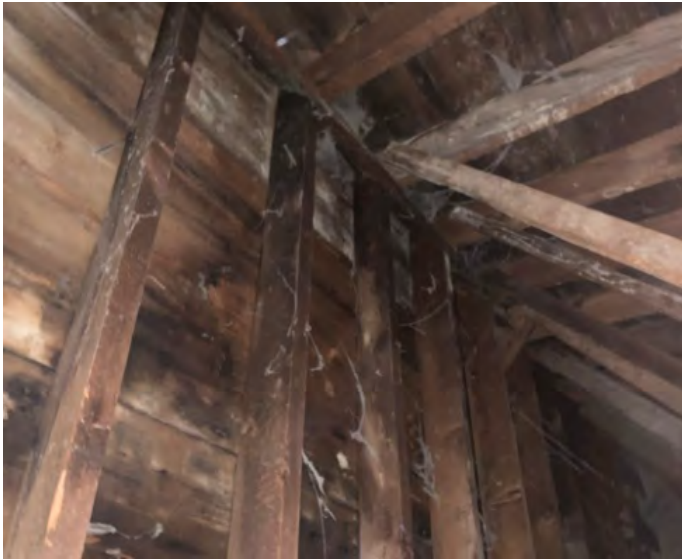
Conventional roof framing. Framing member are stained due to water migration into the building.

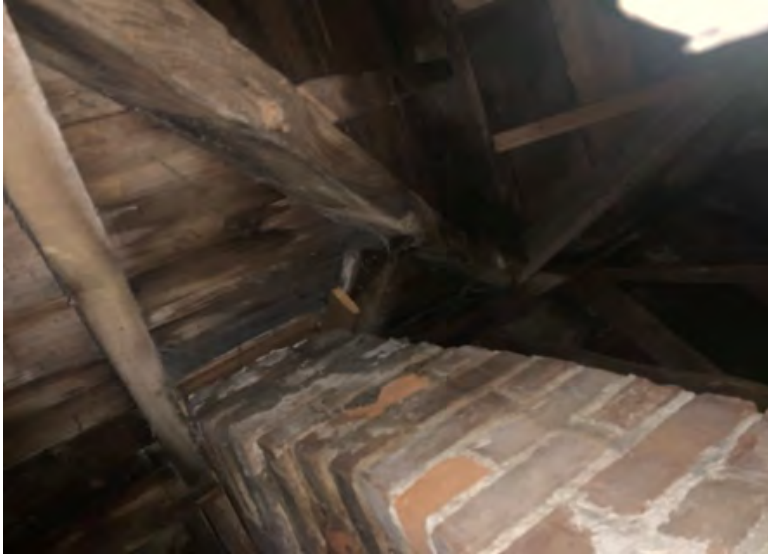
7. The roof rafters are in a good condition, they are supported by the outside walls with the main ridge tied into a centrally located chimney. The chimney does not have adequate support at the base. The existing conditions are unsafe.

Roof rafters are tied into the existing chimney. Rafter and roof sheathing contain signs of water damage.

The chimney is tied at the top and has no support at the base level and will not be capable of resisting centrifugal forces during transportation. Contravention of OHSA and the OBC.

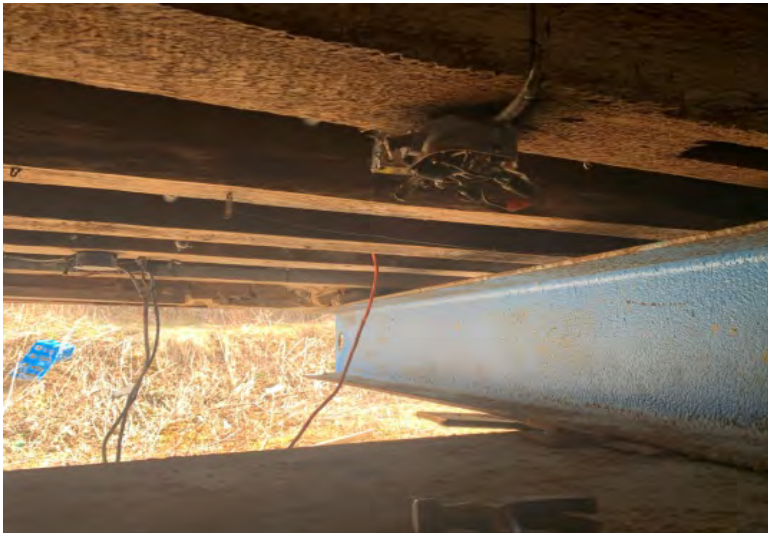
Building decommissioned services

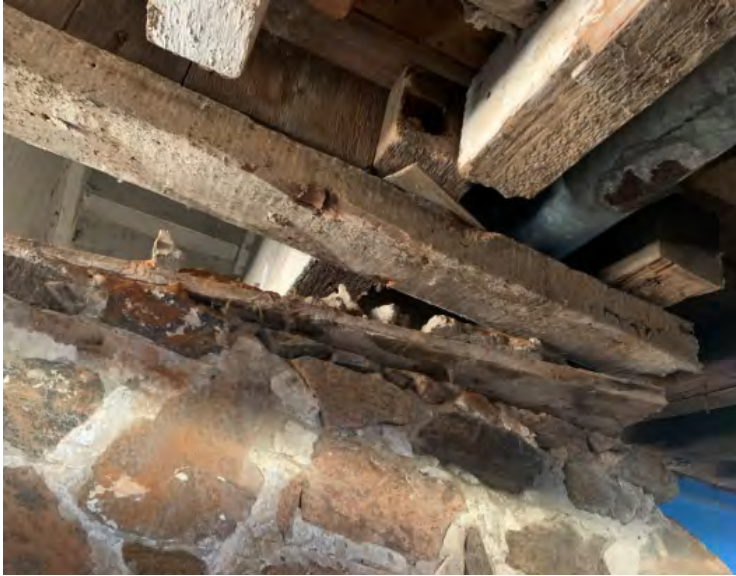
Ground floor framing has no bearing and no connection.

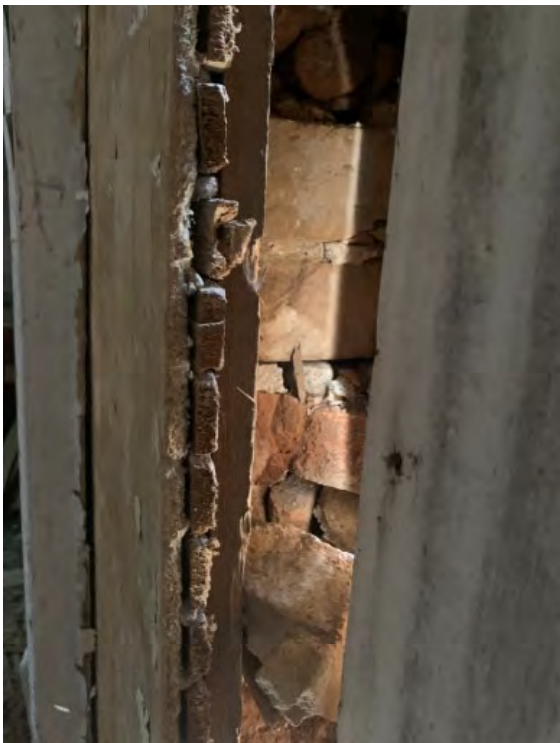
Face sealed load bearing exterior wall assembly comprised of 2 Wythe of masonry brick finished on the inside with lath and plaster.

No air barrier, no moisture barrier and no thermal insulation.

Wall provides no protection against thermal transmission, vapor diffusion and air transmission.

Energy efficiency resistance as required through SB12 is not provided.

Structural integrity of the load bearing is compromised.

Exterior wall is in strict contravention of Part 5 of the OBC and OHSA.

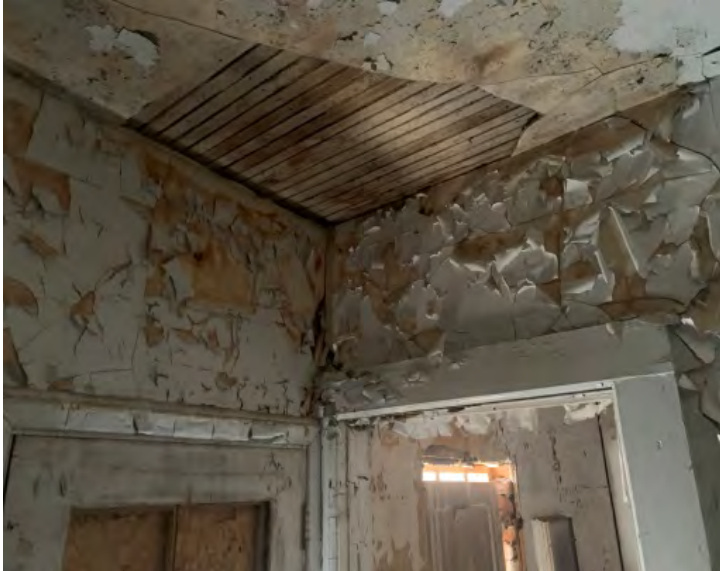
Water migration into the building has resulted in damage to all entire walls. Note that mold and water damage is throughout the building.

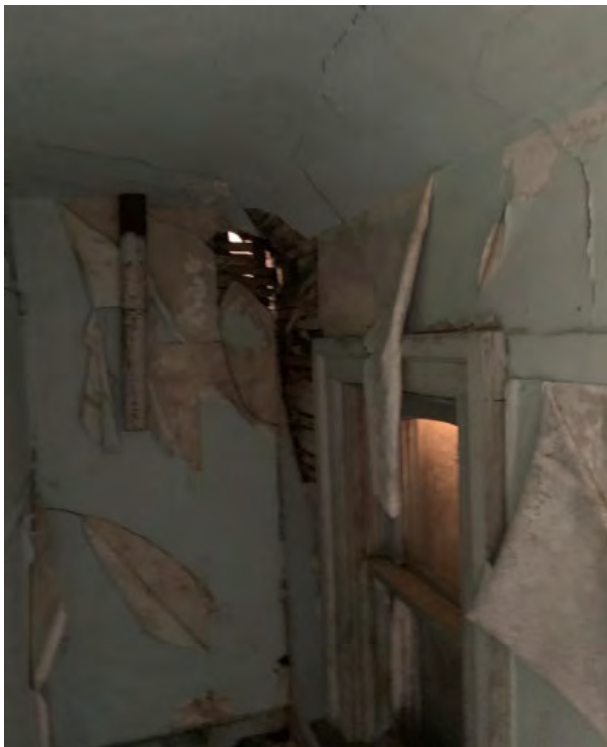
Water migration into the building has resulted in damage to all entire walls. Note that mold and water damage is throughout the building.

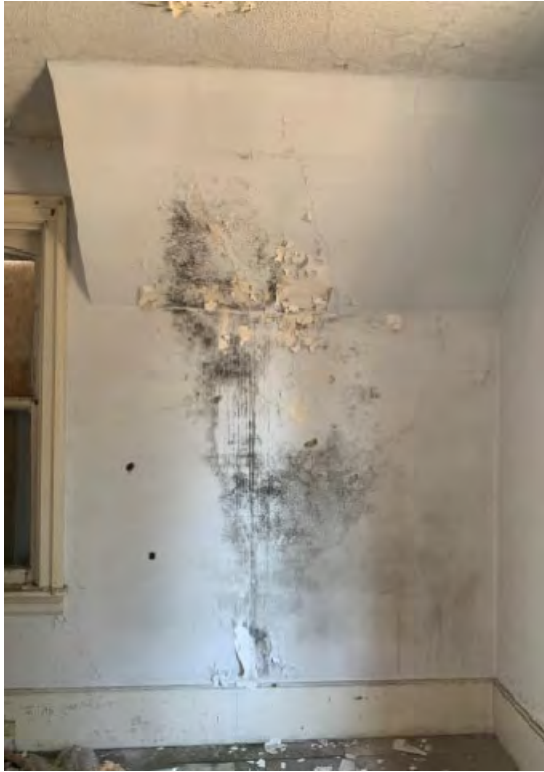
Water migration into the building has resulted in damage to all entire walls. Note that mold and water damage is throughout the building.

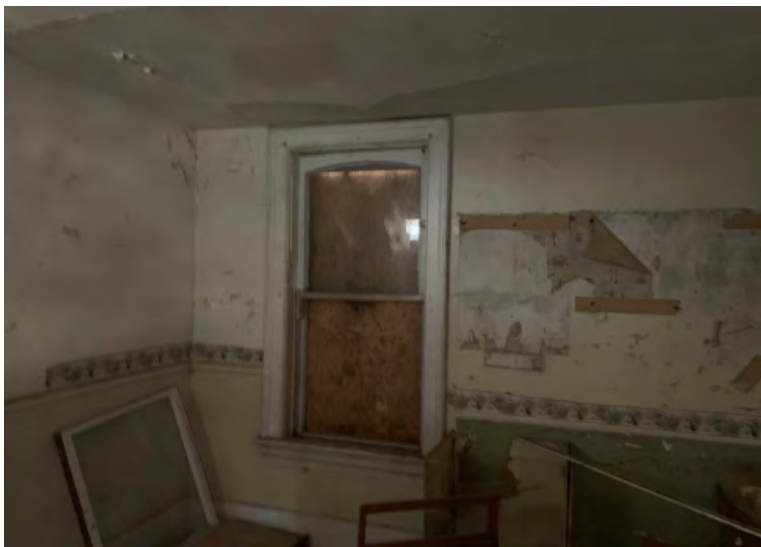
Damaged interior surface.

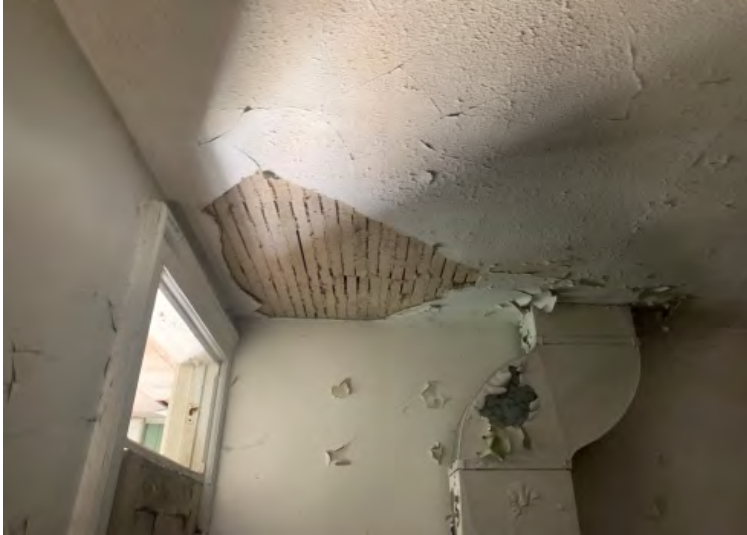
Deteriorated Interior finishes.

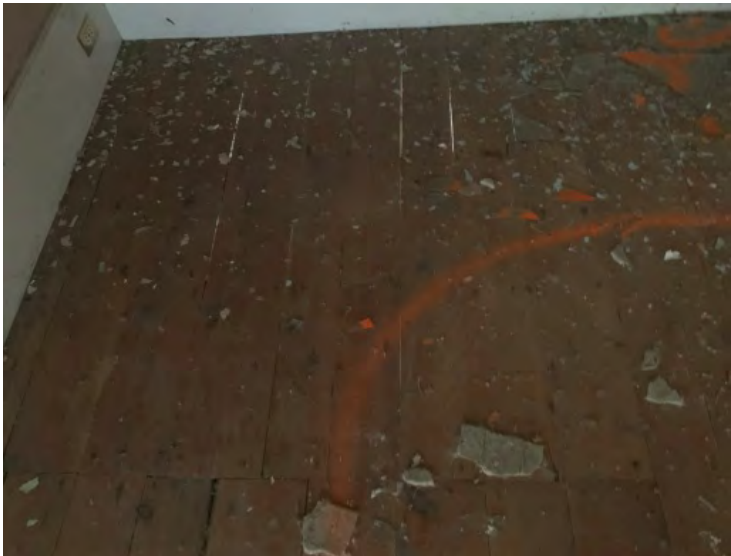
Existing wood sub floor with in adequate framing below.

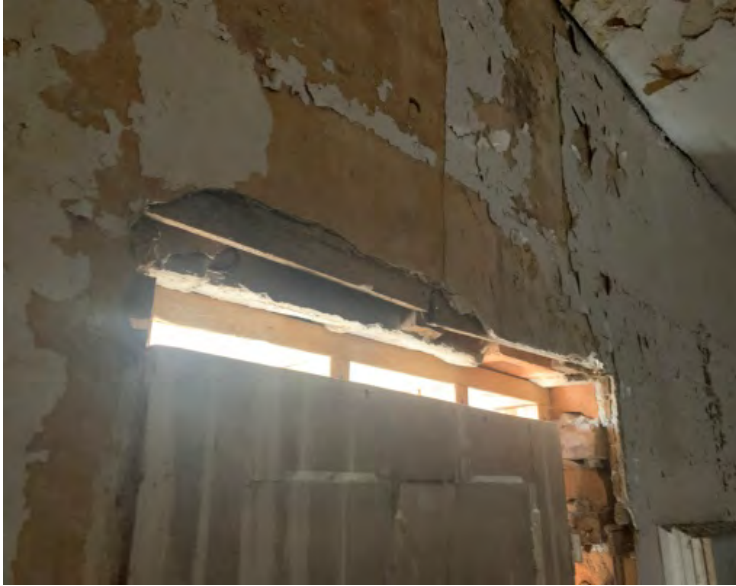
Water damage and build up of mold.

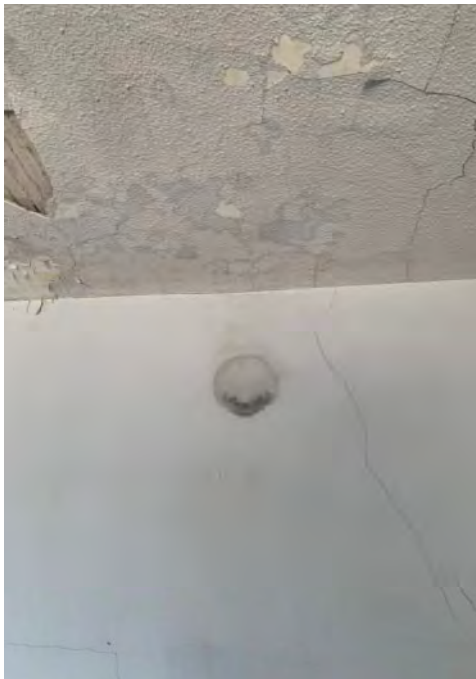
Mold and water damage on ceiling and walls
