# 103 RICHMOND STREET, RICHMOND HILL CONSERVATION BRIEF

FINAL  
MAY 17, 2023

PREPARED FOR  
**SAIM MUMAL**

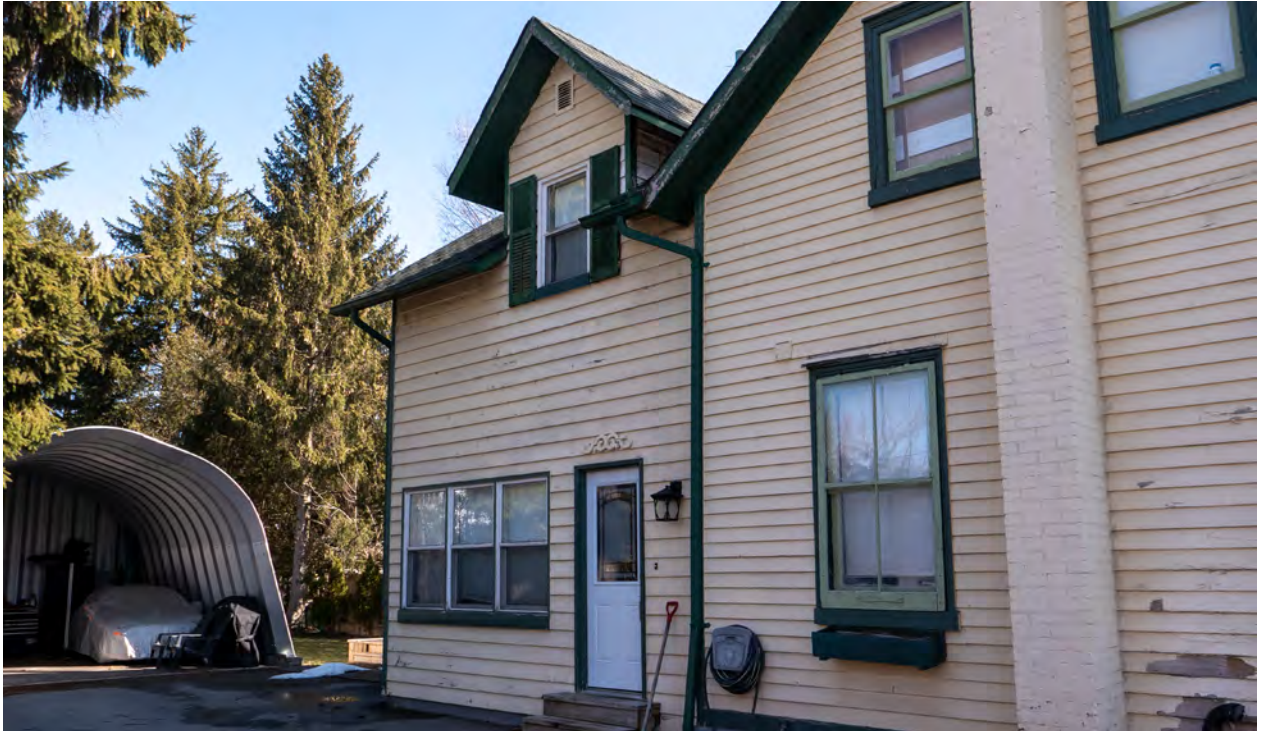
Figure 10: The north extension left of the main south portion. The gable dormer with shuttered window and wide three window opening at grade are both out of character with the Classic Ontario building type (CBCollective 2023).

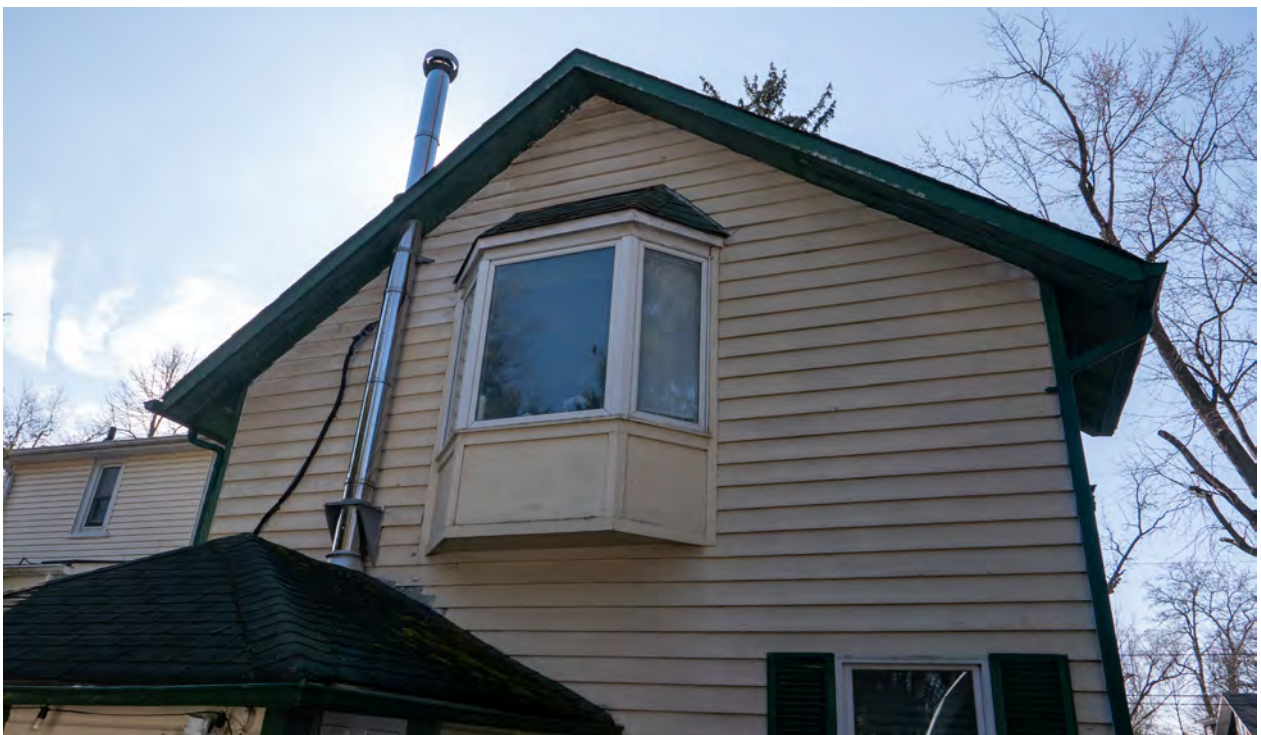
Figure 11: The rear oriel window is out of character with the Classic Ontario building type (CBCollective 2023).

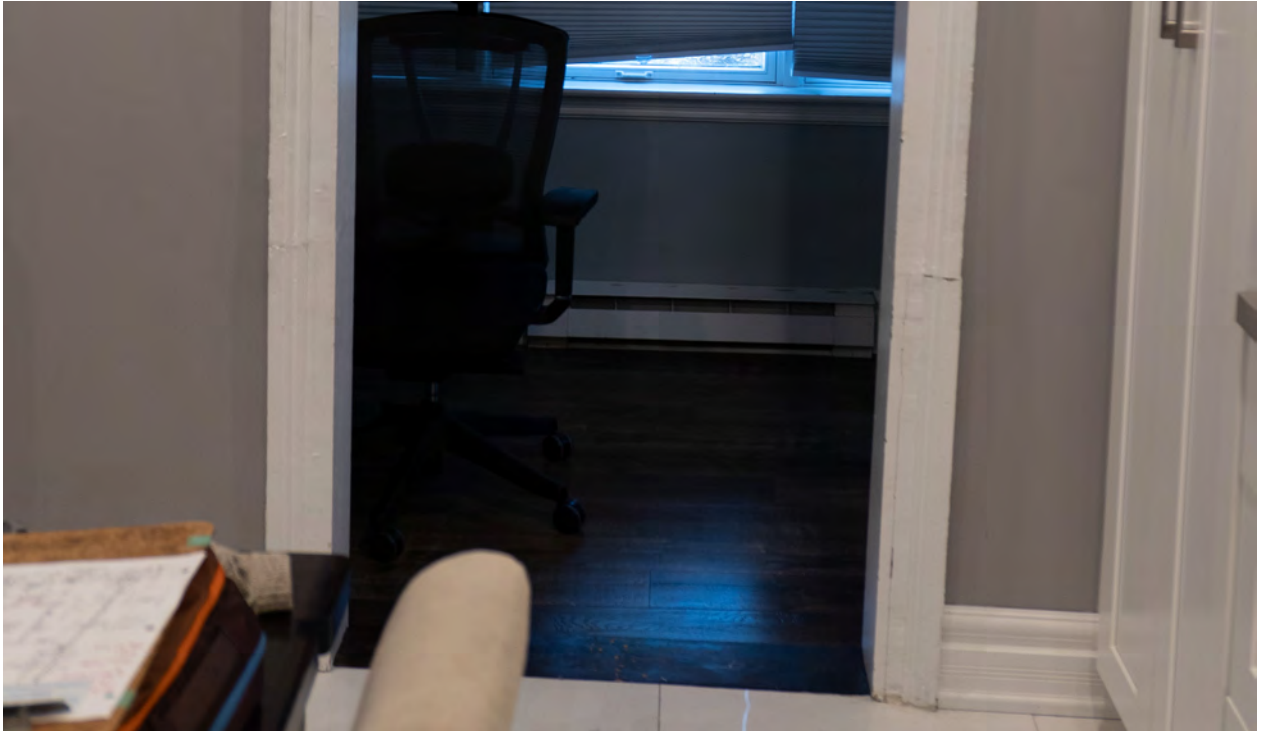
limits of the building, with newer trim indicative of subsequent additions. Newer trim was specifically observed in the two western first floor rooms in the northern portion, and in second storey rooms above the northern portion. The northern doorway on the kitchen's east wall has mouldings with clear joint lines, suggesting the opening was originally a window but was subsequently enlarged into a doorway (Figure 16).

Figure 16: Doorway casings in-line with former side door on west wall of kitchen showing joints, suggesting the opening was originally a window and subsequently expanded to serve as a door (CBCollective 2023).

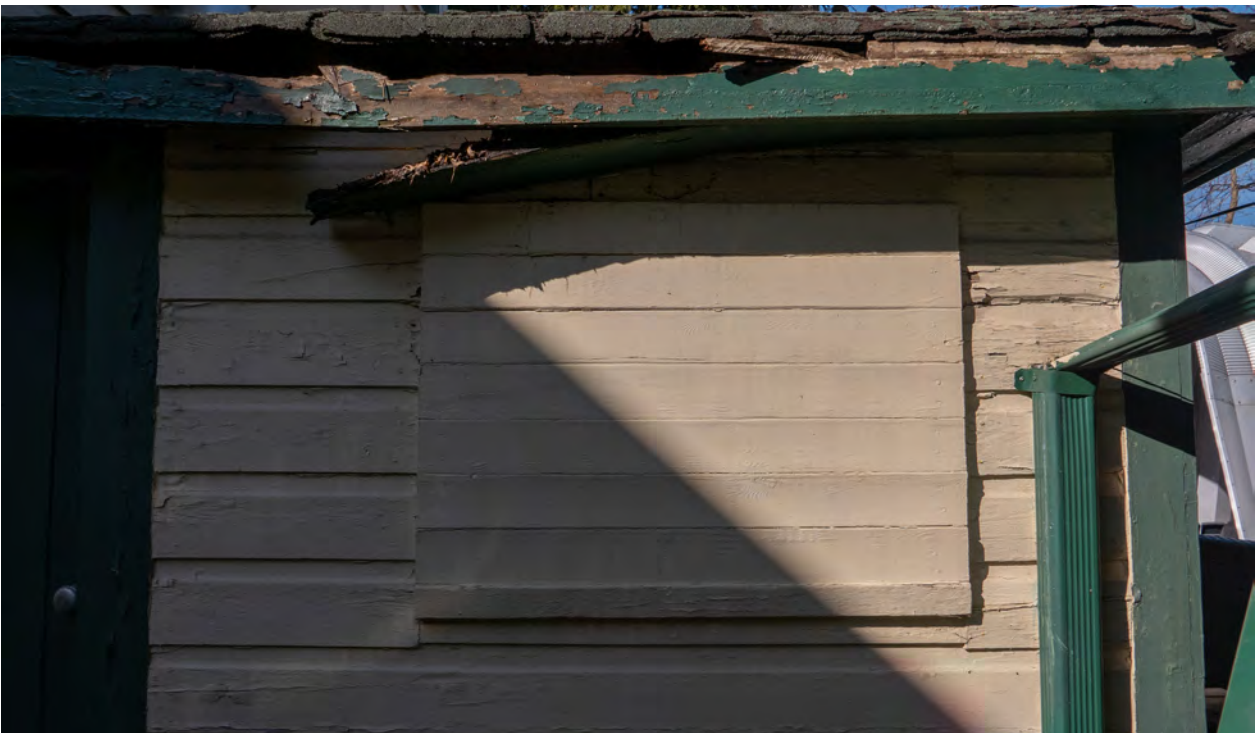
The age of the one-storey vestibule structure extending north from this section is unknown (see Figure 4). Its shiplap siding matches that found on the enclosed porch on the south elevation. It has had previous openings covered, and some fascia boards are highly deteriorated to the point of failure (Figure 19). Thus irrespective of potential age, it appears to have been modified in numerous ways, and displays significant deterioration.

Figure 19: East side of the one-storey vestibule, showing covered openings and damaged fascia (CBCollective 2023).

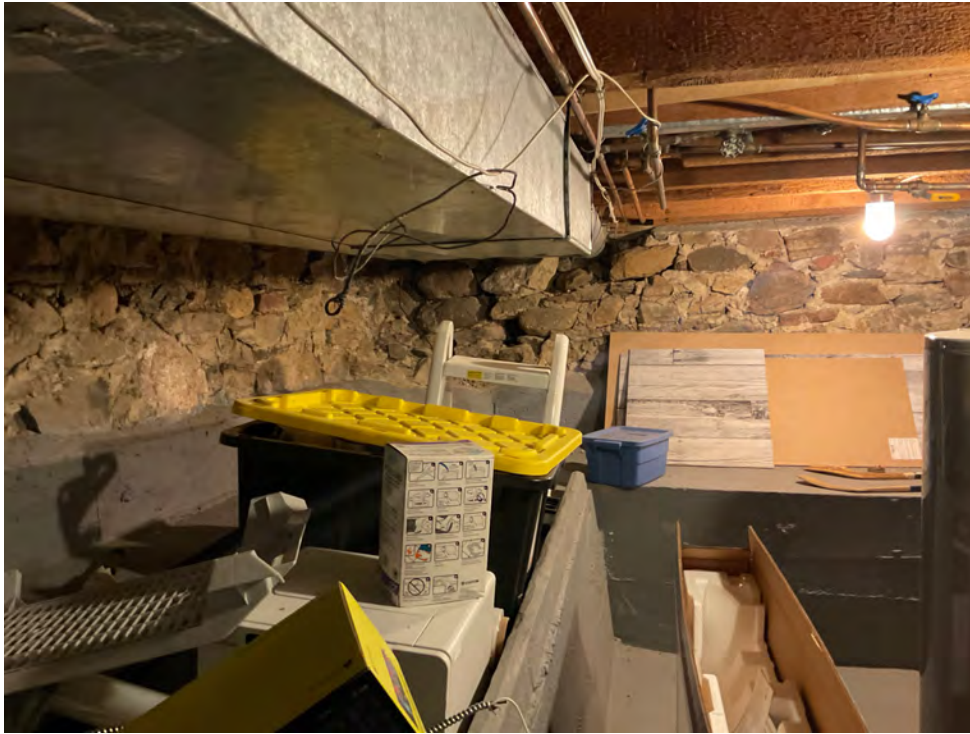
The basement configuration supports the notion that the southern portion of the dwelling was the main part of the original structure, with a portion of the northern structure extending north. Though both sections of the basement appear to have been underpinned subsequently, the area beneath the southern portion has a larger area, and features deeper foundation walls than that beneath the north extension which is limited in size (Figures 20 & 21).

Figure 20: Partial depth foundation walls and subsequent underpinning beneath the north extension (CBCollective 2023).

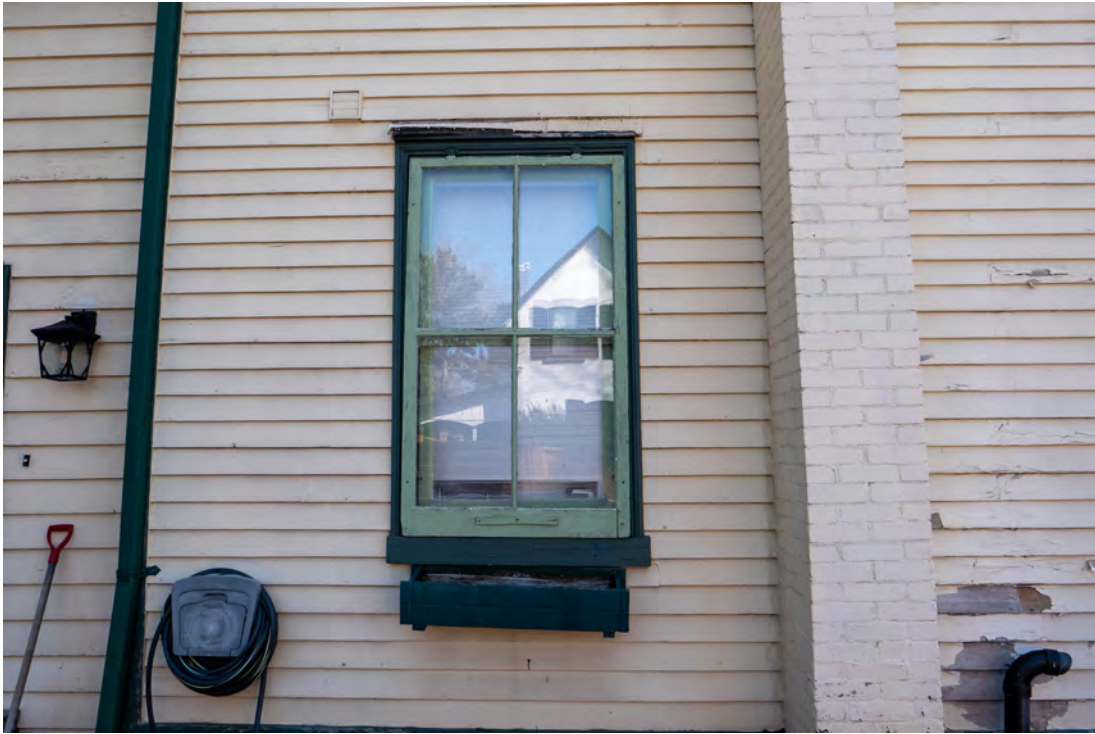
Figure 22: text (*cap*).

The entire dwelling is clad with clapboard siding, with the original (c.1886) boards slightly narrower than those used on later additions. Only the original siding is an attribute, found on the main southern portion of the dwelling, and the ground floor east elevation of the north extension. The siding is currently painted yellow and generally appears to be in good condition. Localized peeling paint was observed, and the underlying wood appears to be sound overall (Figure 22).

The proposed site alteration intends to retain the original clapboard siding on the main south portion. It will be scraped and repainted. Deteriorated siding will be replaced to match existing and painted. This attribute will be adequately protected during repositioning of the main south portion.

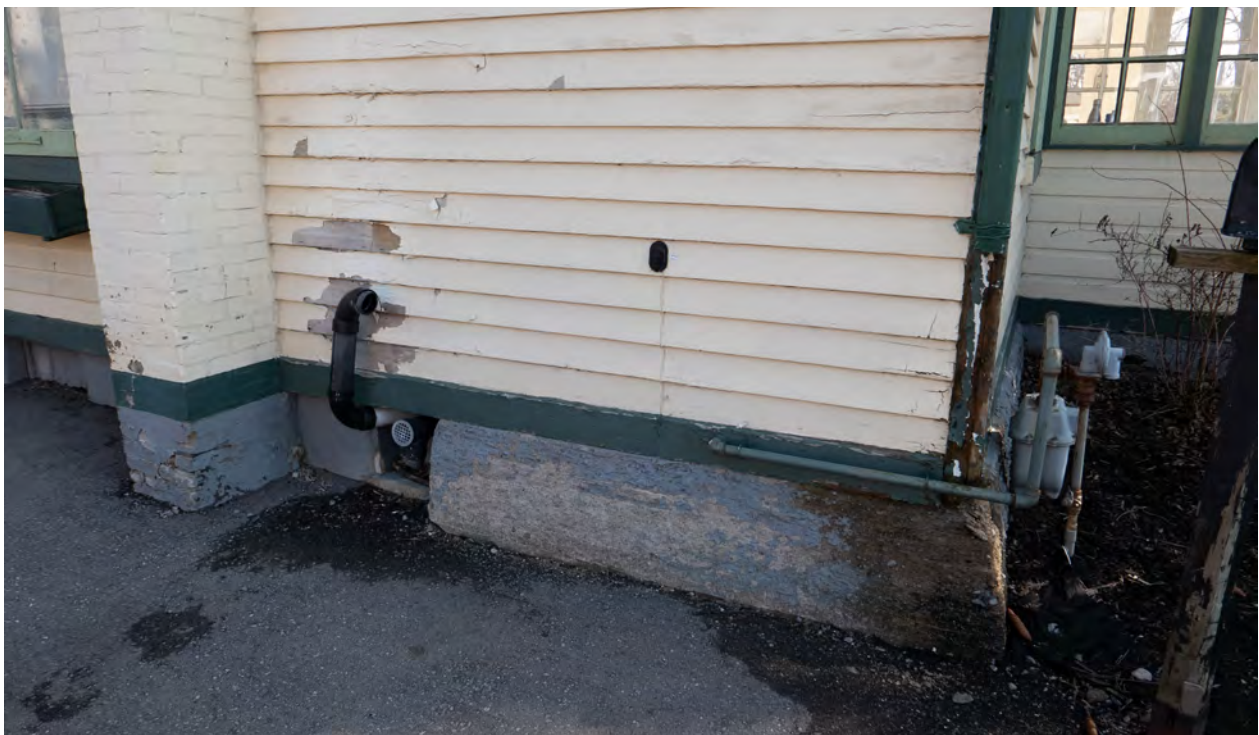
Original corner boards (boards against which the siding is fitted at the corner) were noted on all four corners of the main south portion, and possibly the northeast corner of the historic north extension. These are painted green, with extensive peeling and deterioration observed, particularly where exposed to moisture due to damaged or disconnected downspouts (Figure 23 & see Figure 17).

Figure 23: Corner boards on the southwest corner of the main south portion, showing pronounced damaged at unsecured downspout (CBCollective 2023).

The proposed site alteration intends to retain the original corner boards on the main south portion. Boards in sound condition will be scraped and repainted. Deteriorated boards will be replaced to match existing and painted. This attribute will be adequately protected during repositioning of the main south portion.

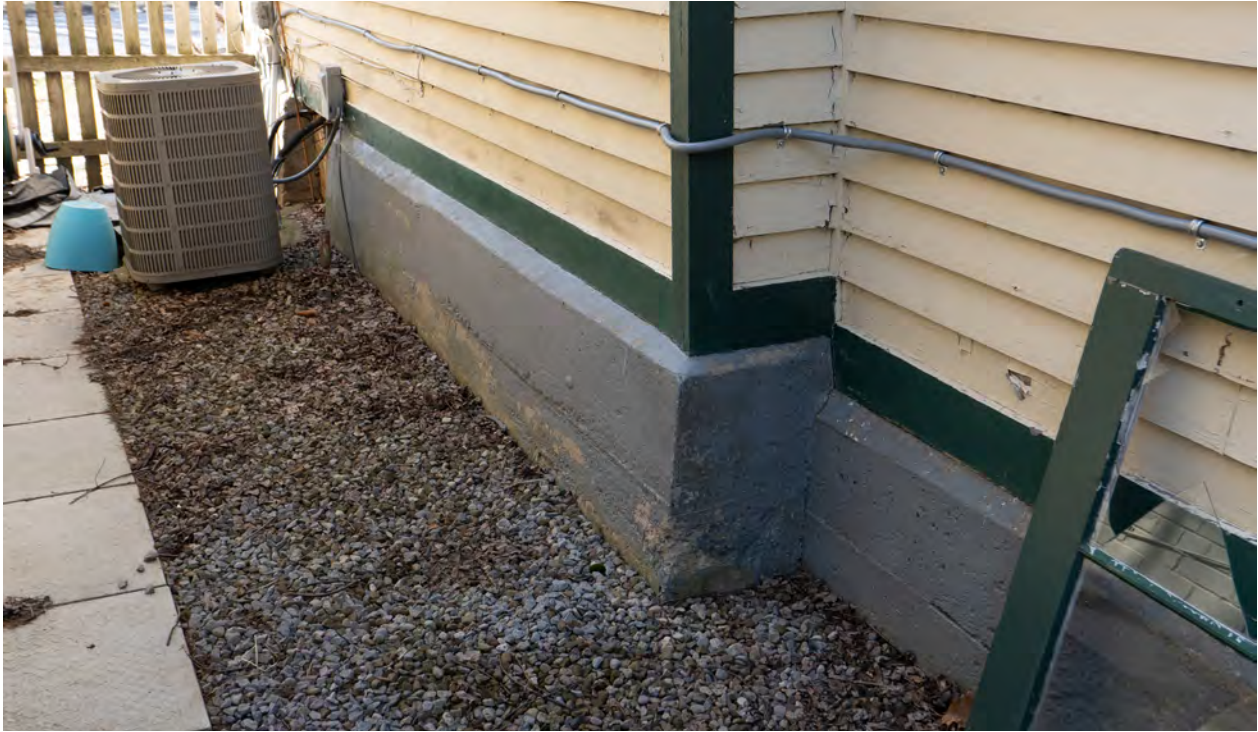
with the corner boards. They are painted green to match the corner boards. Original water table was noted throughout walls on the main south portion and the east elevation of the north extension. They are highly exposed to water, displaying damaged wood and substantial peeling, especially near drainage problems (Figures 24 & 25).

Figure 24: Water table boards running along the east elevation from main south portion (left) to north extension (right) (CBCollective 2023).

The proposed site alteration intends to retain the original corner boards on the main south portion. They will be scraped and repainted. Deteriorated boards will be replaced to match existing and painted. This attribute will be adequately protected during repositioning of the main south portion.

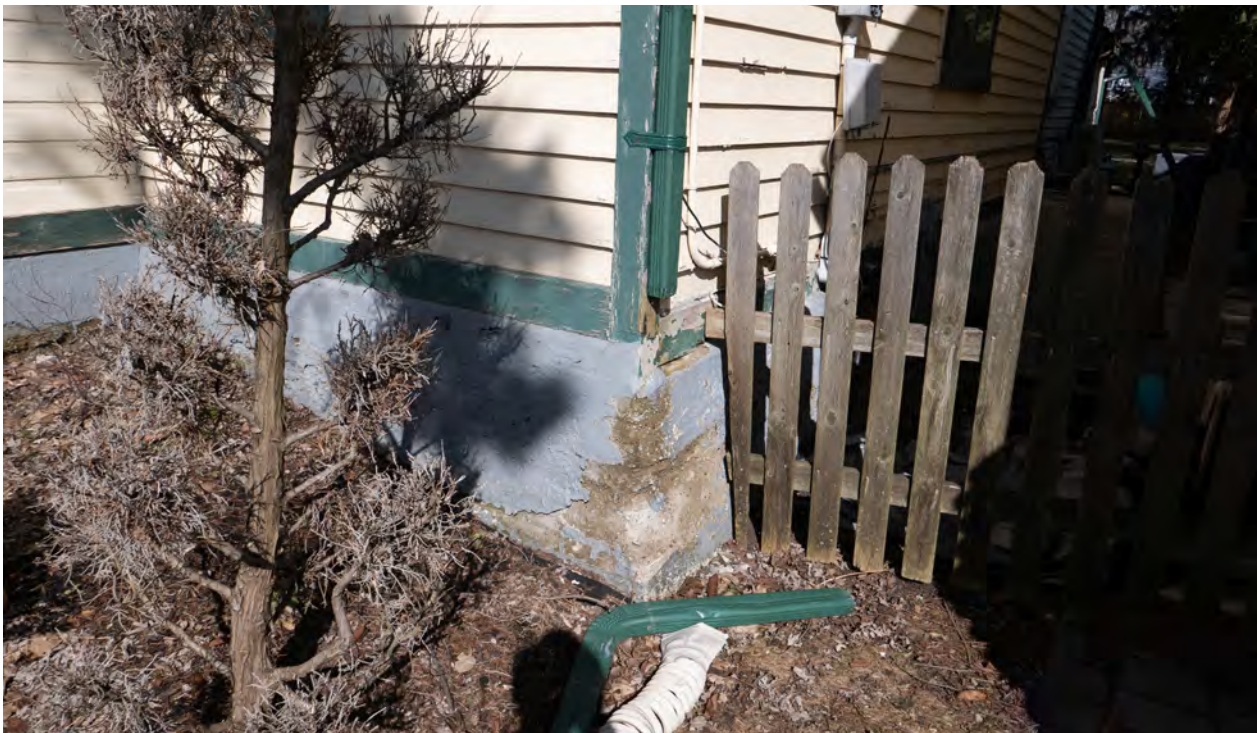
Figure 25: Water table and corner boards at the southeast corner of the main south portion, showing damage from unsecured downspout (CBCollective 2023).

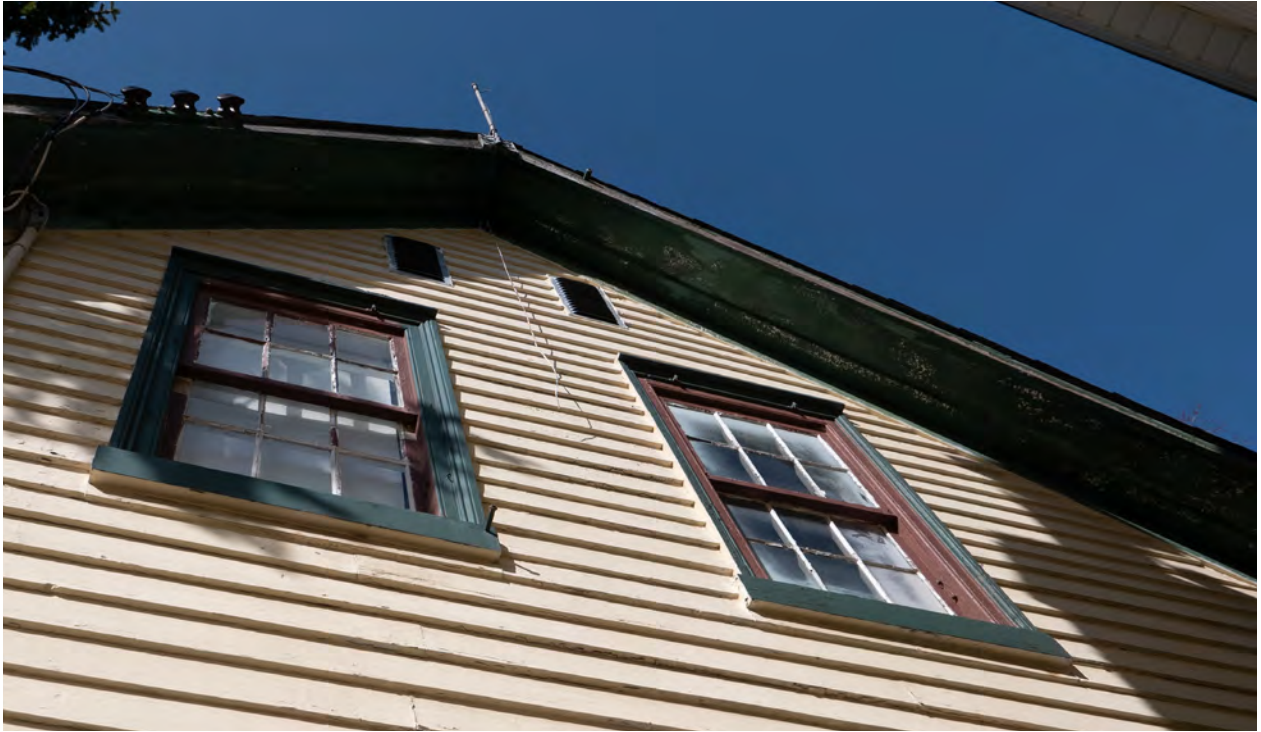
Six-over-six windows are extant on the first and second floors of the dwelling's historic portions with two present on the first floor and two present on the second floor (Figures 30 & 31). Similar to the casings, despite damaged and cracked wood, the windows are generally in sound condition.

Figure 30: Historic 6-over-6 windows on the east elevation of the main south portion (CBCollective 2023).

The proposed site alteration intends to replace three of the four existing six-over-six windows. The fourth window will be removed when the rear portion of the building is demolished.

While the proposed alteration calls for in-kind replacement of three, six-over-six windows, the recommended conservation approach is to consider retaining and repairing them in accordance with Guidelines 8, 15 and 12 as they are heritage attributes. Replacement in-kind of these windows should only be considered if they are determined to be irreparable or cannot meet energy efficient requirements. Windows for other openings can be replaced to match. Additionally, the recommended conservation approach includes:

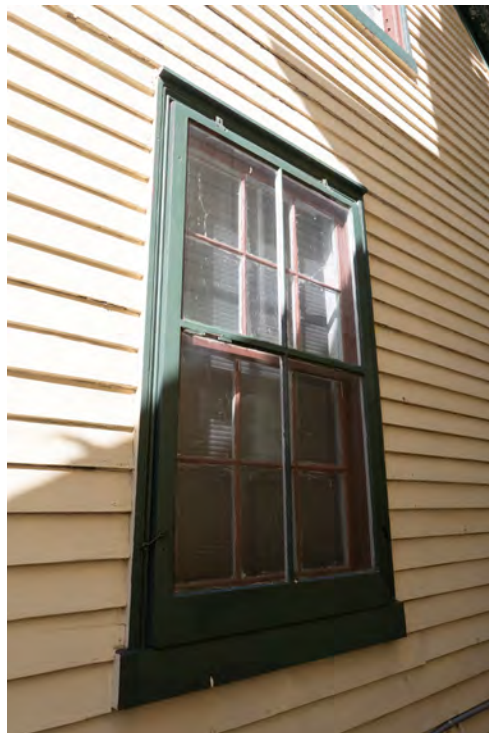
Figure 31: Historic 6-over-6 window on the east elevation of the main south portion at grade (CBCollective 2023).
