Staff Report for Heritage Richmond Hill Meeting

Report Number: SRPBS.24.031

Subject: SRPBS.24.031 – Heritage Permit for 10268
Yonge Street (Old Town Hall) – D12-07471

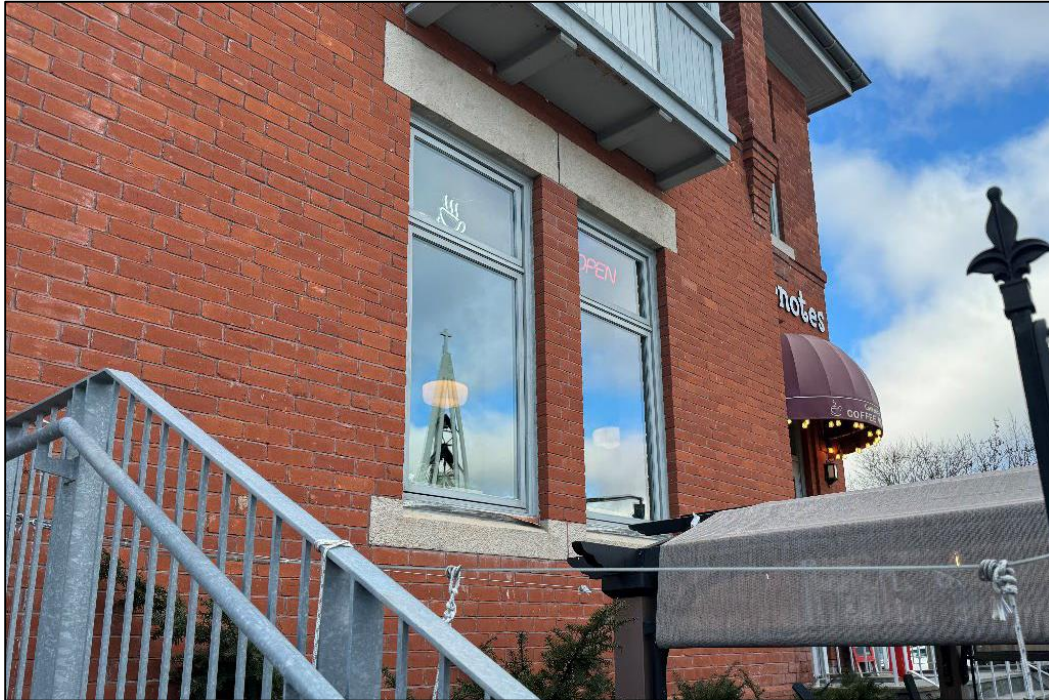
The windows and doors exhibit minimal wear, though specific door frames exhibit separation among frame elements (see Figures 2 and 3). Prior to beginning the repairs, the windows and doors will be power washed on a low pressure setting to remove any accumulated dirt and grime, and then the existing paint in the areas that need repairs will be stripped down to the base wood through scraping and sanding. Care will be taken during these preparatory steps to prevent any damage to the underlying wood including the protection of surfaces that are adjacent and are not to be painted.

Figure 2: Peeling paint on first storey window.

- Re-sealing joints to prevent separation;
- Repairing failing window glaze putty;
- Repairing minor holes and cracks with an epoxy repair system;
- Replacing areas with significant rot with the Dutchman's patch method;
- Removing the front door for off-site restoration, with a temporary door being installed until the repairs are completed.

Once the repairs are completed, the windows and doors will be painted in colours that match the existing.

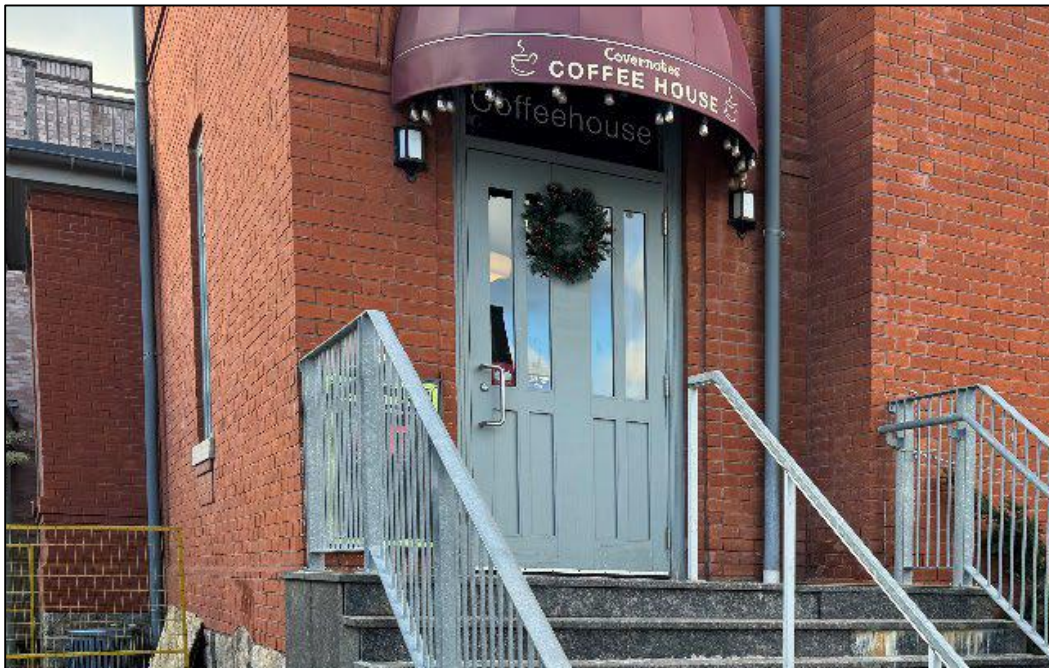
Figure 3: Paint peeling on front door and frame.

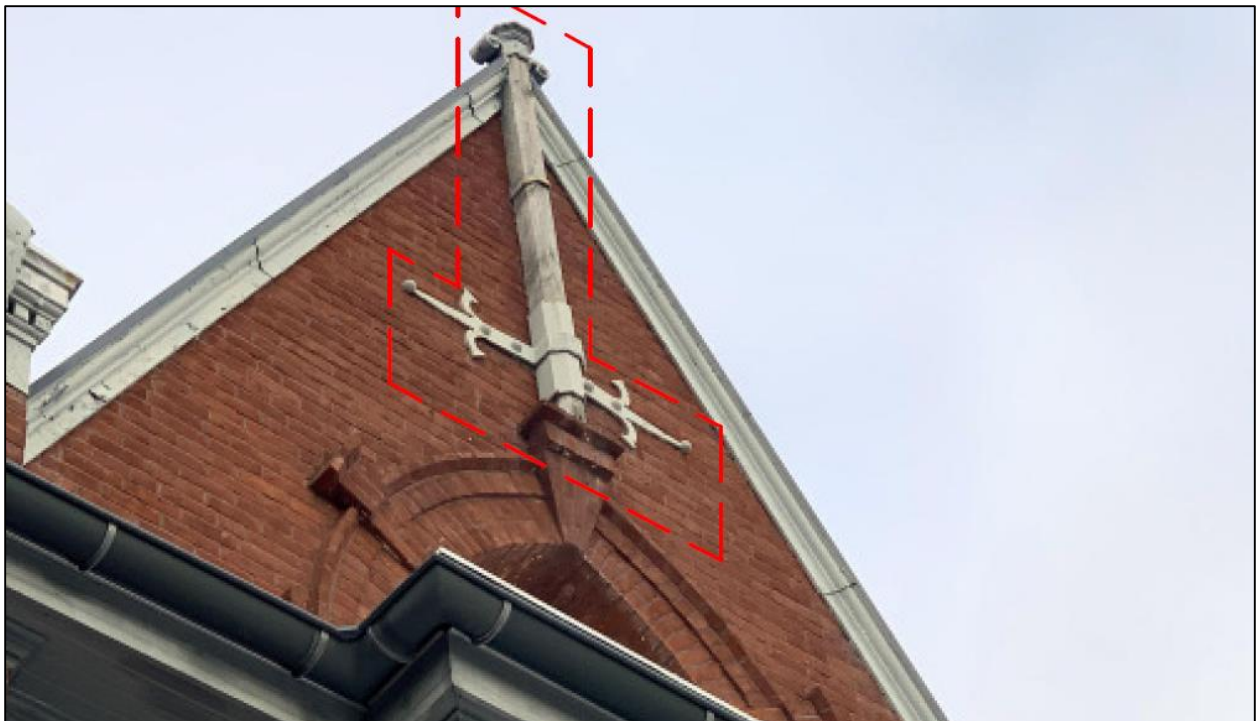
The wooden architectural details including the Oriel window, the flagstaff, boards, and trims, exhibit some areas of extensive weathering and rot (see Figures 4 and 5). Prior to undertaking the repairs, the wooden elements will be prepared in the same manner as the windows and doors.

Figure 4: Peeling paint on gable roof trim and flagstaff.

- Repairing minor imperfections with wood filler;
- Replacing areas with significant rot with new, treated wood that matches the appearance of the original elements.

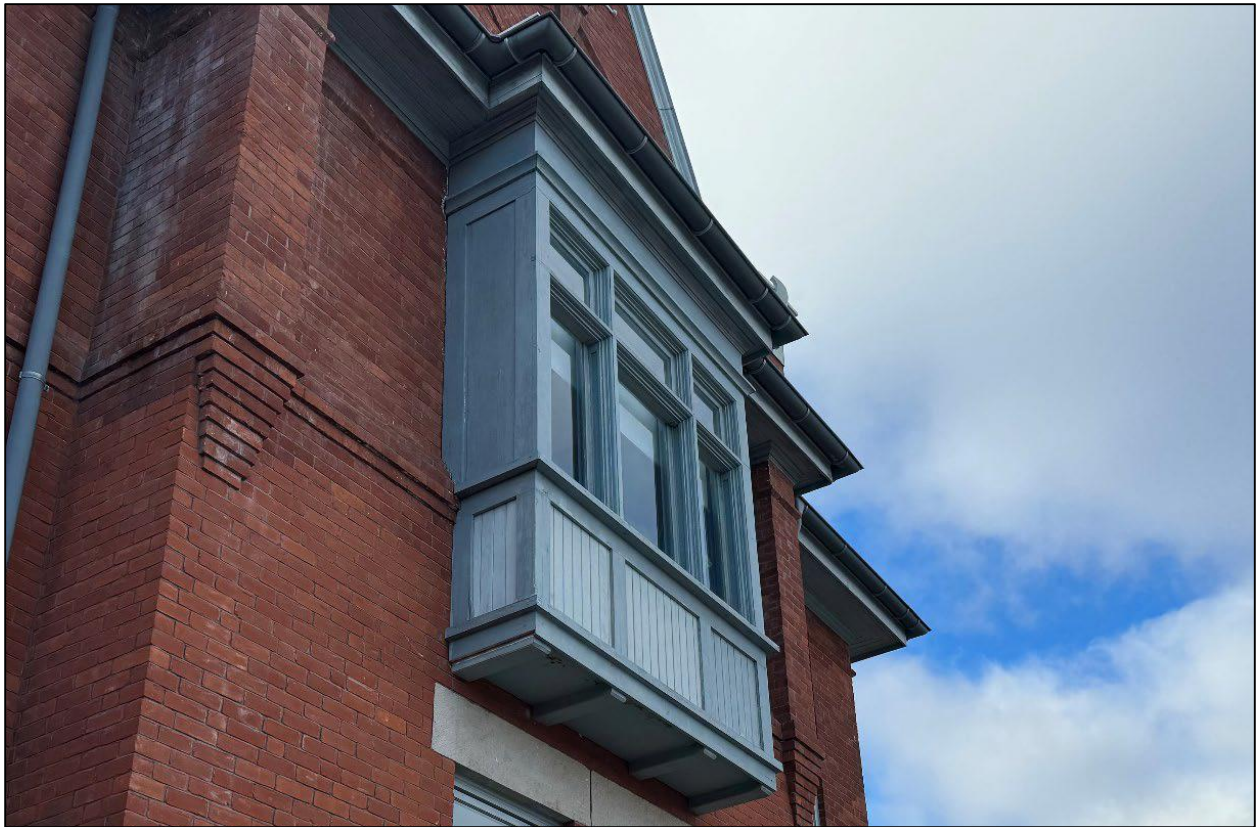
Figure 5: Paint peeling on the oriel window.

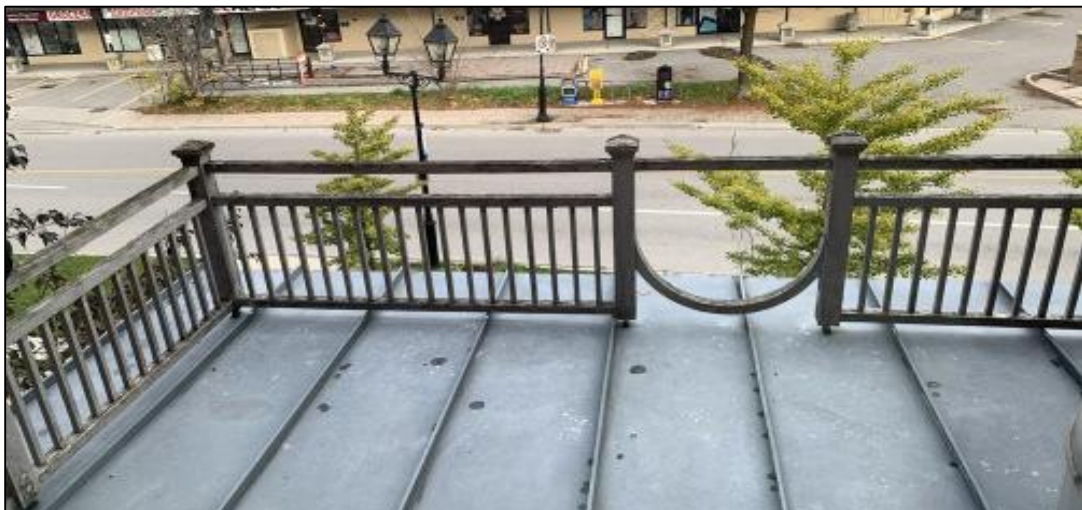
The railing along the roofs of the protruding one-storey bays on the north and south façades exhibit significant deterioration and will need to be completely replaced (see Figures 6 and 7). The new wooden railing will be installed and painted to match the existing railing.

Figure 6: Structural damage and wood rot on roof railing.

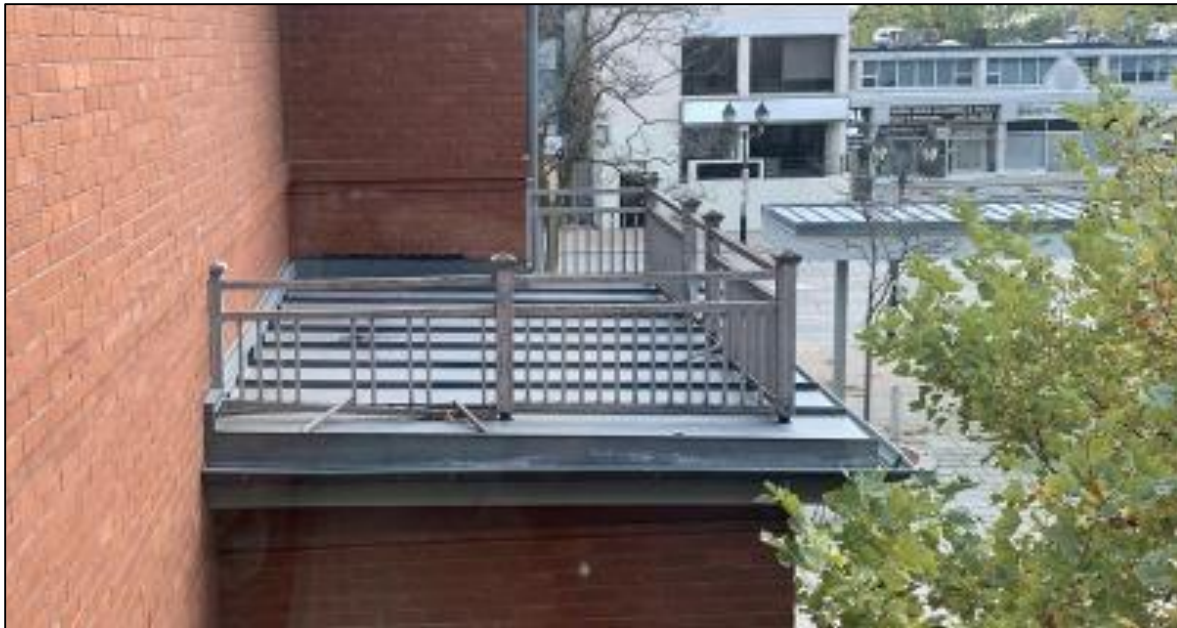
Figure 7: Structural damage and wood rot on roof railing. Note broken rails.

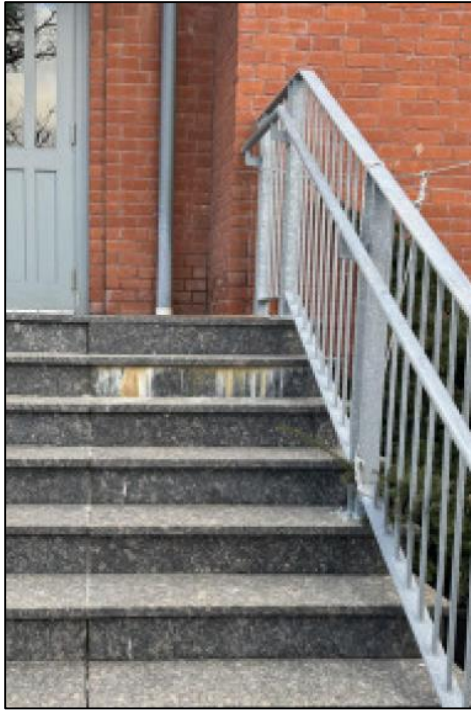
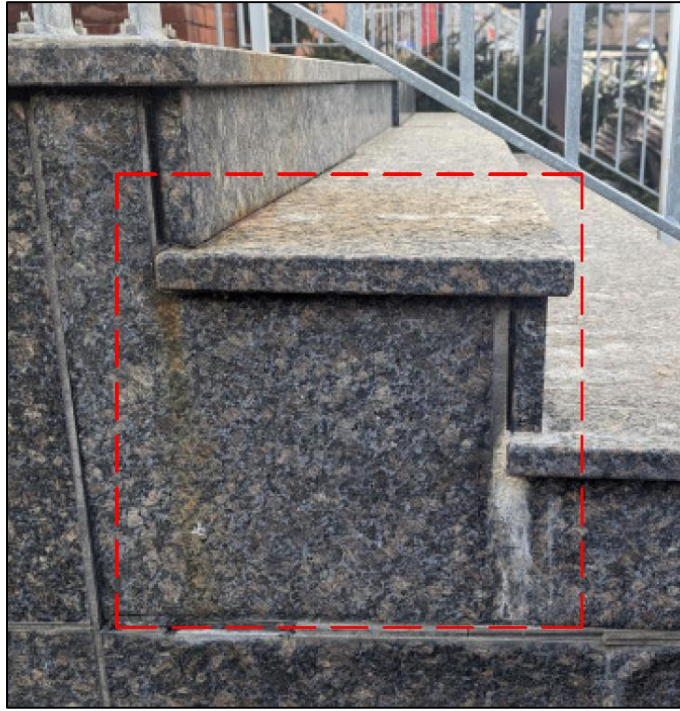
The mortar on the brick façade and the slabs at the front stairs are exhibiting damage along the joints and to the brick itself. This includes areas of efflorescence (see Figures 11 and 12), previous repointing done with the wrong mortar (see Figure 13), and noticeable gaps in the mortar (see Figure 10). The slabs on the stairs have also begun to separate and pull away from the stairs themselves (see Figures 8 and 9).

Figures 8 and 9: Front steps showing separation, built-up dirt.

- Cleaning the brick and slab surfaces to remove efflorescence and grime;
- Removing mortar exhibiting signs of deterioration or damage;
- Removing mortar from previous repointing that does not match original mortar;
- Repointing using new mortar that matches the existing mortar;
- Any slabs that have pulled away will be repositioned;
- Any slabs or bricks with damage that cannot be repaired will be removed and replaced with new slabs or bricks.

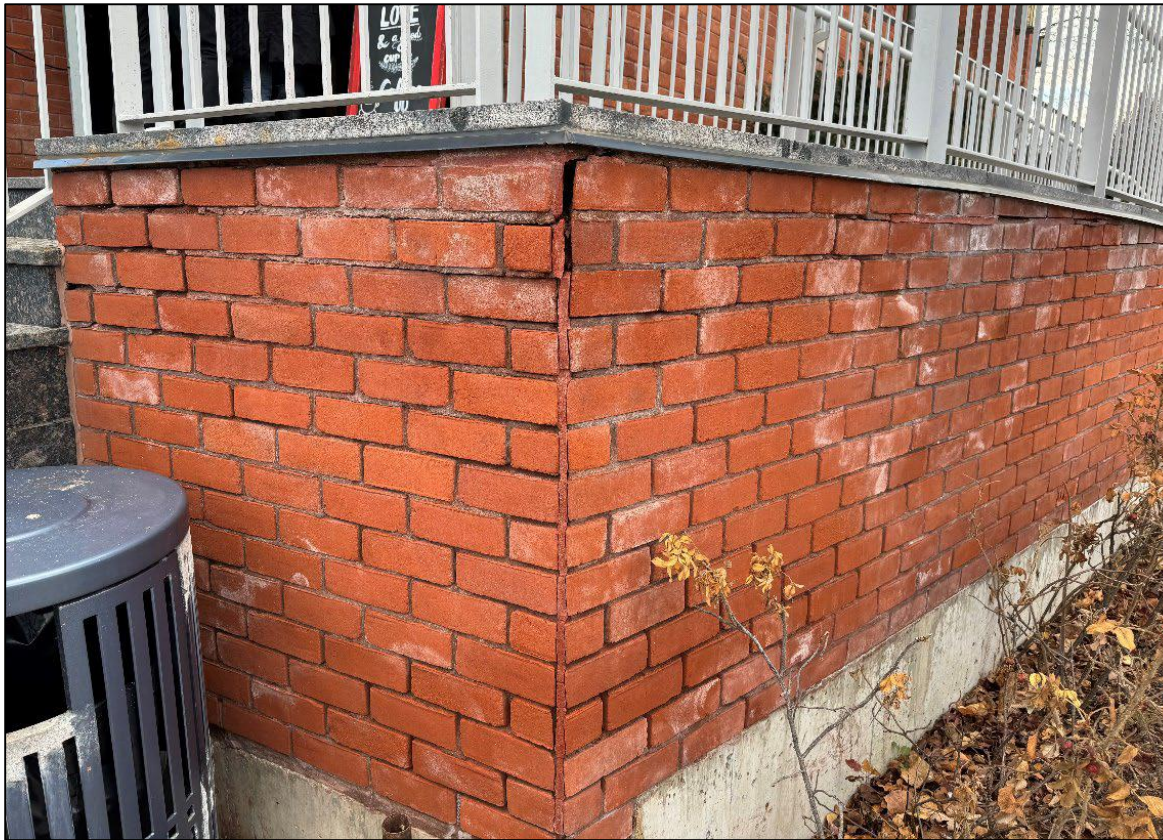
Figure 10: Flaking, failing mortar and efflorescence on ramp.

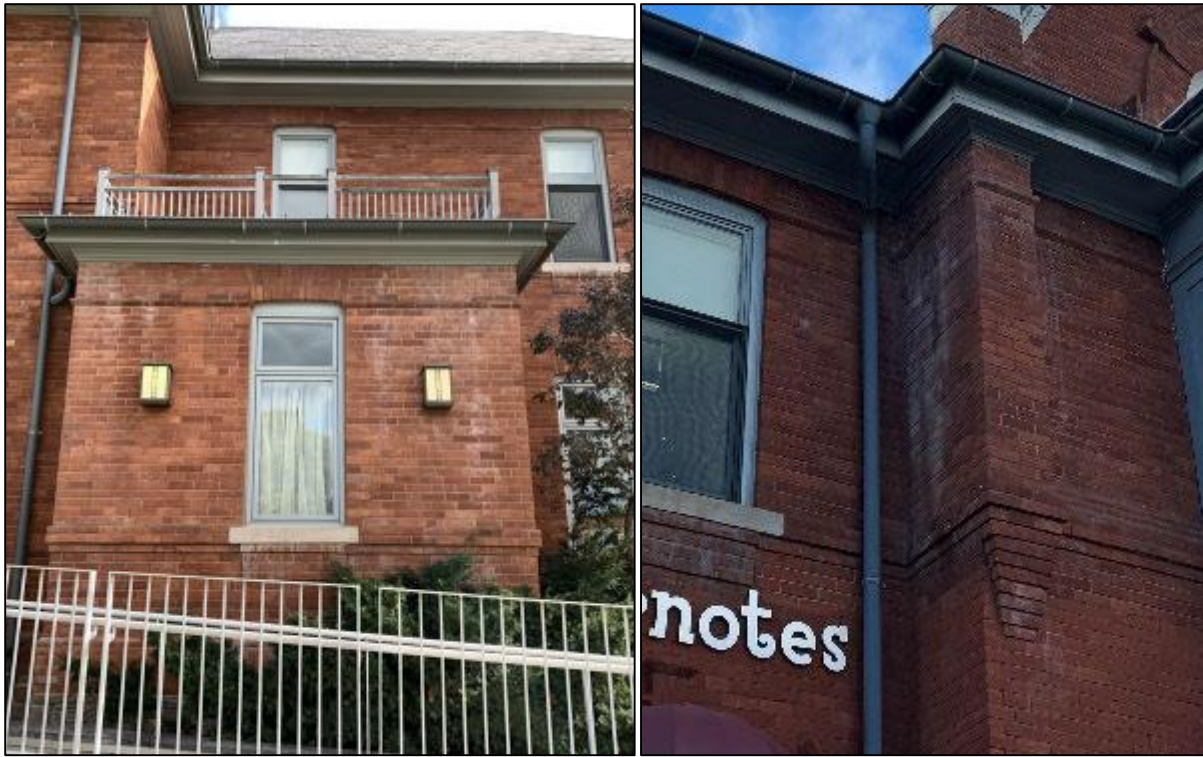
Figures 11 and 12: Examples of efflorescence caused by water runoff.

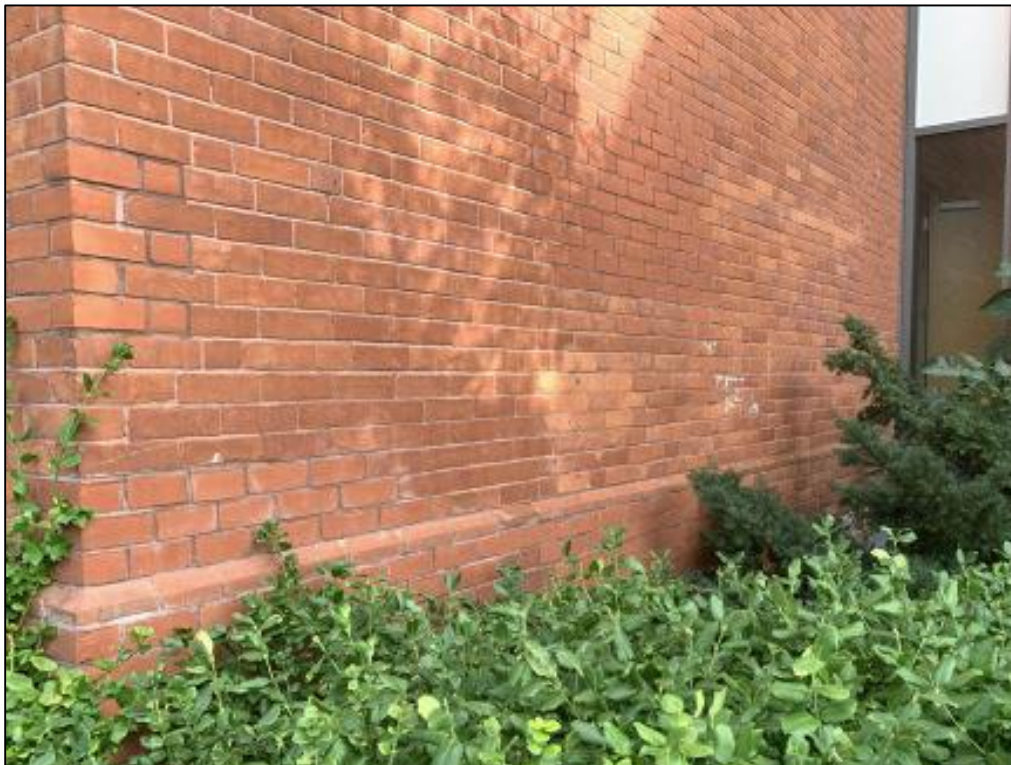
Figure 13: Areas of repointing done in with a mortar that does not match the original mortar colour.

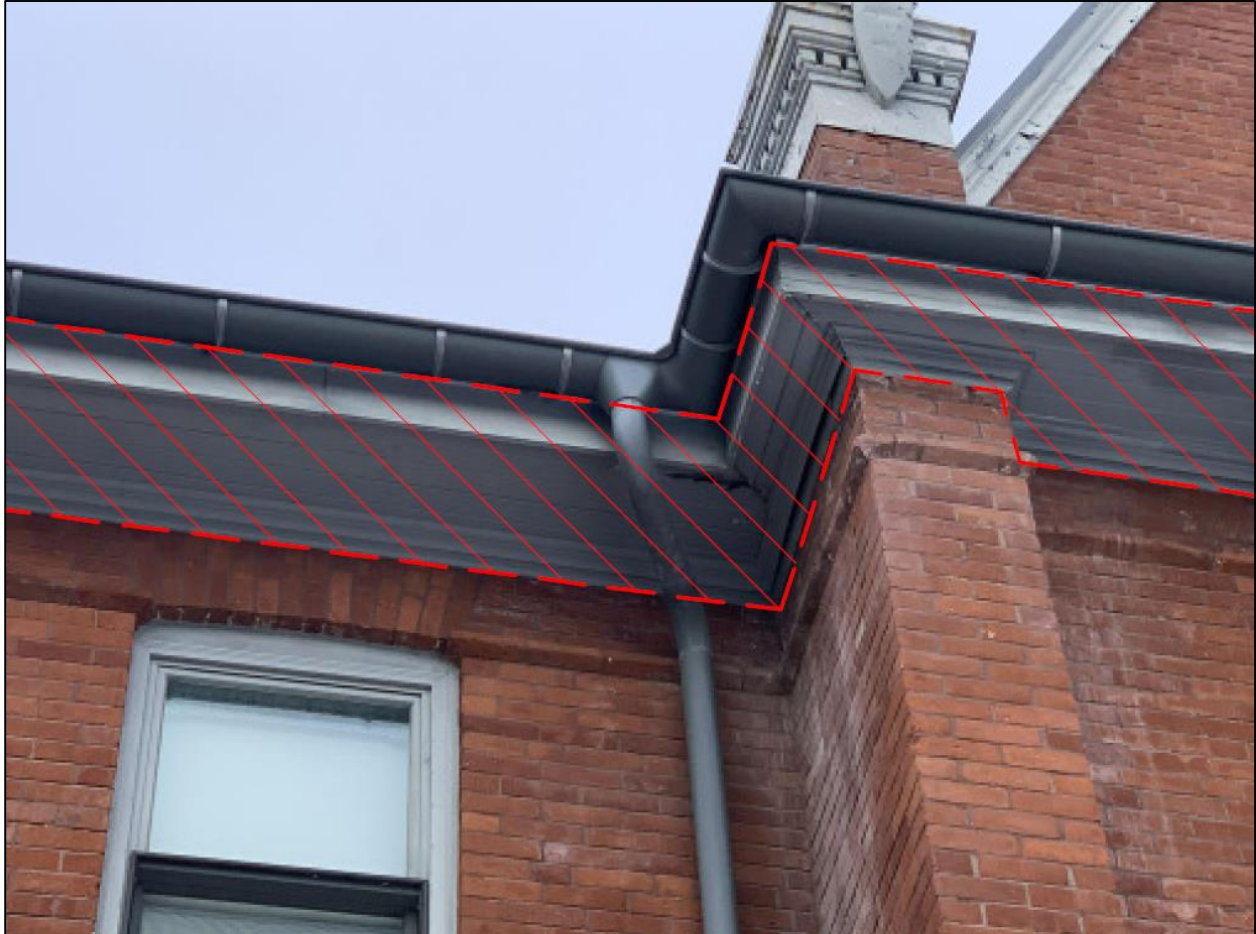
Portions of the wooden soffits exhibit signs of deterioration (see Figure 14). The proposed repairs include:

Figure 14: Damaged soffit board at corner, areas of peeling paint.

- Removing loose soffit board and replacing with new wooden board;
- Cutting out damaged sections along the full length of the board with a straight edge cut at both ends, cutting a new section of tongue and groove wood board to match the length of the opening and securing in place.
