Staff Report for Heritage Richmond Hill Meeting

Report Number: SRPBS.24.087

Subject: SRPBS.24.087 - Heritage Permit for David Dunlap Observatory Building Repairs - City File D12-07228

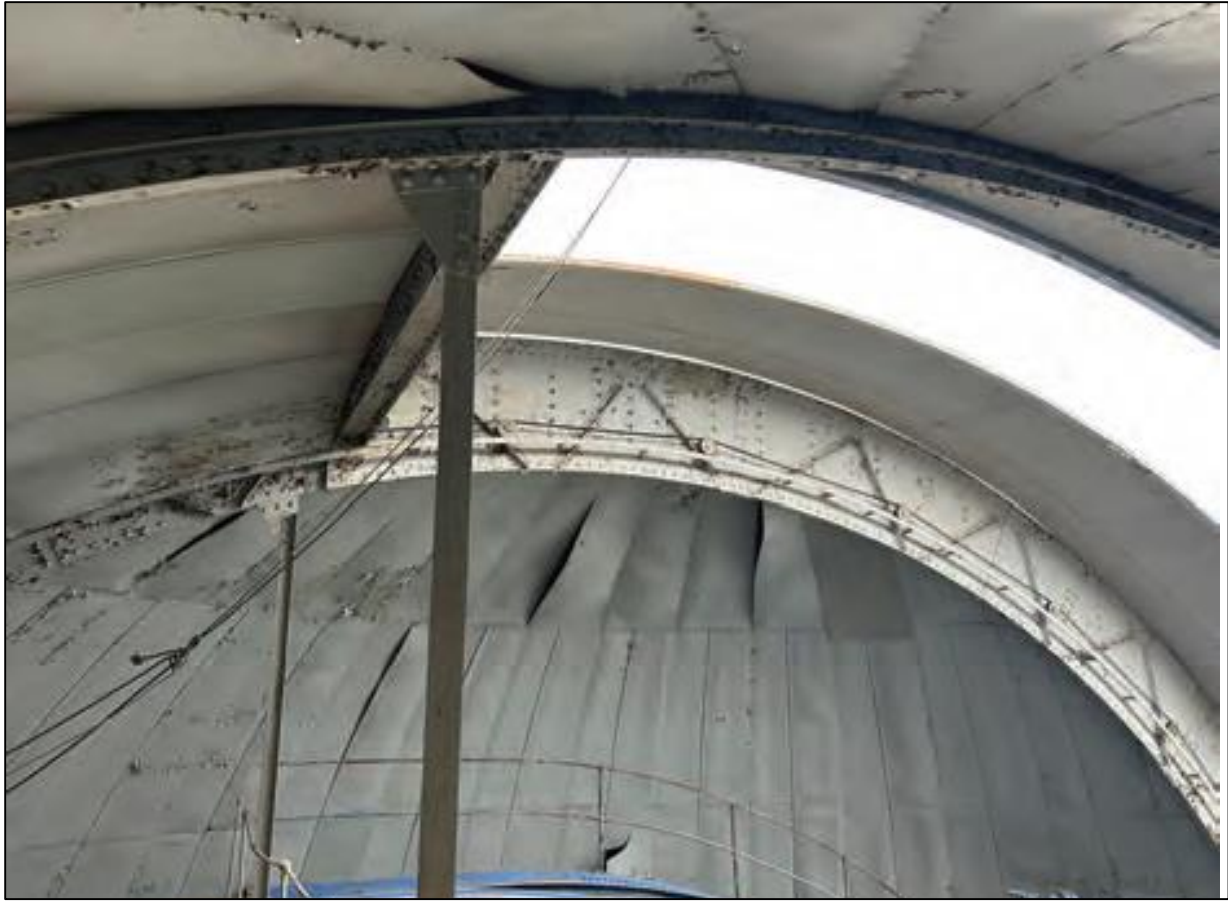
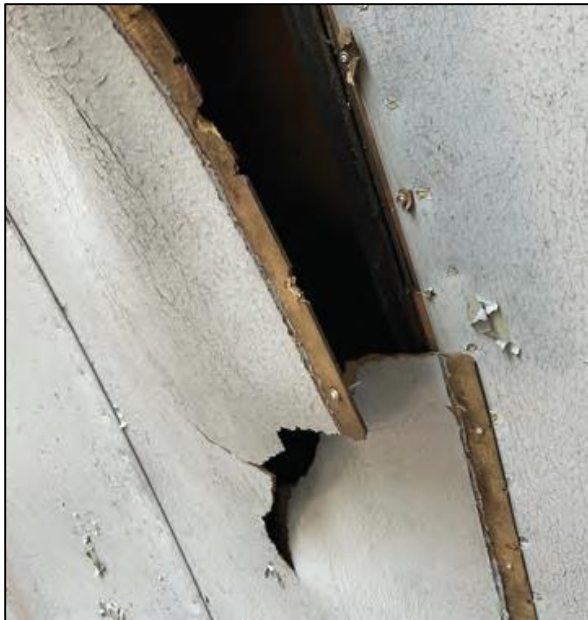
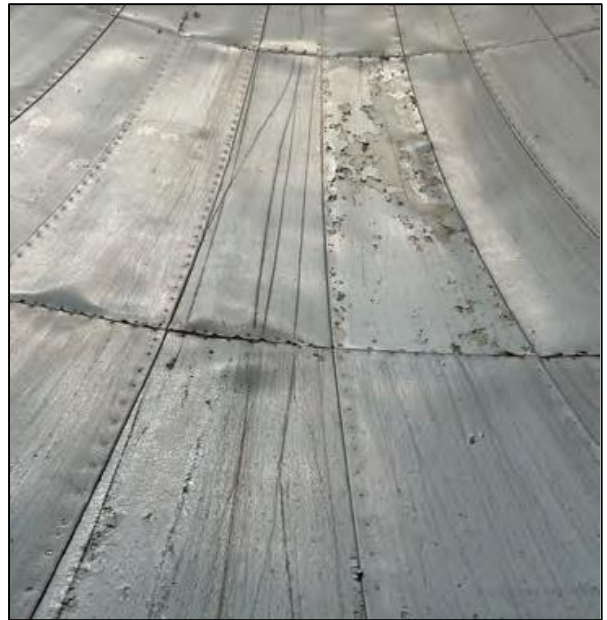
In 2023, a condition assessment was undertaken of the interior of the Observatory building. It was found that the Agasote panels that line the interior of the dome are warped, damaged and have become detached from the underlying frame (see Figures 1 to 5) and that the paint on the dome's metal frame is peeling (see Figures 4 and 5). These conditions are believed to have been caused by natural condensation cycles and past water infiltrations. The lobby's terrazzo flooring has also cracked along the exterior wall due to seasonal floor movements (see Figure 6). The City is proposing to replace the damaged Agasote panels, repaint the dome's interior visible metal components, and repair the crack in the lobby's terrazzo flooring.

Figures 1-3 Agasote panels showing degradation, including warping, peeling, and failed joints (Source: +VG Architects)

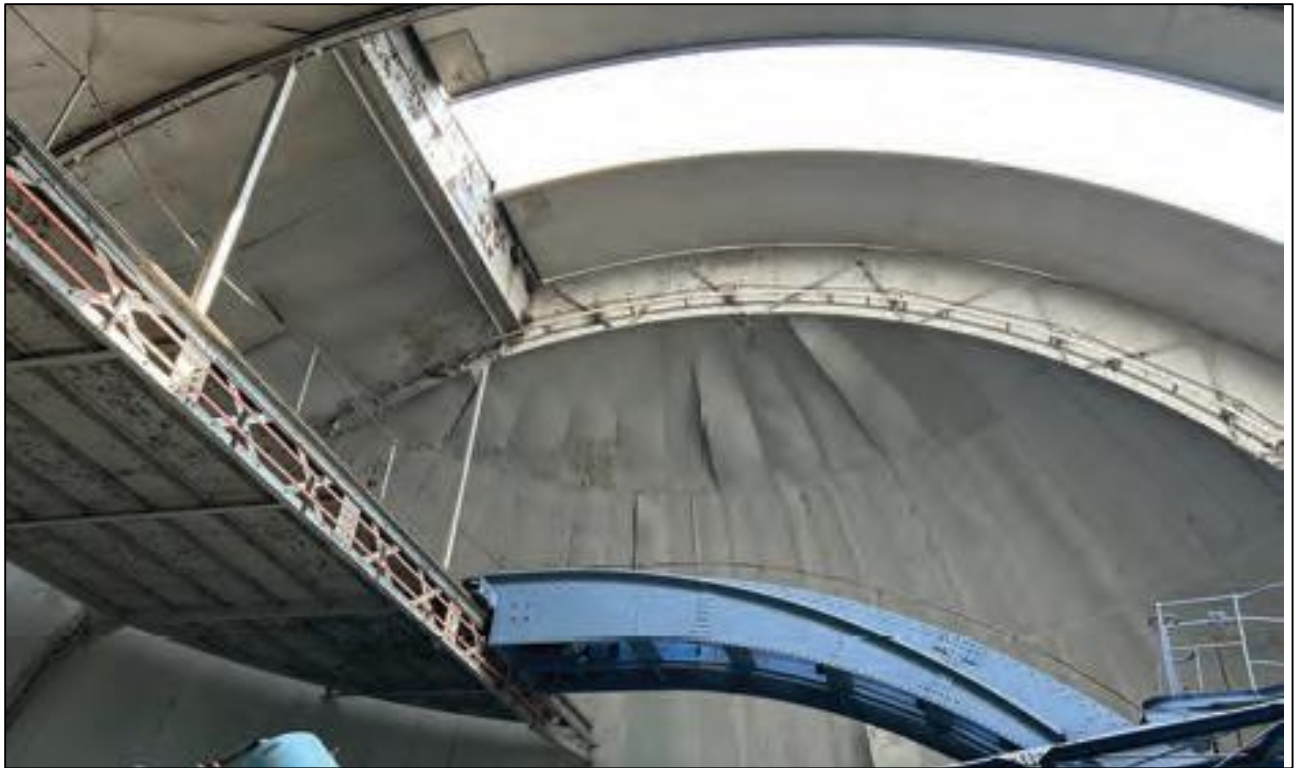
Figure 4 The upper portion of the dome showing degraded Agasote panels and peeling paint (Source: +VG Architects)

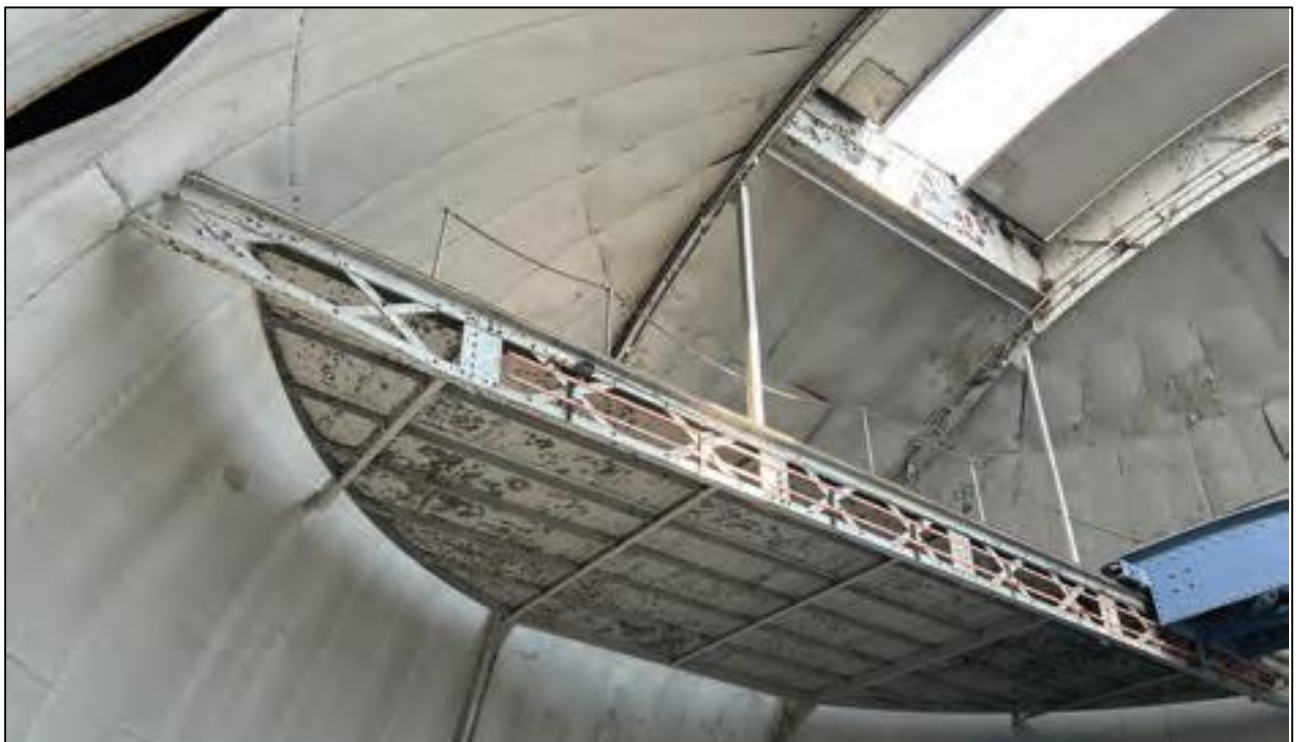
Figure 5 The upper portion of the dome showing degraded Agasote panels and peeling paint (Source: +VG Architects).

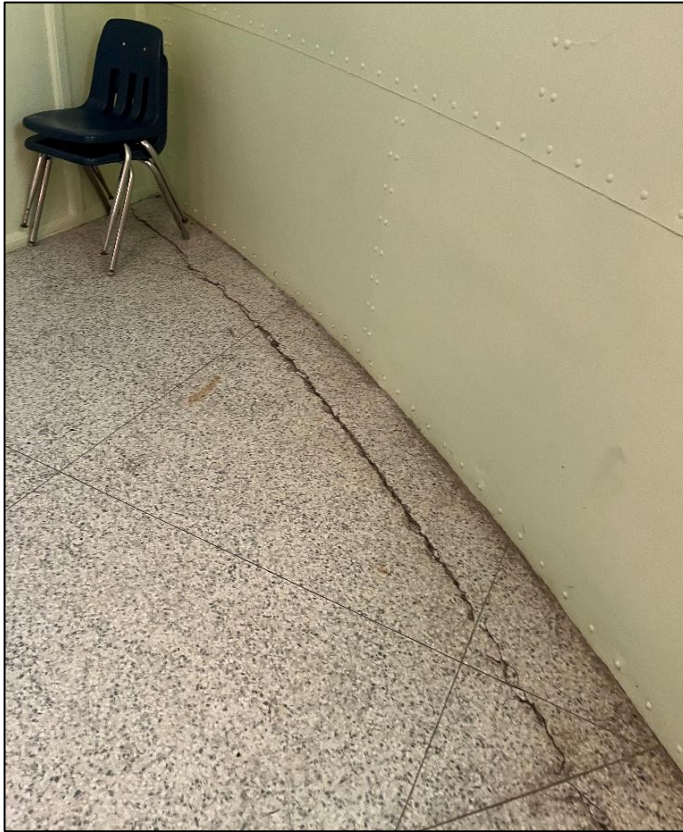
Figure 6 A portion of the crack in the terrazzo flooring that runs parallel to the exterior Observatory wall (Source: City of Richmond Hill).

A long crack has appeared on the terrazzo flooring that runs parallel to the exterior wall of the Observatory (see Figure 12). This crack has formed because the outer foundation and the inner “floating” slab move at different rates. As the “floating” slab moves with changing temperatures while the exterior foundation wall does not. This causes stress on the terrazzo flooring and, due to its low elasticity, has broken where the foundation and “floating” slab meet.

Damaged, spalling, and loose material within the crack and over the adjacent floor surfaces will be grinded back to a sound substrate to achieve a clean, continuous joint width and stable surface on which to adhere the repair materials. The joint will then be plugged with a temporary separation strip to maintain a consistent opening while the patching material is applied to the adjacent floor surfaces.

A terrazzo flooring cementitious mix that matches the existing flooring will then be applied to both sides of the joint and to the adjacent floor areas that require repair. The existing construction joints and patterns will be maintained where they cross the new joint and the areas that are to be repaired.

Once the flooring material has finished curing, the separation strip will be removed and the repaired areas will be grinded down to achieve a level surface, then polished. A floor sealant will then be applied.

To allow for the “floating” slab to move independently from the exterior foundation wall, a backer rod will be placed in the joint and covered with a sealant. This sealant will be of industrial strength, resistant to mildew and will be elastic enough to bend with floor movements without breaking. This sealant will be level with the adjacent floor surfaces.

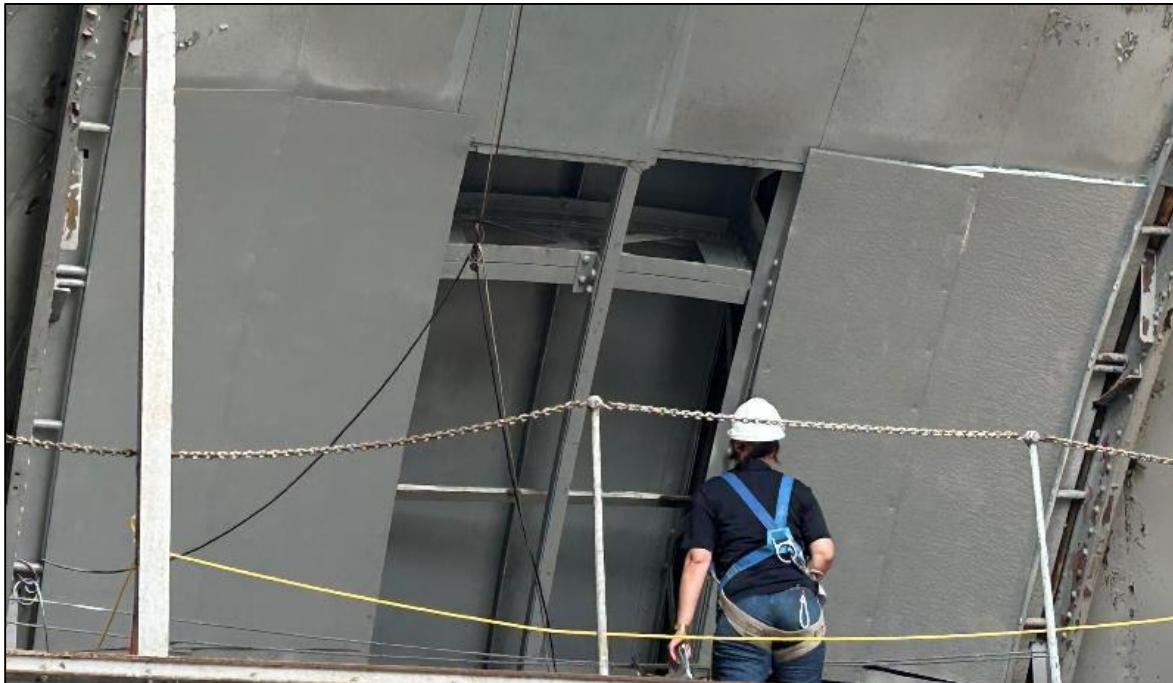
The Homasote panels were noticeably thicker than the existing panels and created significant shadow lines along the joints where they overlapped the adjacent panels; this was not an issue with the HDF panels which were the same thickness as the existing panels. Further, the Homasote panels were also difficult to shape and curve as needed. The HDF panels' texture better matched the texture of the existing panels whereas the Homasote panels were noticeably different, having a dimpled rather than smooth texture.

There were also concerns about the Homasote's longevity. These concerns were due to the fact that the Homasote fibres are less compressed than the HDF and are thus more likely to be damaged by impact. Also, the Homasote appeared to be more porous and thus more prone to absorb moisture than the HDF, which would be detrimental to both the panel itself and to the underlying metal structures.

Figure 7 The three mockups (built in pairs), from left to right: HDF panels; acoustic paint in cavity; Homasote panels (Source: +VG Architects)

Accordingly, it was determined that the HDF panels are the most appropriate replacement material.

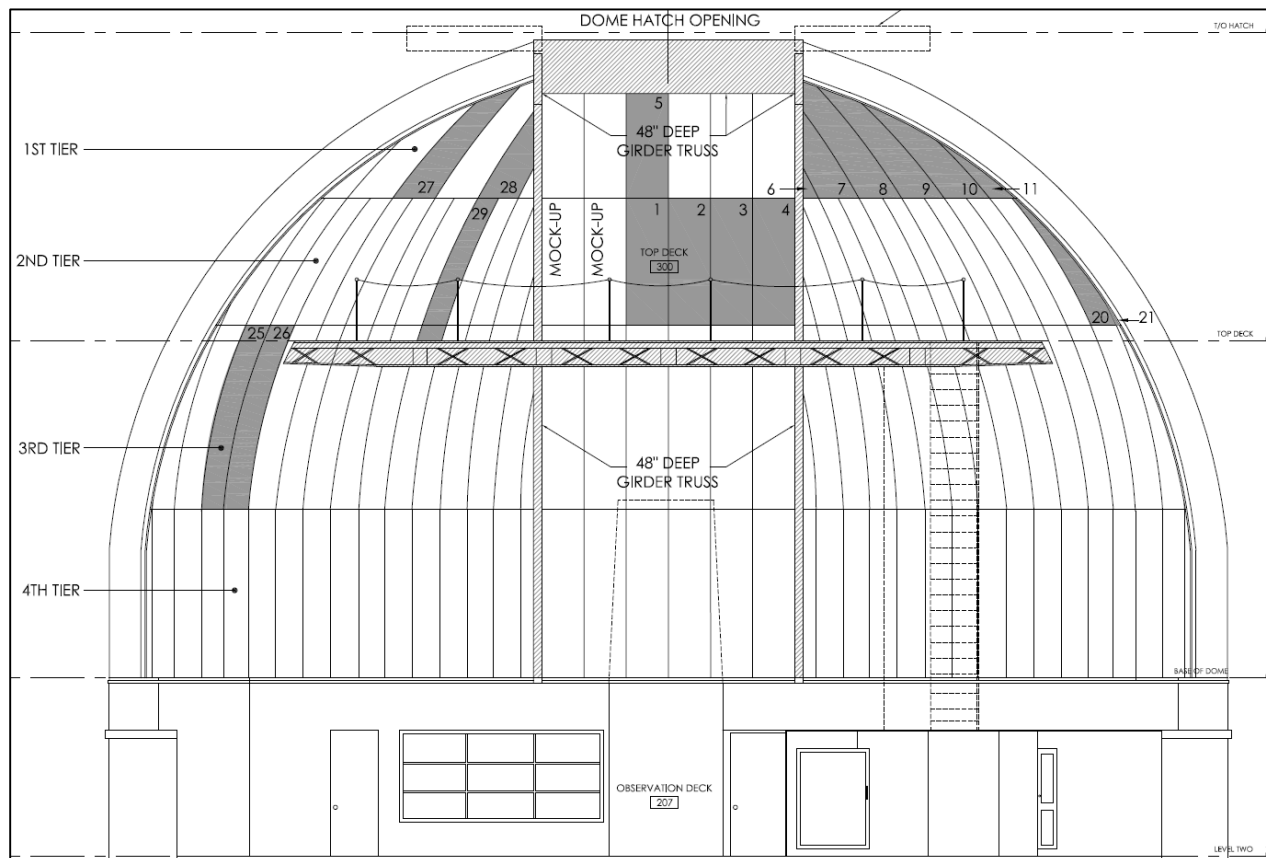
Approximately 10% of the Agasote panels require replacement, most of which are located at the apex of the dome (see Figures 8, 9). These panels exhibit advanced deterioration, warping, and are no longer positively fastened to the underlying metal frame. As a result, the panels cannot be repaired and must be replaced.

Figure 8 Location of panels to be replaced and metal components to be repainted, north portion of dome. Dark grey indicates panels to be replaced, and the hatched areas indicate metal surfaces that are to be refinished and repainted (Source: +VG Architects).

29 panels are proposed to be replaced (see Figures 8 and 9). Once the panels are removed, the wood substrates, blocking and strapping will be inspected and any unsound wood will be repaired or replaced with new wood to match the existing (see Figures 9 and 10). The replacement panels will be cut, sized, and shaped to match the original panel and fastened back into place. New stainless-steel screws that match the size and head type of the existing screws will be used to fasten the panels to the substrates. The new liner panels will then be painted with an exterior-grade latex paint. The existing panels within the first and second tiers and those on the third and fourth tiers between the 48-inch-deep girder trusses will also be painted (see Figures 8, 9).

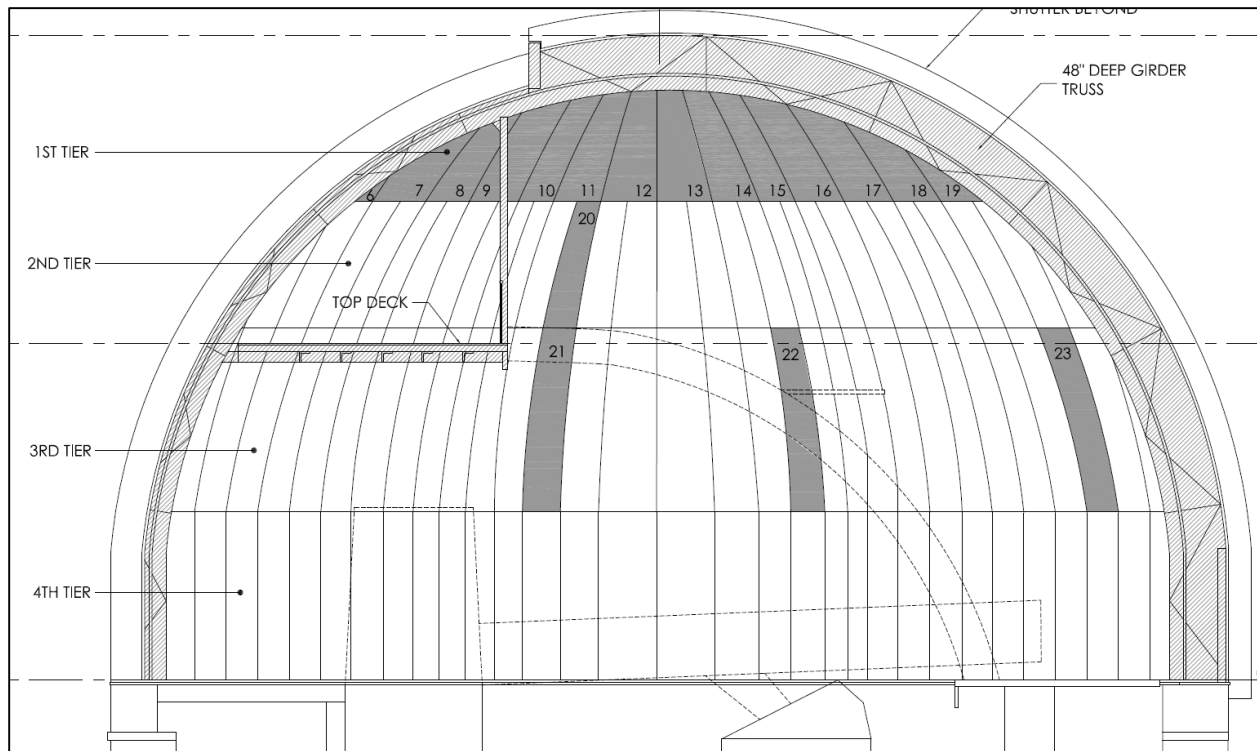
Figure 9 Location of panels to be replaced and metal components to be repainted, south portion of dome. Dark grey indicates panels to be replaced, and the hatched areas indicate metal surfaces that are to be refinished and repainted (Source: +VG Architects).

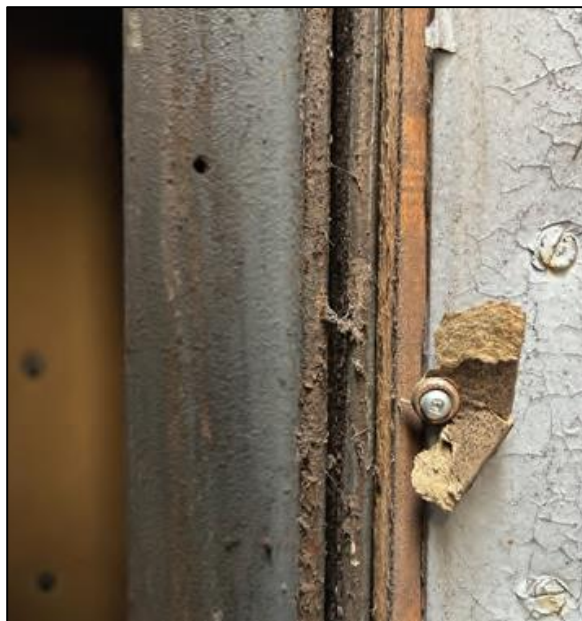
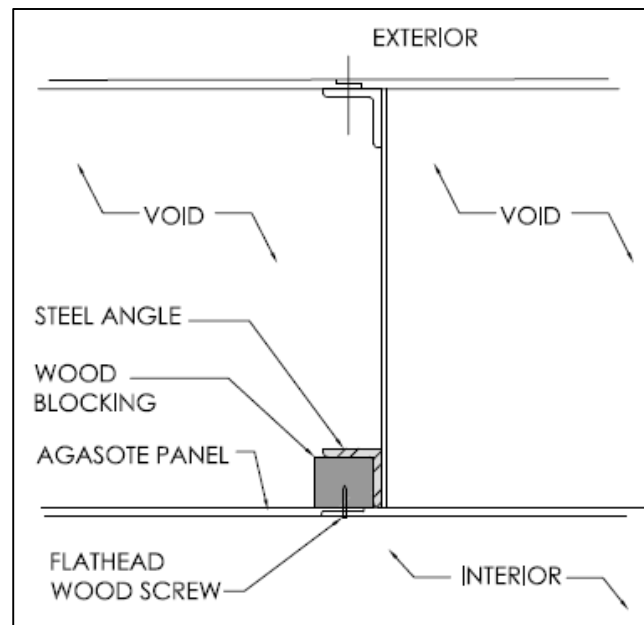
Figures 10, 11 Panel removed to show underlying wood strapping and supporting metal structure (left); illustration of how existing panels overlap and are attached to the steel girder (Source: +VG Architects).

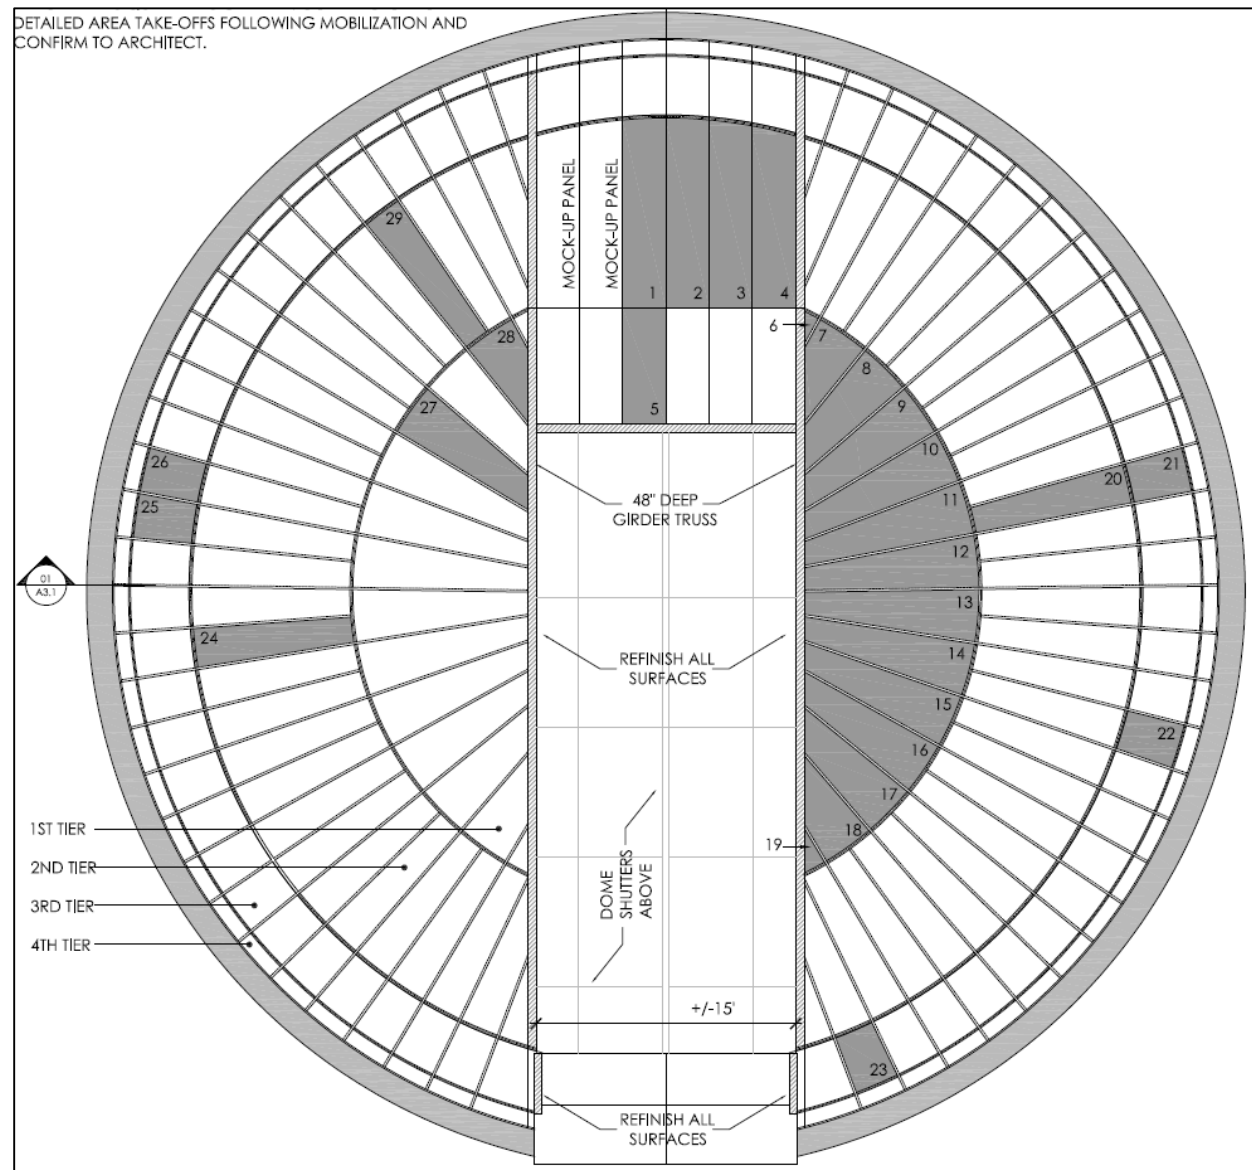
Figure 12 Location of panels to be replaced and metal components to be repainted. Dark grey indicates panels to be replaced (Source: +VG Architects).

Paint, rust, and loose particles will be removed prior to the area being cleaned. The surfaces will then be patched where needed before being repainted in a colour that matches the existing paint. While all the repairs are proposed to be done onsite, the exception will be related to the top deck's guards and balustrades, which will be completely disassembled, removed, and refinished offsite before being reinstalled.

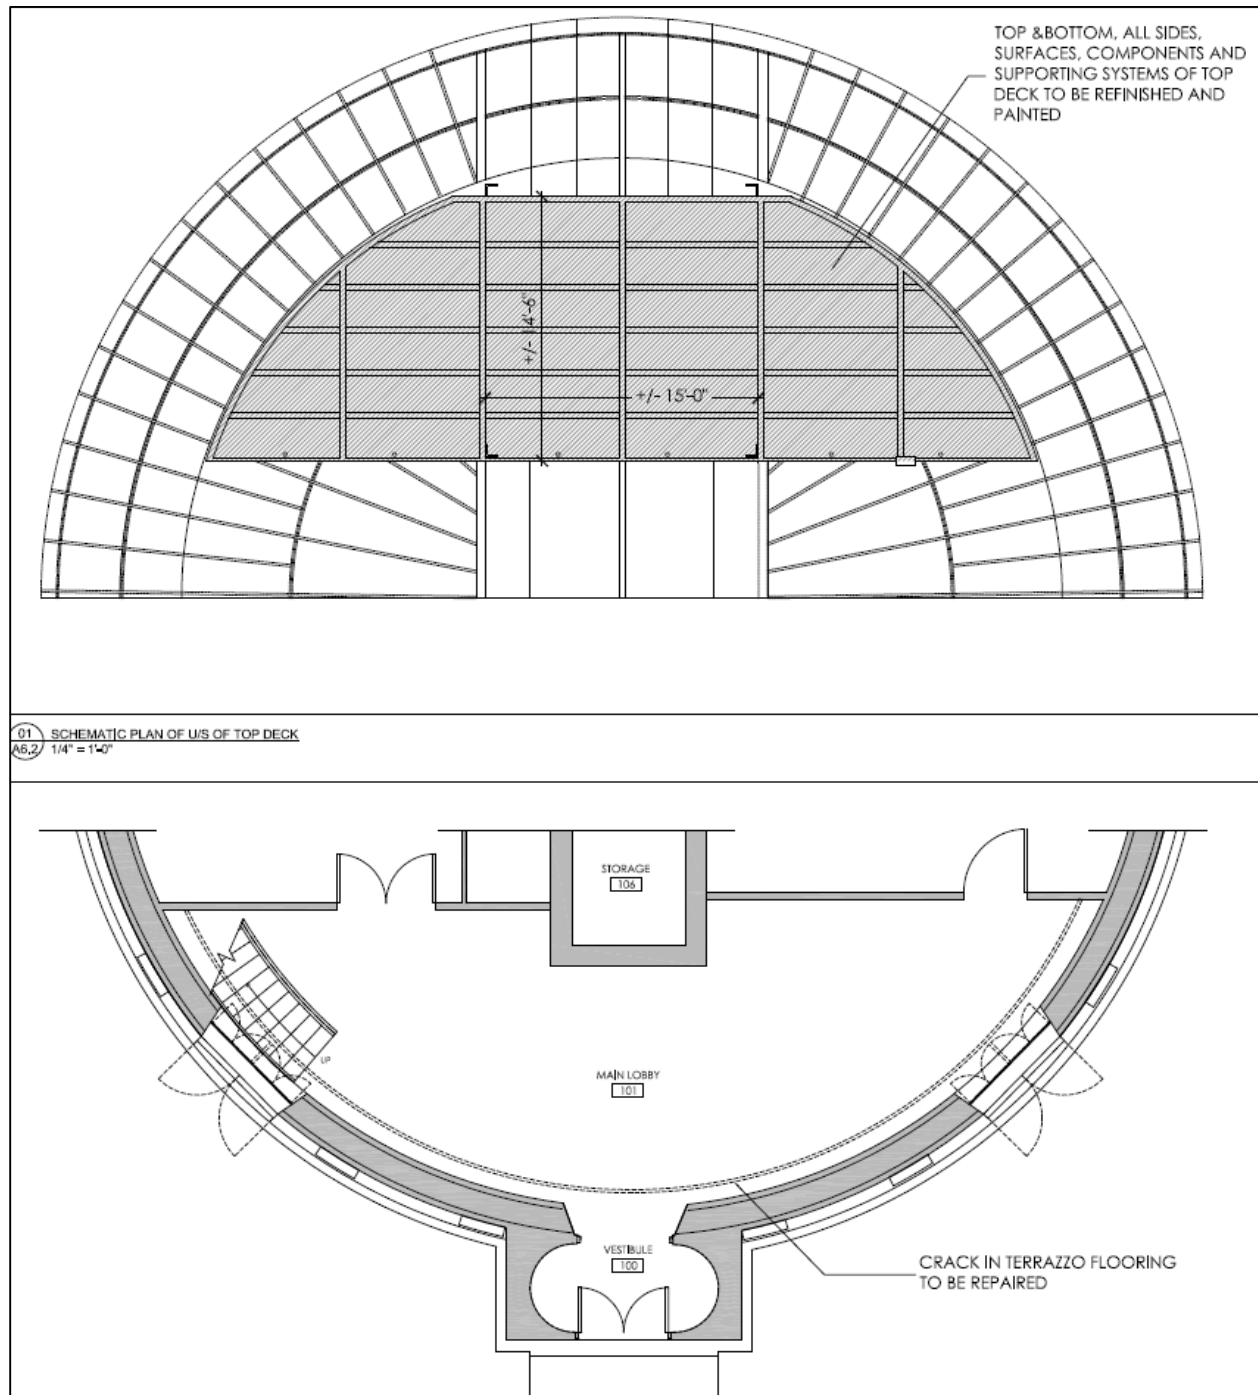
As the dome is not heated or air conditioned, its internal temperature and moisture levels fluctuate throughout the year. This has caused the paint on the exposed metal elements in the dome to peel.

Figure 13 Areas to be repainted (top), and location of crack in terrazzo flooring (bottom). The hatched areas indicate metal surfaces that are to be refinished and repainted (Source: +VG Architects).
