# STRUCTURAL ASSESSMENT REPORT OF THE TWO-STORY HOUSE

at 26 Church Street South, Richmond Hill,  
Ontario

**Re: Structural Assessment Report of The Two-story House at 26 Church Street, Richmond Hill ON**

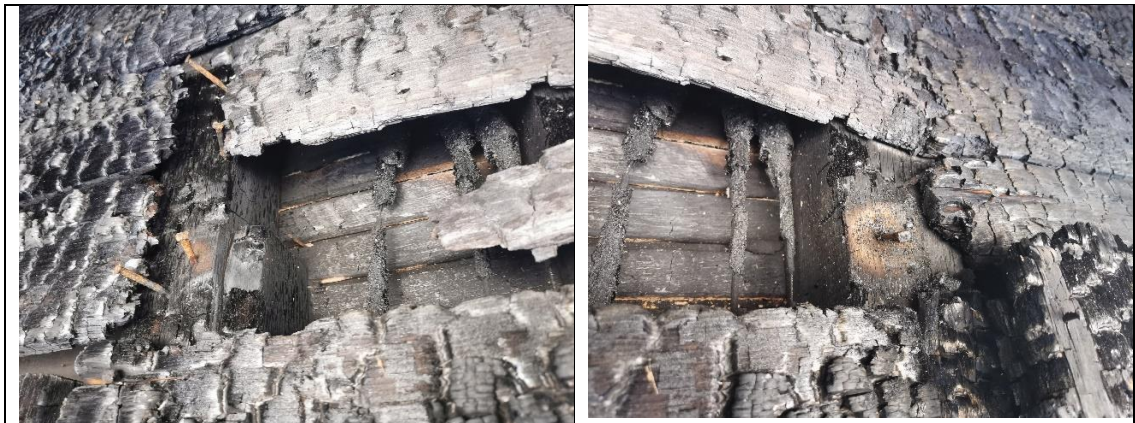
- a. Loadbearing walls were damaged by fire, including large areas of damaged wood studs and wood sheathing

Based on our observations: the most parts of foundations have serious deterioration, and a large areas of the structures of loadbearing walls and floors have been damaged by fire. The house structure can not take its original design loads. It is our opinion that the house is not stable, not safe and not possible to be repaired. We recommend to demolish entire house, including foundations and superstructure.

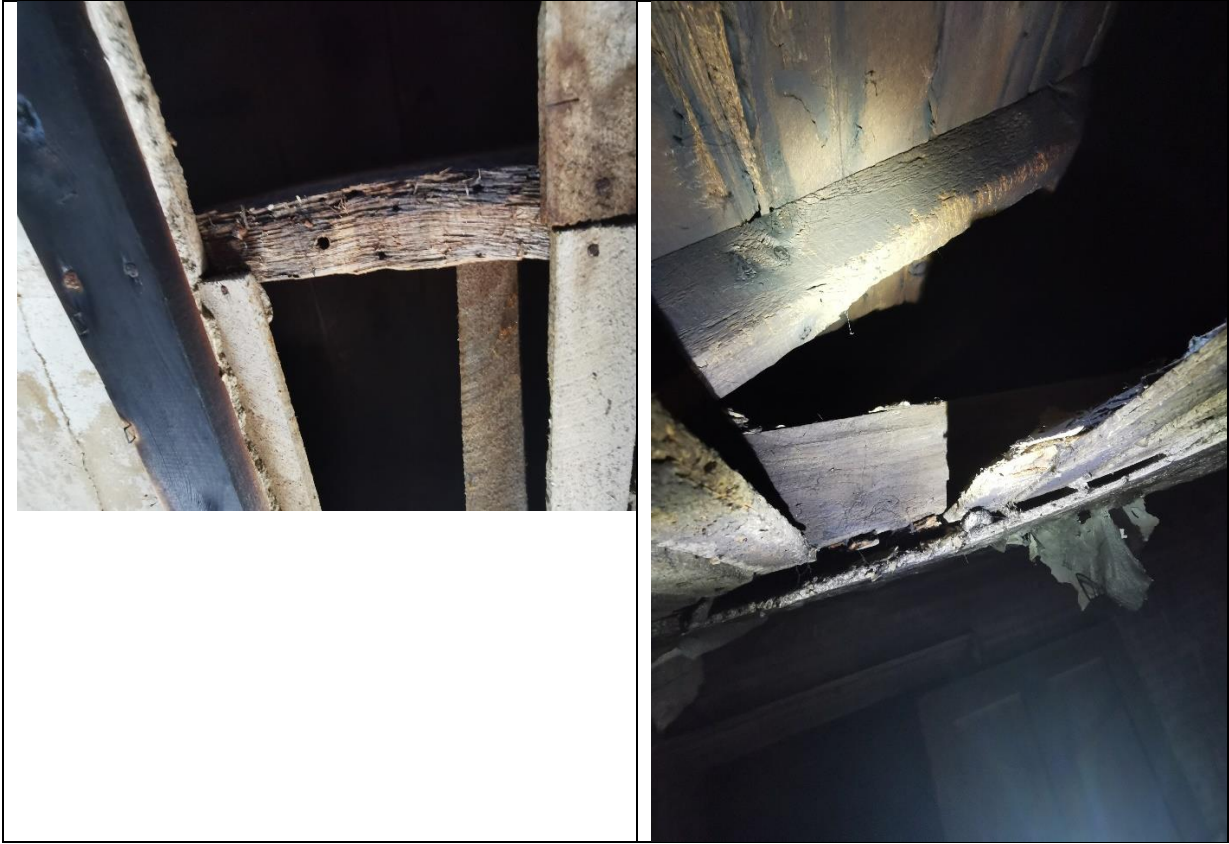
- b. Large areas of floor joists were damaged by fire and decayed.

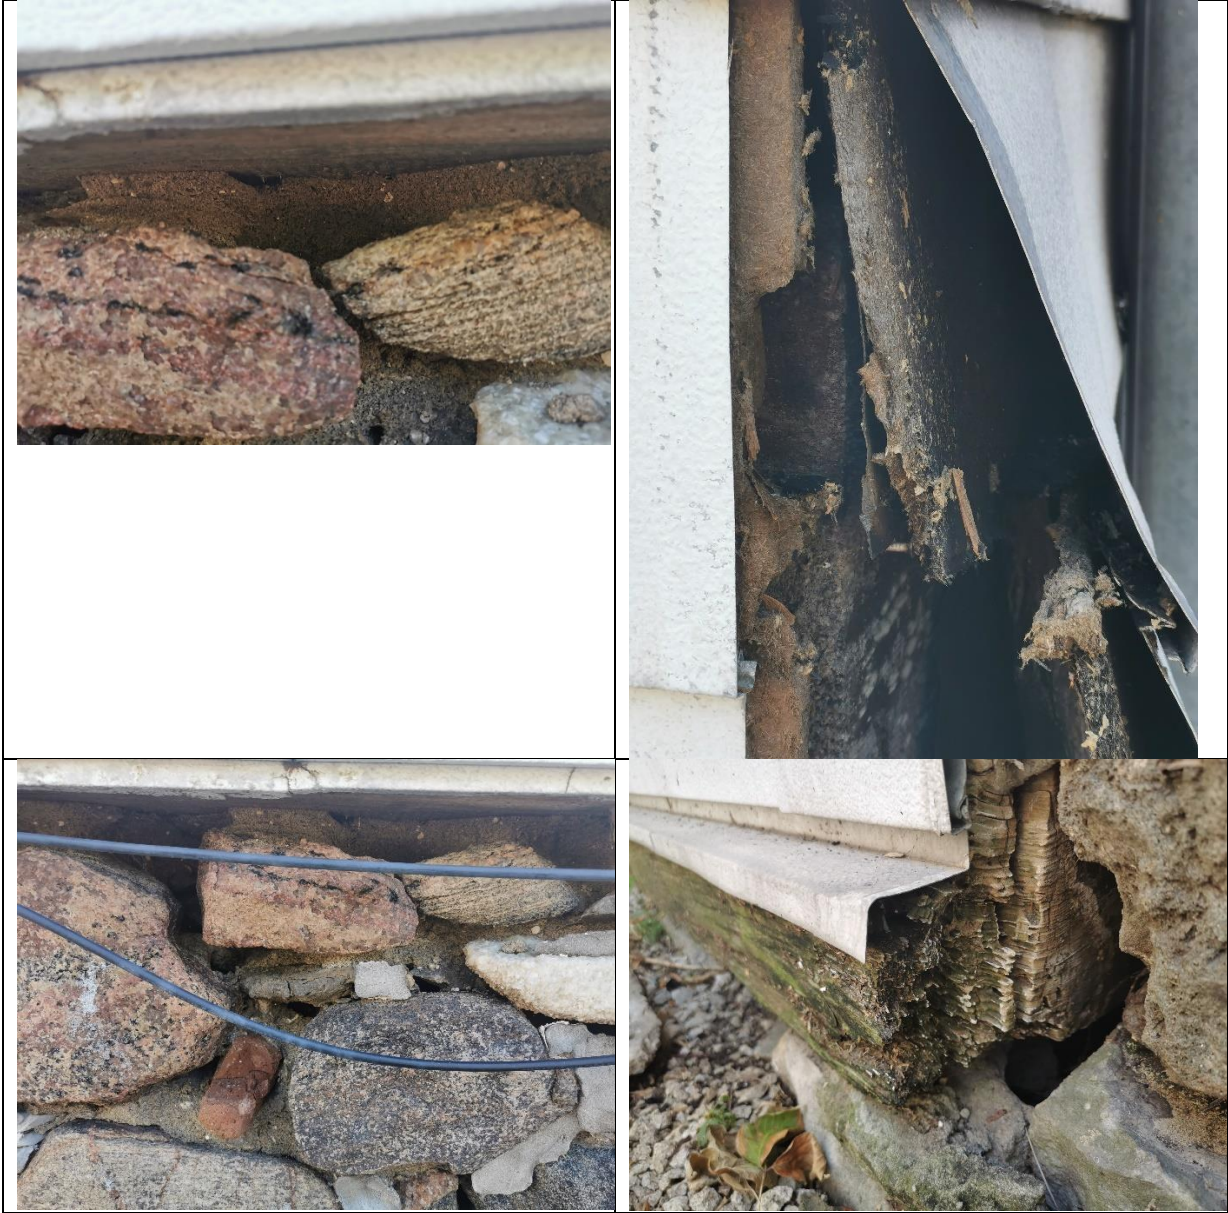
c. Cement in stone foundation walls is loose and wood plates are decayed.

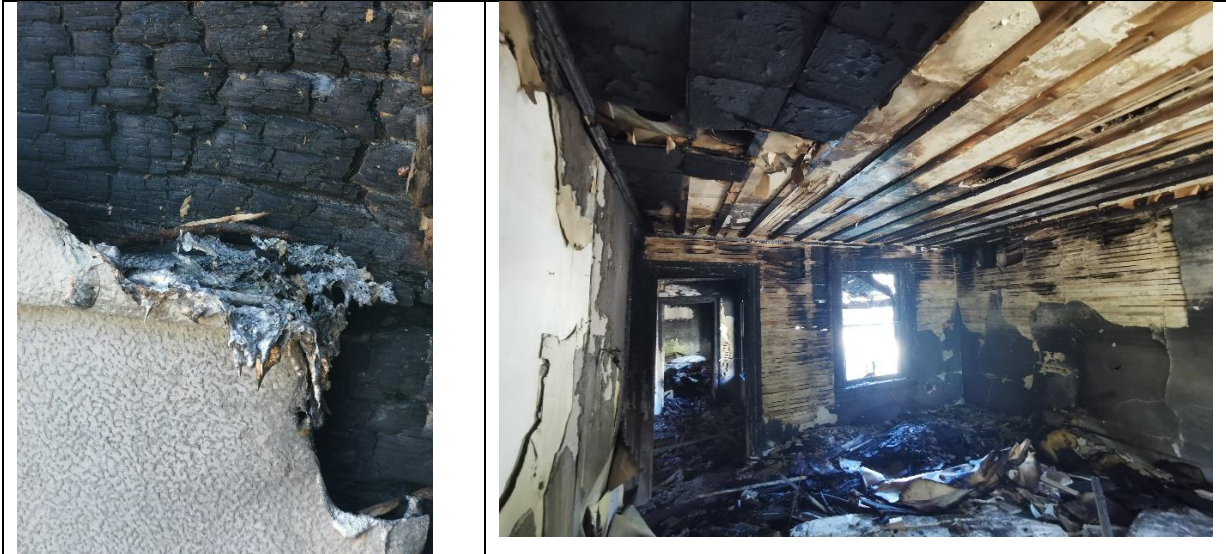
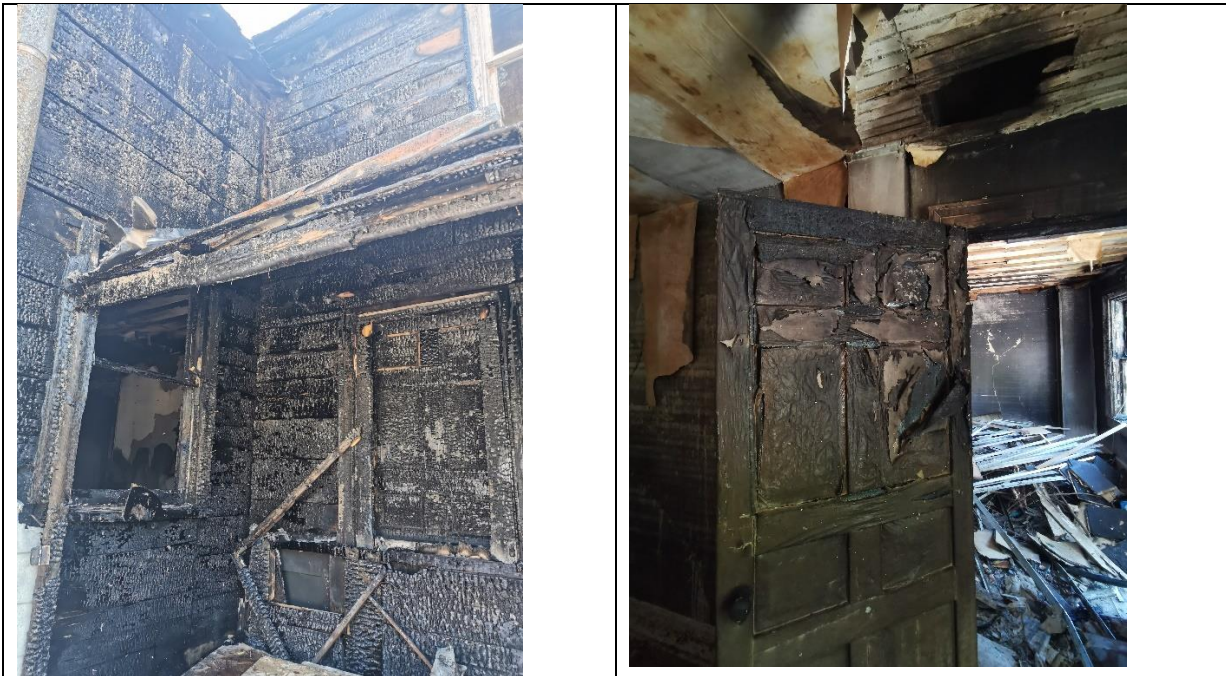
d. Nonstructural damages caused by fire, like damaged cladding and ceiling
