Staff Report for Heritage Richmond Hill Meeting

Subject: SRPBS.24.046 Heritage Permit for 10066 Yonge Street (Richmond Hill Presbyterian Cemetery Octagonal Vault) - D12-07438

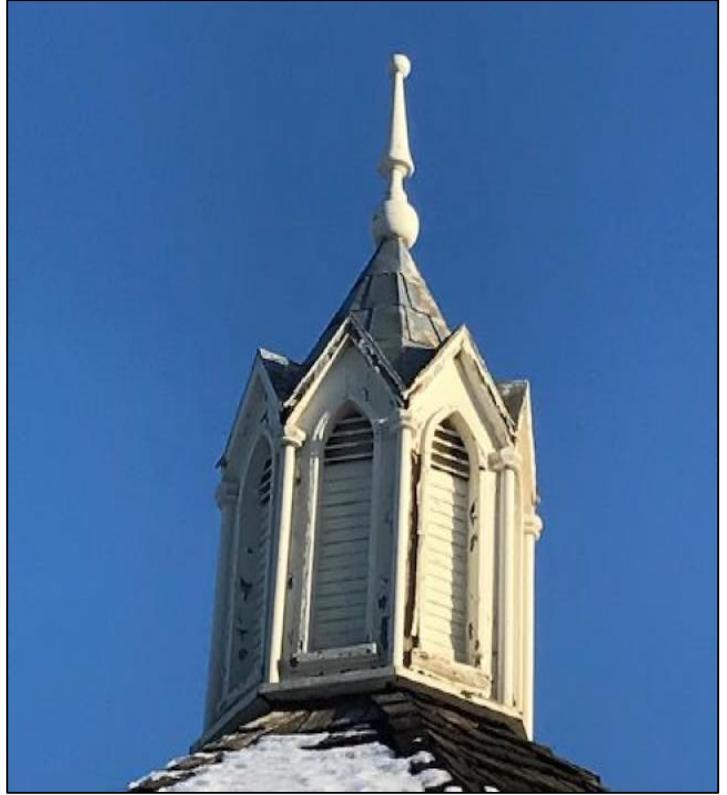
While the roof ventilator, also known as the lantern, appears to be intact, its paint is peeling (see Figure 3) and its interior showed evidence of water damage. Because water seems to be entering the Vault through the roof ventilator, its repair aims to conserve the roof ventilator and also prevent moisture from entering the Vault.

Figure 3: The roof ventilator exhibiting signs of peeling paint.

- Removing loose or flaking paint down to firm substrate;
- Replacing areas with damaged, decayed and punky wood with the Dutchman's patch method;
- Constructing replacement pieces in Eastern White Pine to match existing in size, profile and details;
- Piecing-in replacement components, then gluing and screwing them in place;
- Replacing the sills of five bays;
- Replacing the fascia boards to 6 bays and installing wood with the Dutchman's patch method;
- Closing any open or loose lock seams in the ventilator's roof;
- Priming and painting the wooden components;
- Caulking any gaps between wooden elements with exterior-grade sealant.

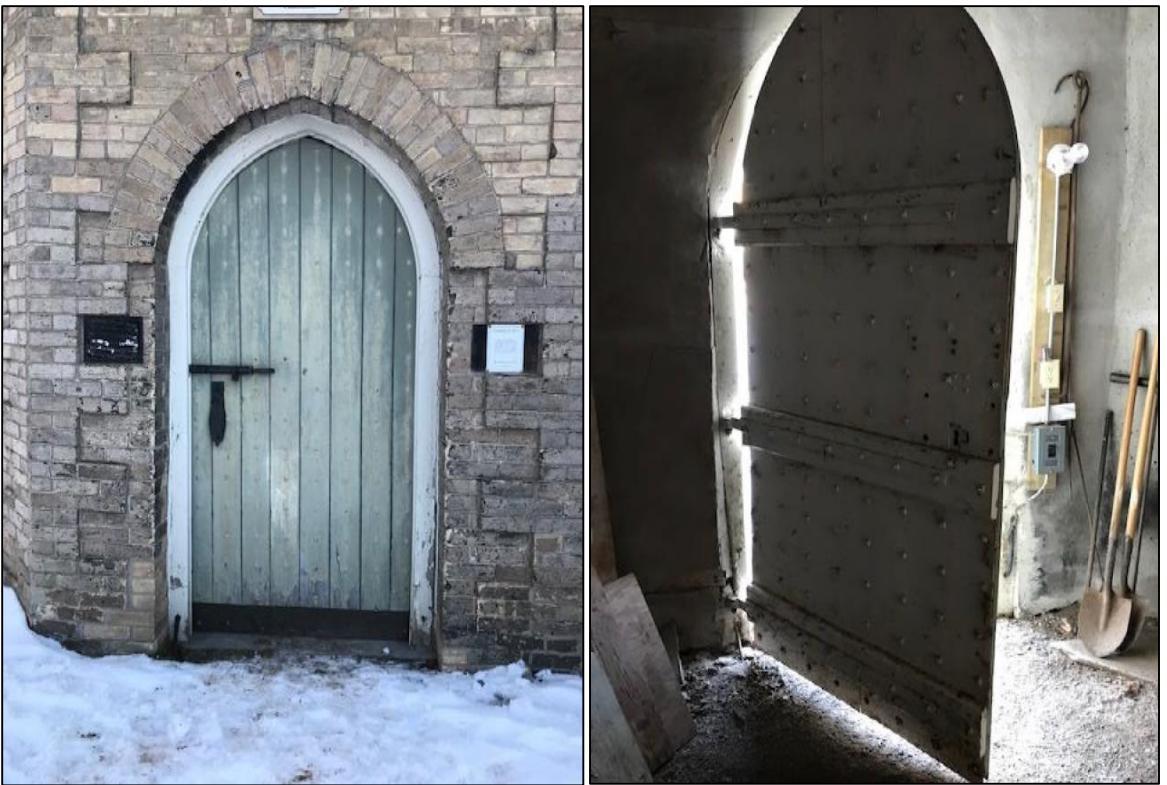
The lower portion of the wooden door frame exhibits decay, which has caused the lower door hinge to drop out of alignment (see Figures 4 and 5). The cast concrete door threshold also shows wear, being completely cracked through.

Figures 4, 5: The exterior of the door and frame showing peeling paint (left). The interior frame exhibits signs of decay; note lower hinge out of alignment (right).

- Removing the existing door from its hinges and removing all hardware;
- Removing loose and cracked paint from the door and frame;
- Replacing the rotten lower section of the door frame with a new wood section, fastening it and the existing frame to the brick opening with stainless steel dowels;
- Straightening the crooked hinge;
- Painting the door and frame;
- Rehanging the door and reinstalling all existing hardware;
- Removing the door threshold, installing a dowel across the crack and reinstalling the threshold.

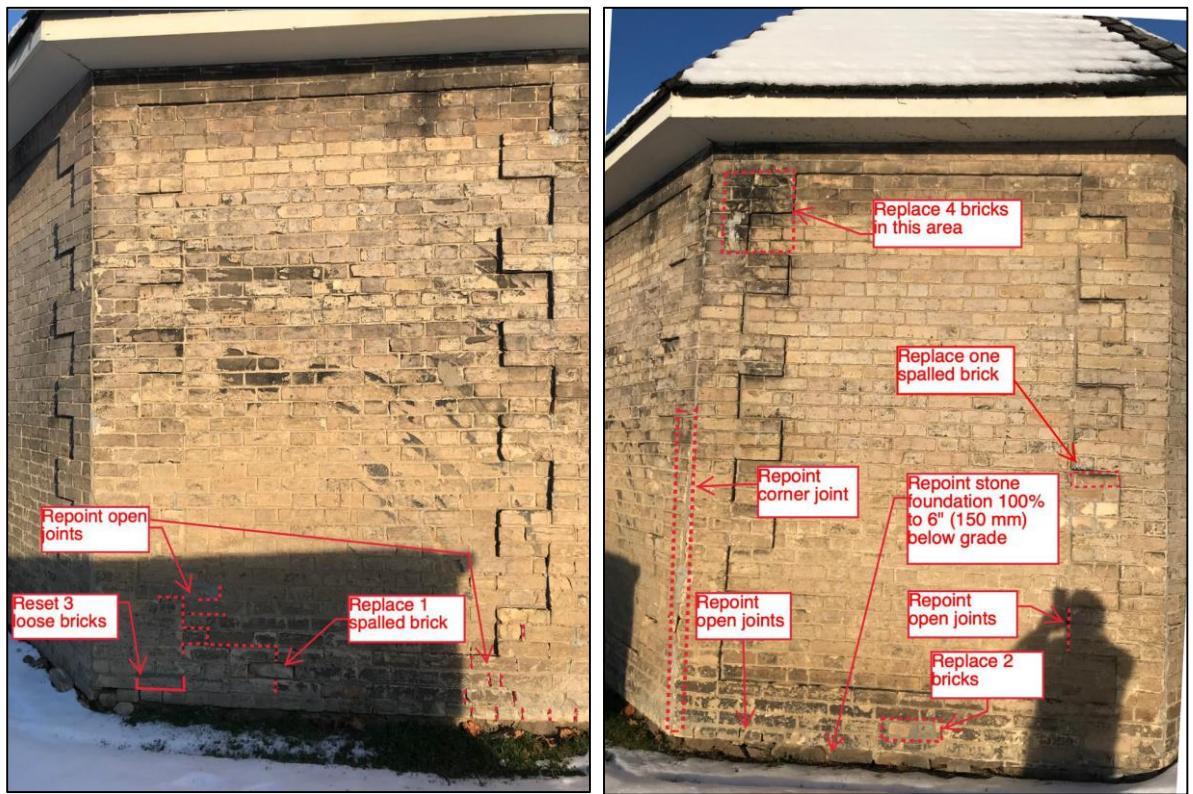
The brick walls of the Vault are in remarkably good condition given their age. While there are no signs of structural concerns, there are areas that exhibit deterioration (see Figures 6 and 7), including brick spalling, failing mortar, and movement of the bricks in the door arch (see Figure 4).

Figures 6, 7: Sample west (left) and southwest (right) elevations showing areas in need of repair.

- Cutting out and replacing approximately 70 bricks that are spalling, cracked, or previously patched with cement mortar; if reclaimed bricks cannot be found, the replacement bricks will be new bricks that match the existing;
- Repointing areas with crumbling or missing mortar with traditional quicklime mortar prepared on site;
- At cracked mortar joints where movement has occurred, cutting out masonry joints to the full depth of the outer wythe, and re-pointing in lifts using quicklime mortar;
- At other areas where mortar joints are missing, recessed or where inappropriate previous repairs were made, cutting out masonry joints and repointing using quicklime mortar;
- Removing bricks above the arch where movement has occurred, lifting the voussoirs at the top of the arch into their original position and installing temporary wedges to

hold them in place before cutting out the cracked masonry joints to the full depth of the outer brick and re-pointing and reinstalling the bricks.
