Staff Report for Heritage Richmond Hill Meeting

Report Number: SRPI.21.011

Subject: **SRPI.21.011 Notice of Intent to Demolish 16
Centre Street West, City File D12-07105**

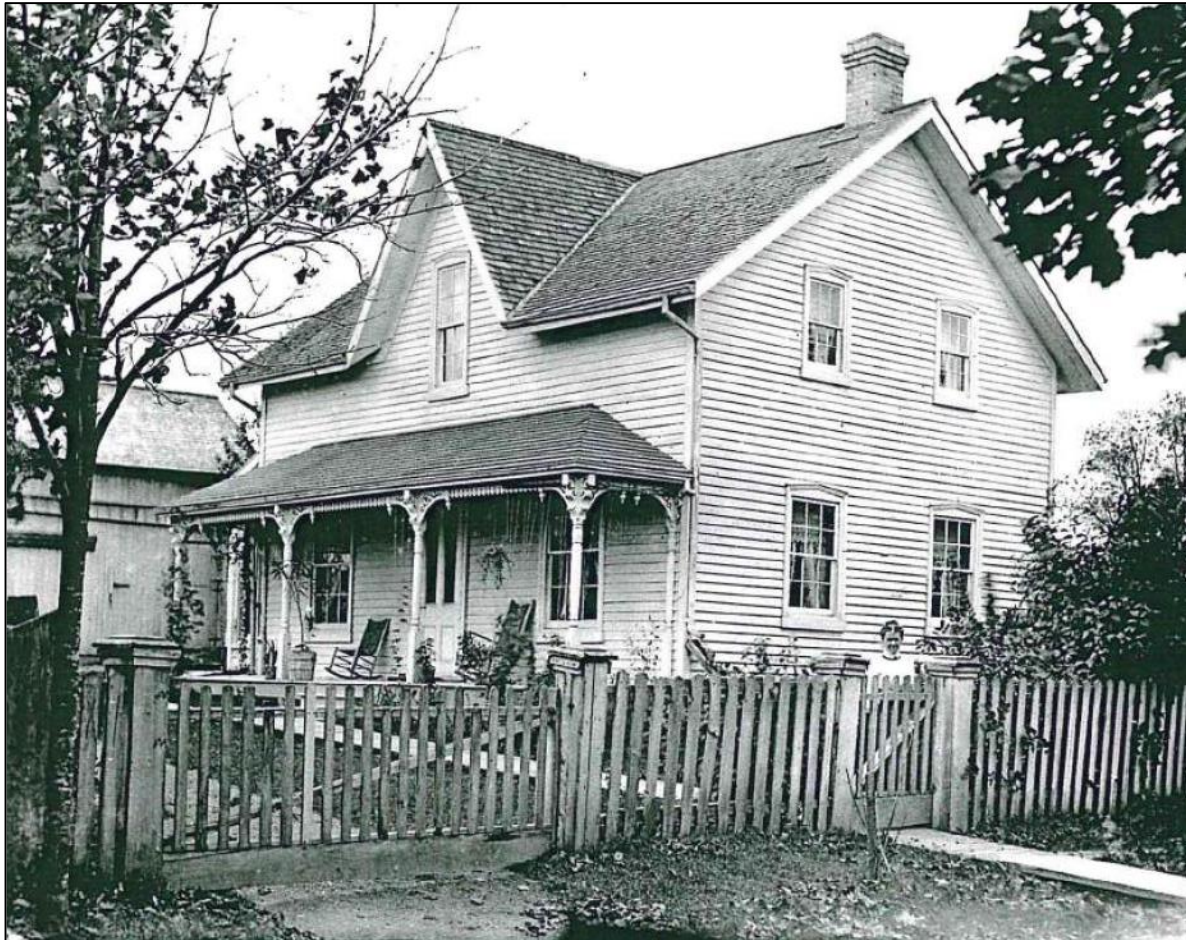
Undated photo of subject property illustrating how the dwelling looked prior to the alterations.

The building was constructed circa 1872 and was a modest 1.5-storey building at the time of its original construction. It was significantly altered during the earlier part of the 20th century by moving the front door to the west façade, changing the interior layout, changing the windows, adding a full basement, and adding a flat dormer to the east

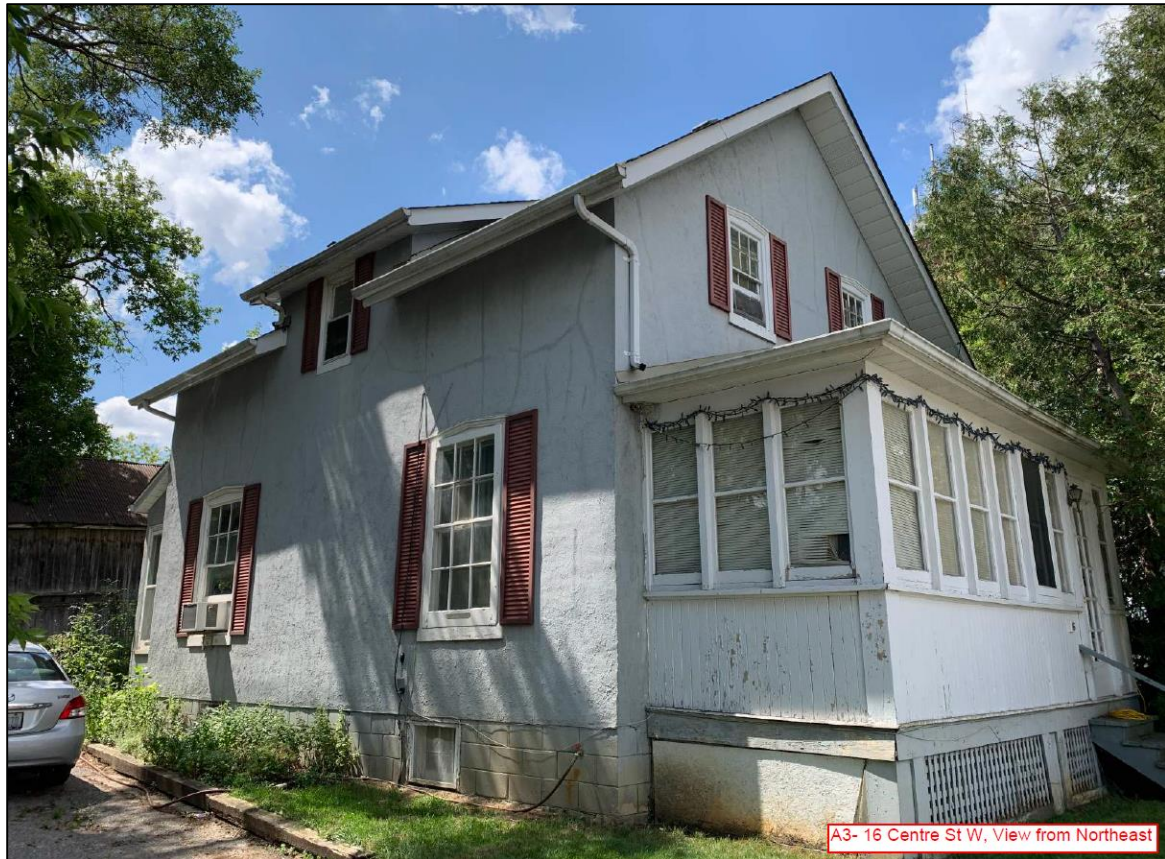
Photo taken in 2020 illustrating how the subject property looks today.

side. It has a frame one-storey addition at the rear. The wooden outbuilding at the rear of the property is also modest in design.

The subject property contains limited design value. It is not a rare, unique or early example of an architectural style, and the alterations to the exterior prevent the dwelling from being representative of a specific style. It also does not exhibit a high degree of artistic merit either in its craftsmanship or in its design. Staff concurs with the CHIA's assessment that the subject property does not have physical or design value.
