Heritage Impact Assessment

John Love House

630 King Road
Richmond Hill
Ontario, CA

DATE ISSUED: APRIL 28th, 2022

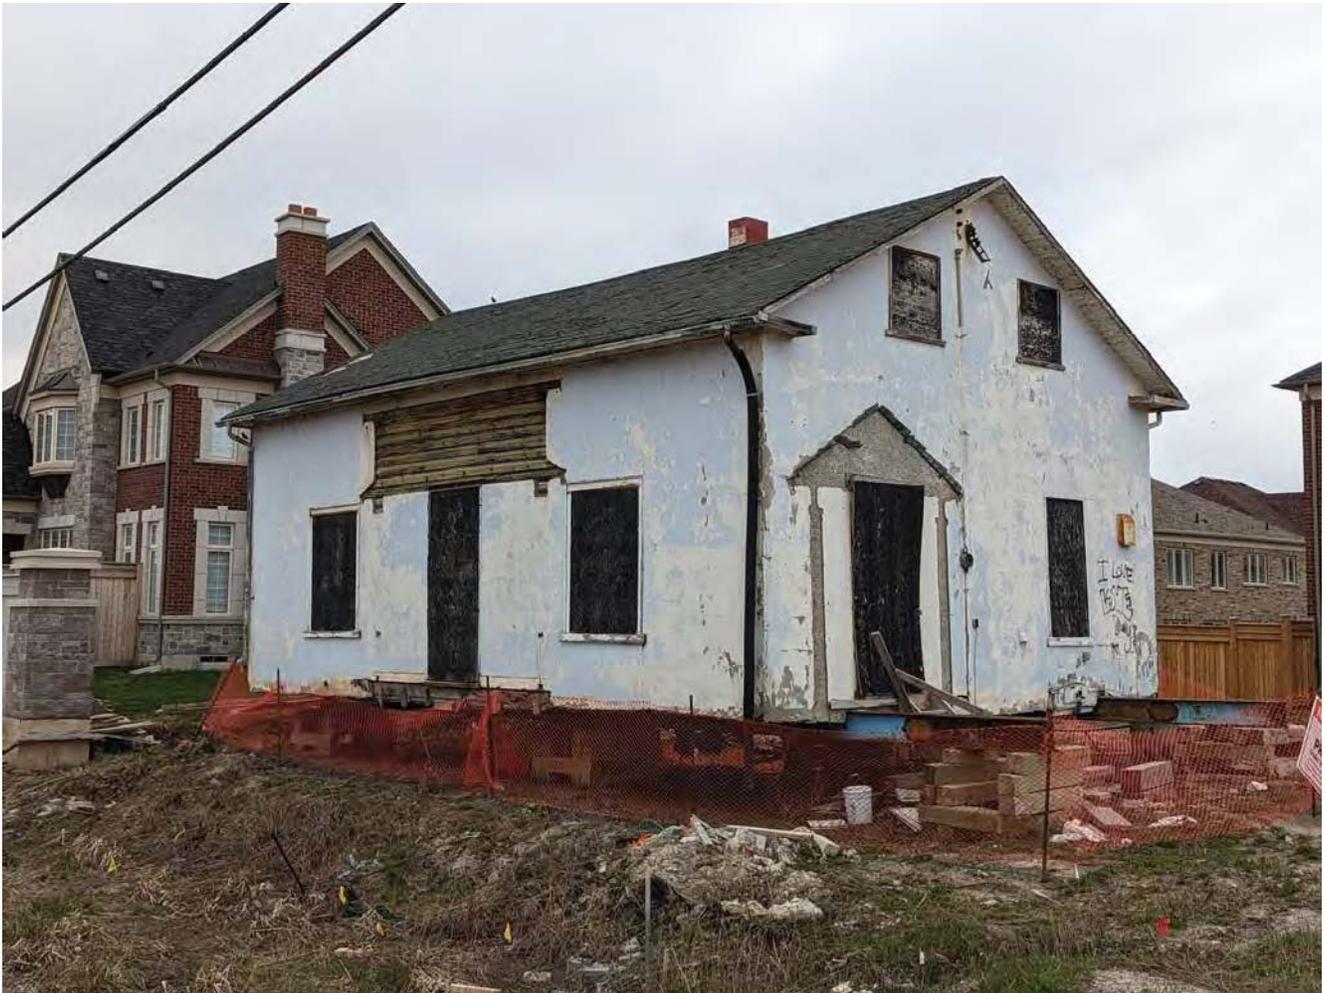
**Existing John Love House
(facing south / east)**

The dwelling currently sits on a raised steel and wood cage platform at the corner of King Road and Greywacke Street, southeast of its original location. This current location (Lot 52) is the intended lot for the final resting location for the dwelling. The dwelling in its temporarily suspended state, has been in this location for a number of years prior to this assessment.

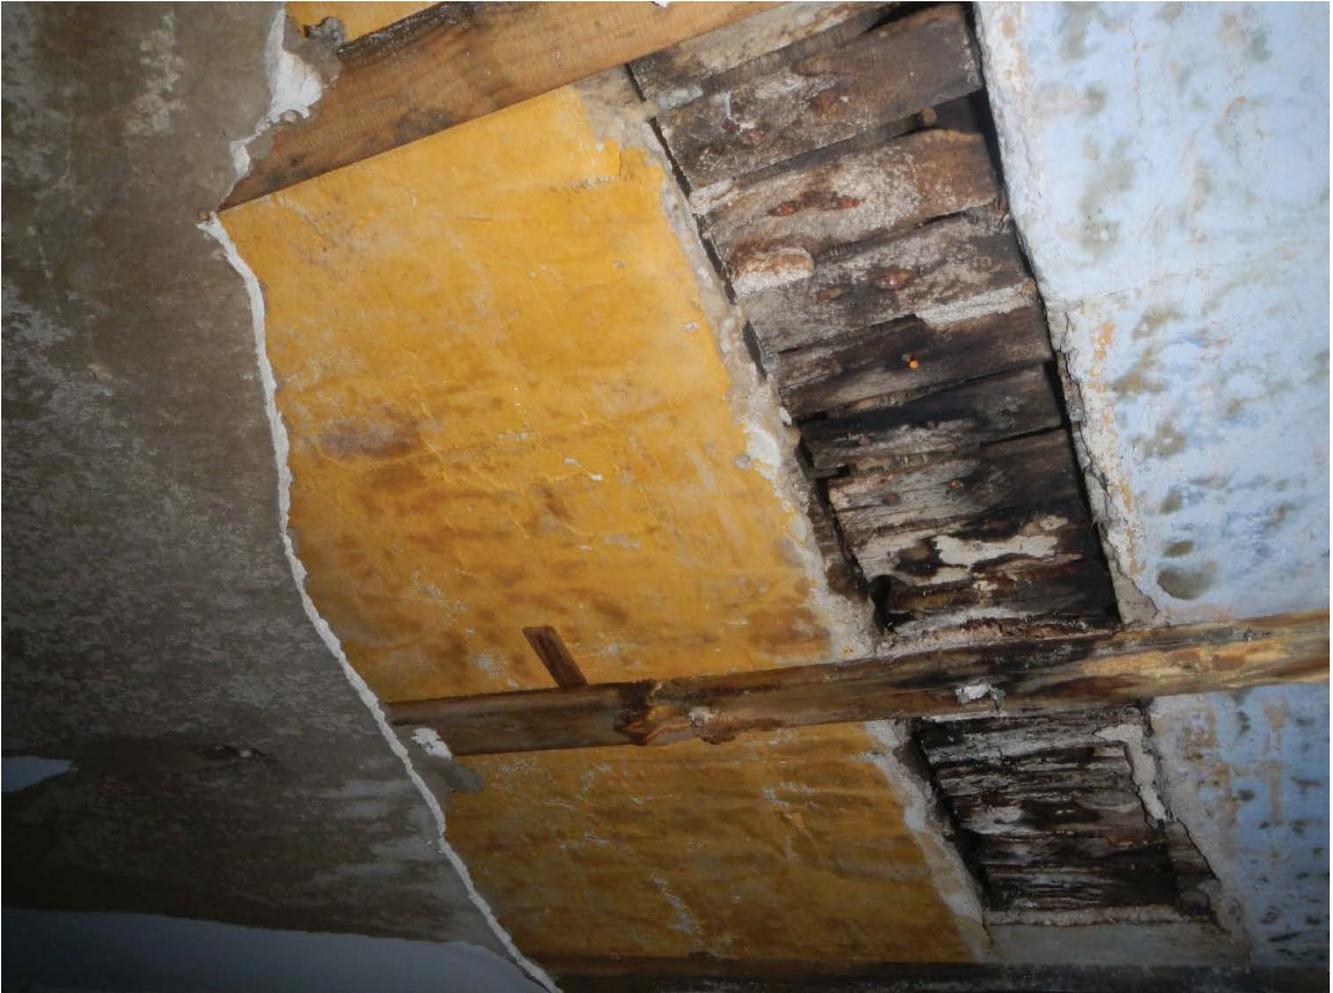
A review of the dwelling to determine the possible building relocation, restoration and sympathetic addition was started in 2021 by VA3 Design. During the review of the condition of the existing structure, high levels of wood rot and potential structural failure was observed. Extensive water damage, rot and mold was observed on the walls, floors and roof structure, necessitating a thorough review by a qualified structural engineer.

Ceiling of second floor showing water damage and mold

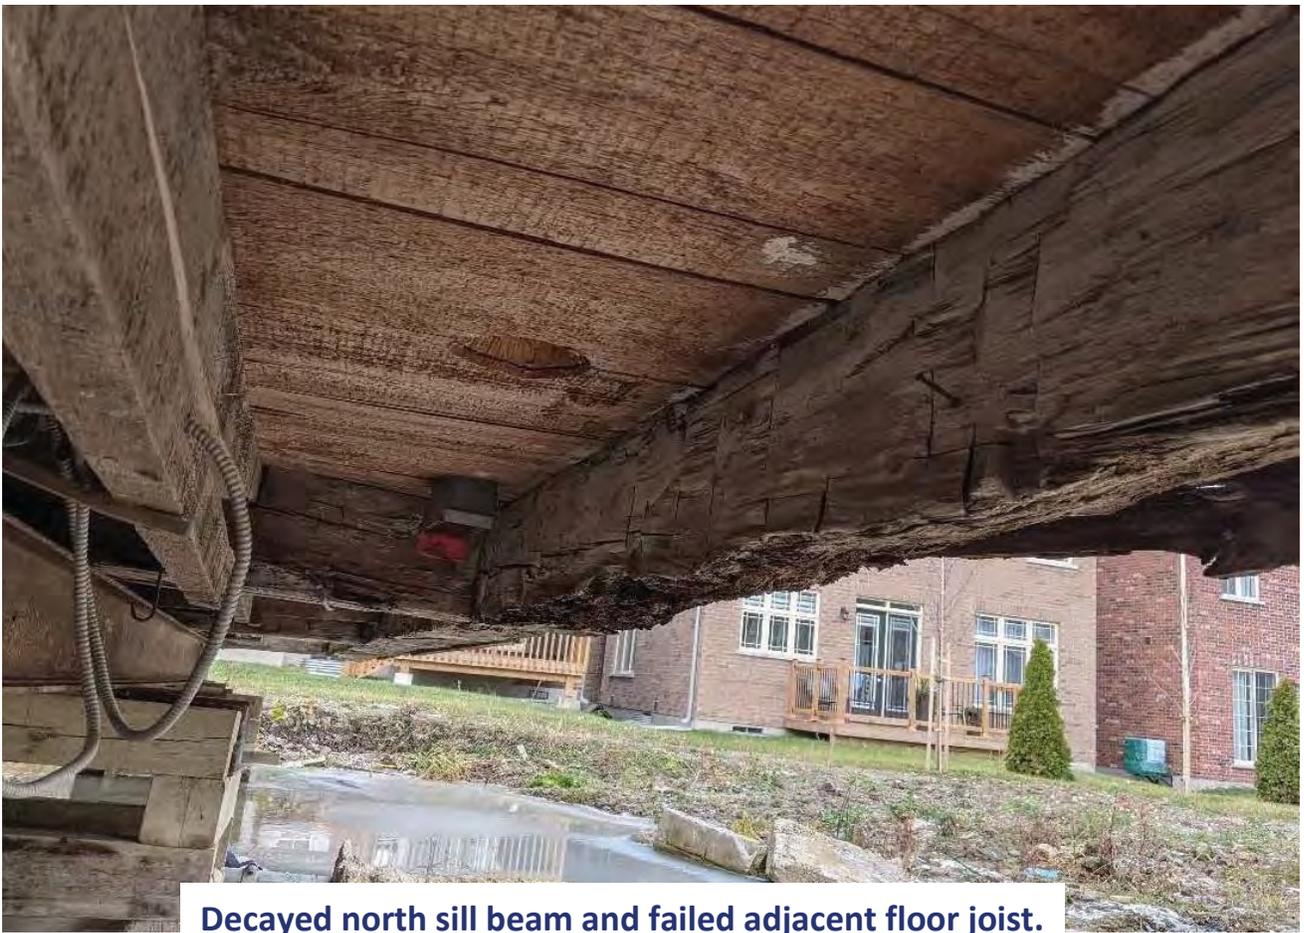
- Significant rot to the exterior, sill beams was identified.
- The unique design of the house structure constructed of vertical 2 1/2" x 14" wood planks tied into the bottom floor sill beams and supporting the upper floor and roof are the only support for the structure. No back-up stud support is evident to provide additional structural support to the upper floor or roof.
- The vertical plank support is cut off in some areas and rotted in other areas; resulting in a structurally unstable building.
- Moisture damage to the roof structure is evident causing damage to the structure and mold growth to the second-floor ceiling.

Decayed north sill beam and failed adjacent floor joist.

The two structural engineering reports concur that the condition of the "*John Love House*" is structurally unstable and too difficult and dangerous to safely repair.

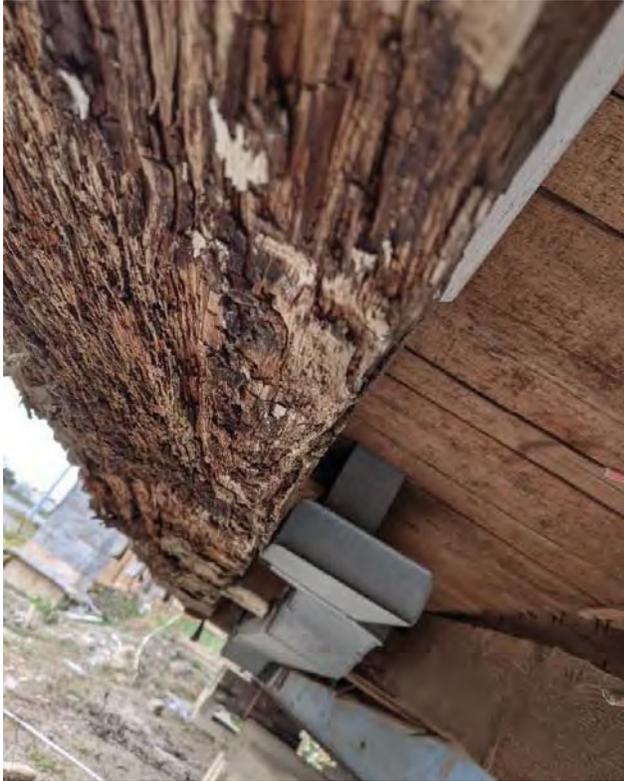
Decayed south sill beam and failed adjacent floor joist.

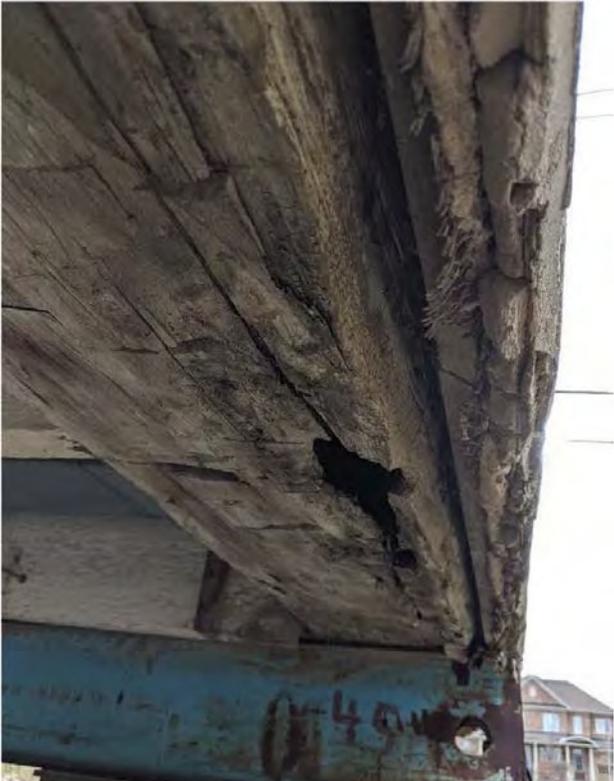
Decayed sill beam at south-west corner of the house.

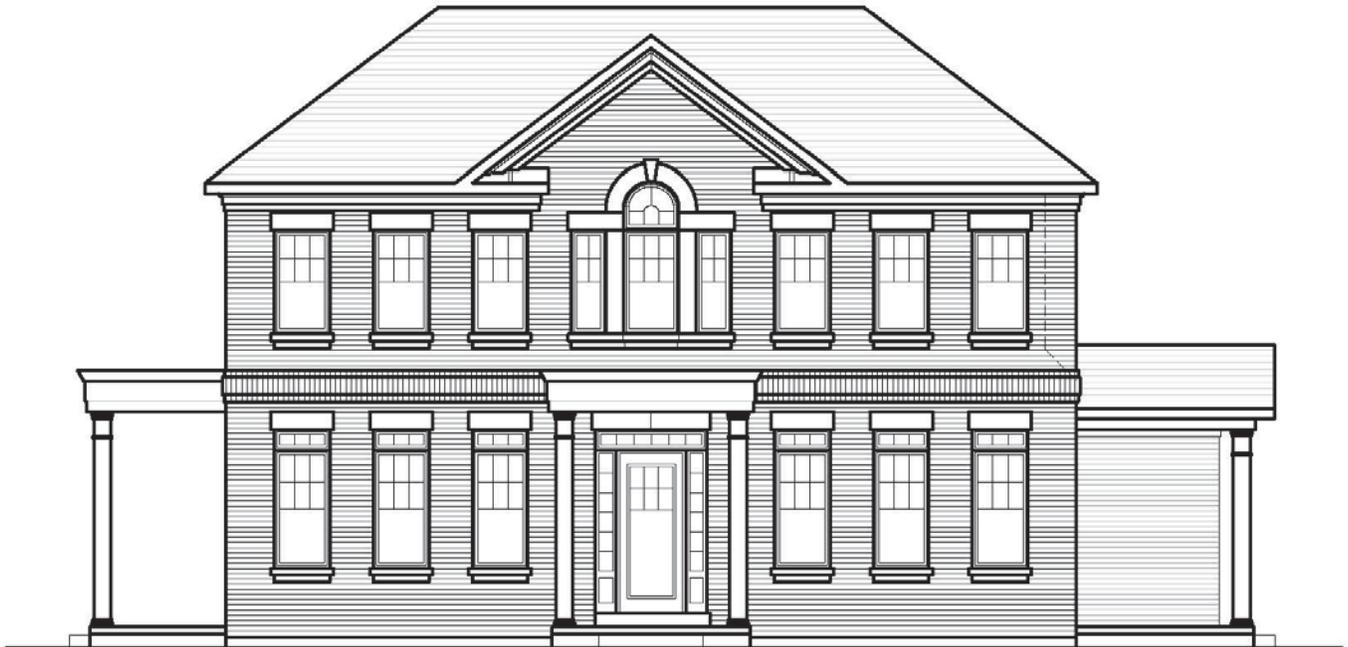
SOUTH ELEVATION
South Elevation (Proposed Dwelling)

The front facade has simple, single casement windows in the traditional Georgian-style placement. The dwelling will be of brick veneer construction with simplistic Georgian detailing and stone headers over the windows. The simplistic level of detail will ensure the facade does not overpower the streetscape while ensuring the dwelling has a presence on the King Road intersection to signify there is a historical link to the community.

The King Road entry will incorporate a small Georgian-style front porch that is proportional to the dwelling facade and does not dominate the streetscape.

The exterior brick will be a light grey colour and combined with the stone window headers will be a subtle colour palette that does not detract from the “*James Carscadden House*”, with a more traditional red brick exterior.
