## **Staff Report for Heritage Richmond Hill Meeting**

**Report Number:** SRPI.23.036

**Subject:** **SRPI.23.036 Heritage Permit - 1380 Elgin Mills Road East (Thomas F. Boynton House)**

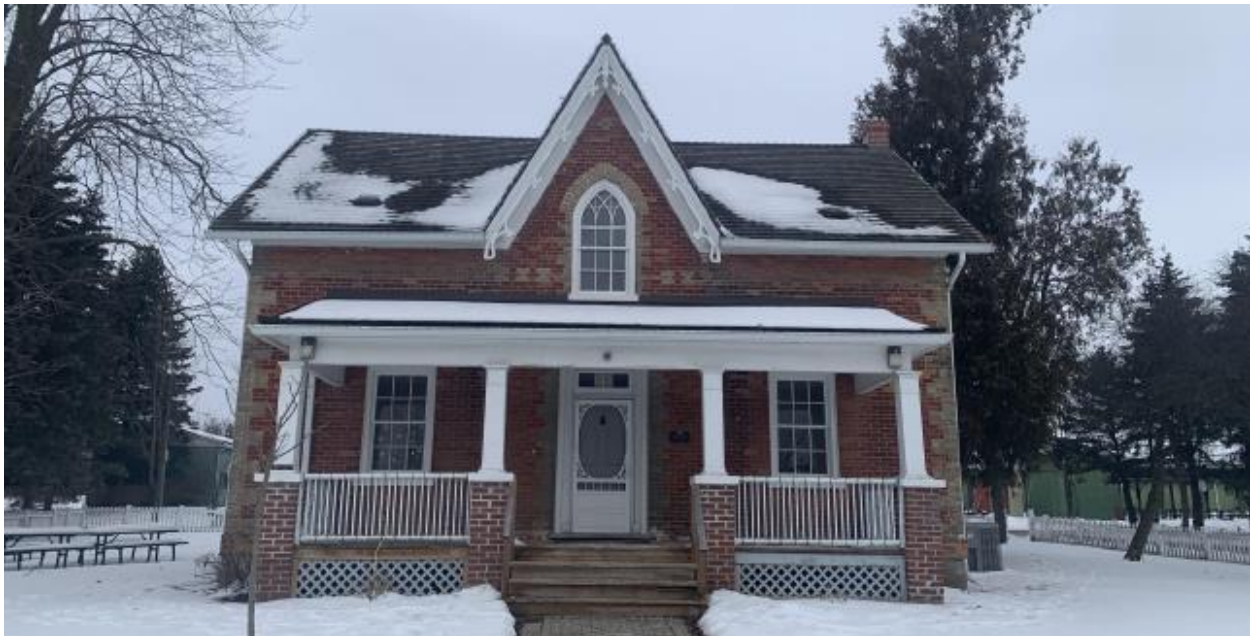
Figure 1 Front (south) elevation of the Thomas F. Boynton House at 1380 Elgin Mills Rd E

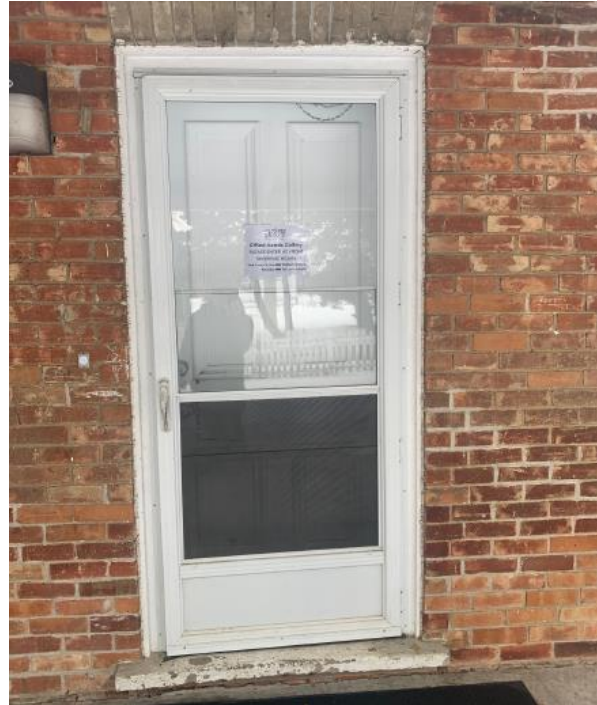
**Figure 2** Front (left) and secondary (right) entrances at the Thomas F. Boynton House, showing areas of peeling paint and damaged wooden doorsills, to be replaced in kind.

Door restoration at the front (south) and secondary (east) entrances of the Thomas F. Boynton House (see Figure 2) will comprise:

- Removing the existing damaged wooden doorsills, and replacing them with new wooden sills to match the existing; and

- Repainting the sills, doors and frames at the front (south) and secondary (east) entrances to match the existing.

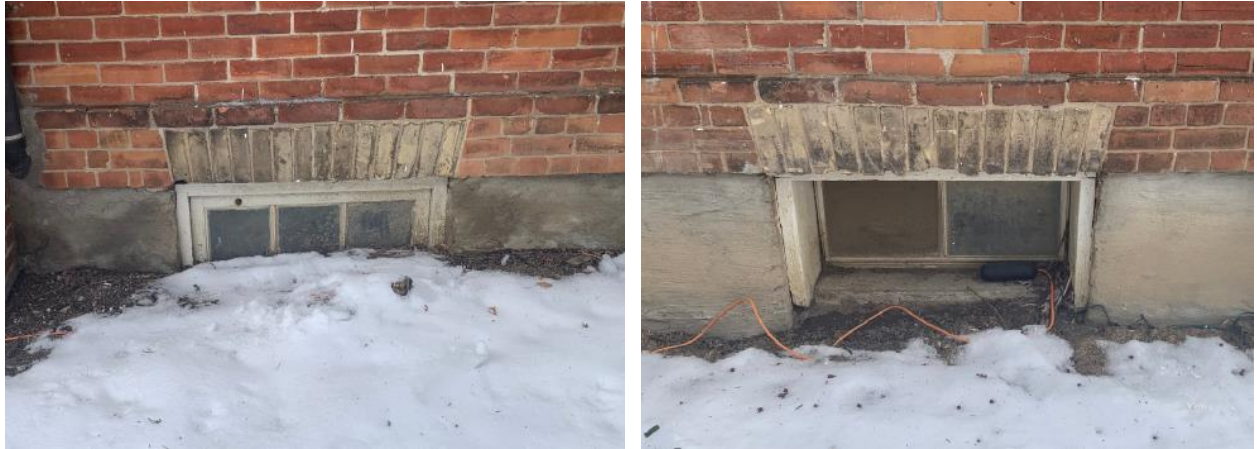
**Figure 3** Typical basement windows at the Thomas F. Boynton House's west (left) and east (right) elevations, showing damaged wooden frames and concrete sills, and need for re-grading.

Restoration of four basement windows on the east and west elevations of the Thomas F. Boynton House (see Figure 3) will comprise:

- Re-grading the area around the basement windows, and sloping the grade away from the building, to help direct water away from the foundations;
- Repairing areas of wood deterioration and damage due to cracks, hardware holes, and wood rot using accepted heritage conservation techniques and methods;
- Repainting all basement window frames to match the existing; and

- Replacing existing deteriorated concrete windowsills with new sills to match the existing.

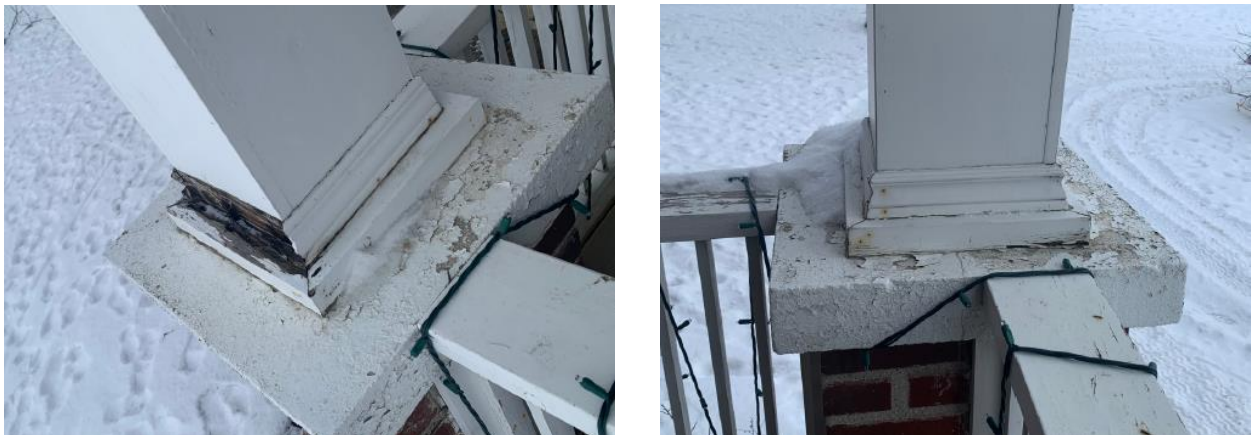
**Figure 4** Detailed view of the damaged base trim and peeling paint at the Thomas F. Boynton House's west (left) and east (right) front porch columns.

Additional heritage wood elements proposed to be repaired as part of this scope of work include areas of damage to the wood trim at the base of the building's front porch columns, as shown in Figure 4. This work will comprise:

- Removing damaged base trim and replacing it with new to match the existing; and
- Repainting porch column bases and trims to match the existing.
