Appendix A to Staff Report SRPBS.23.002

Town of Richmond Hill
Cultural Heritage Impact Assessment
for
9893 Leslie Street
Richmond Hill, Ontario

March, 25th 2020
SBA Project No. 20011
Re-issued February 23, 2021

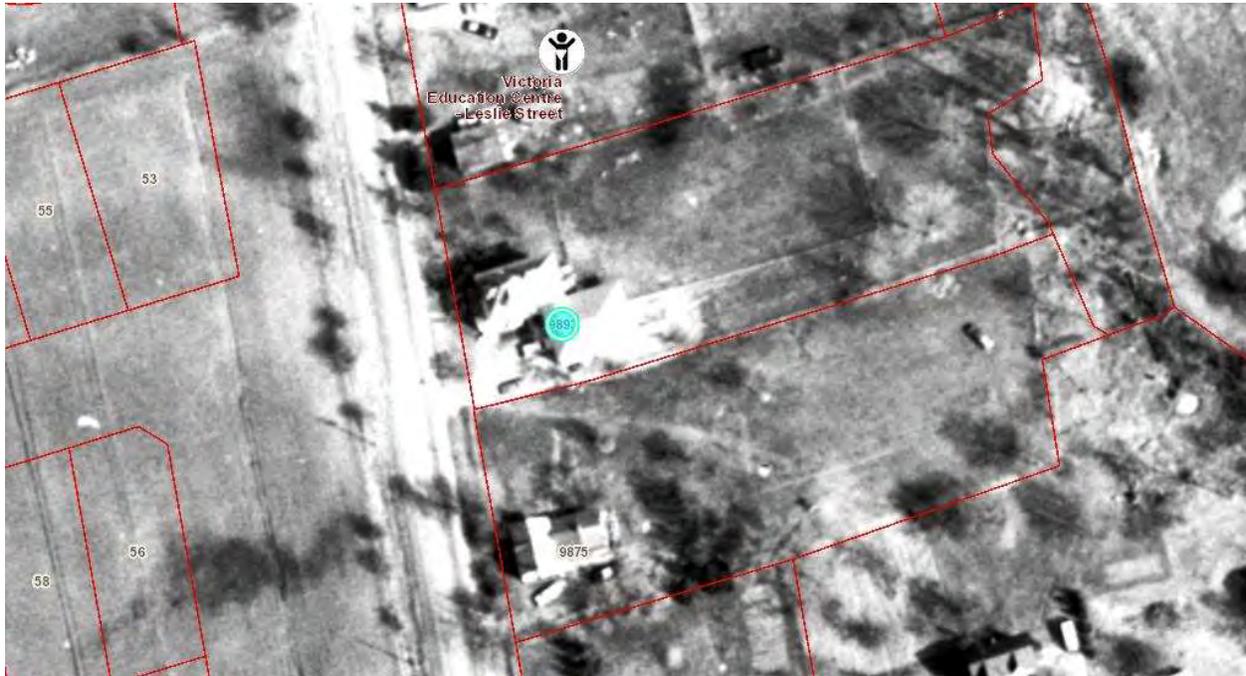
1970

The maps below show the context of the house as part of largely rural landscape that changes to an agricultural-suburban context in the 1990s.

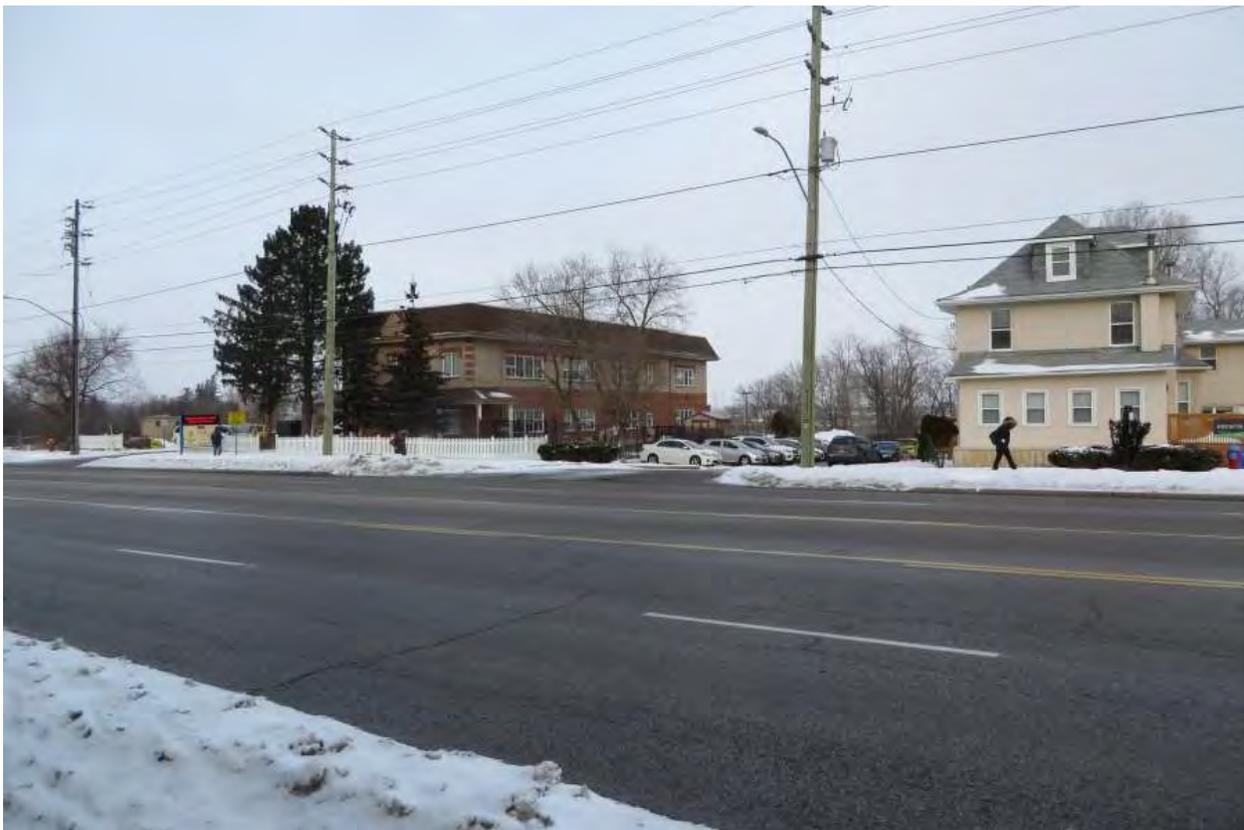
While the properties at 9893, 9875 and 9861 are adjacent they do not combine to present a cohesive heritage streetscape due to the large spacing between the buildings, extensive previous exterior alterations, and the presence of larger contemporary developments to the north of the site. The existing buildings, including Cultural Heritage Resources and contemporary buildings, have maintained a similar setback from Leslie Street.

Existing Property to the North

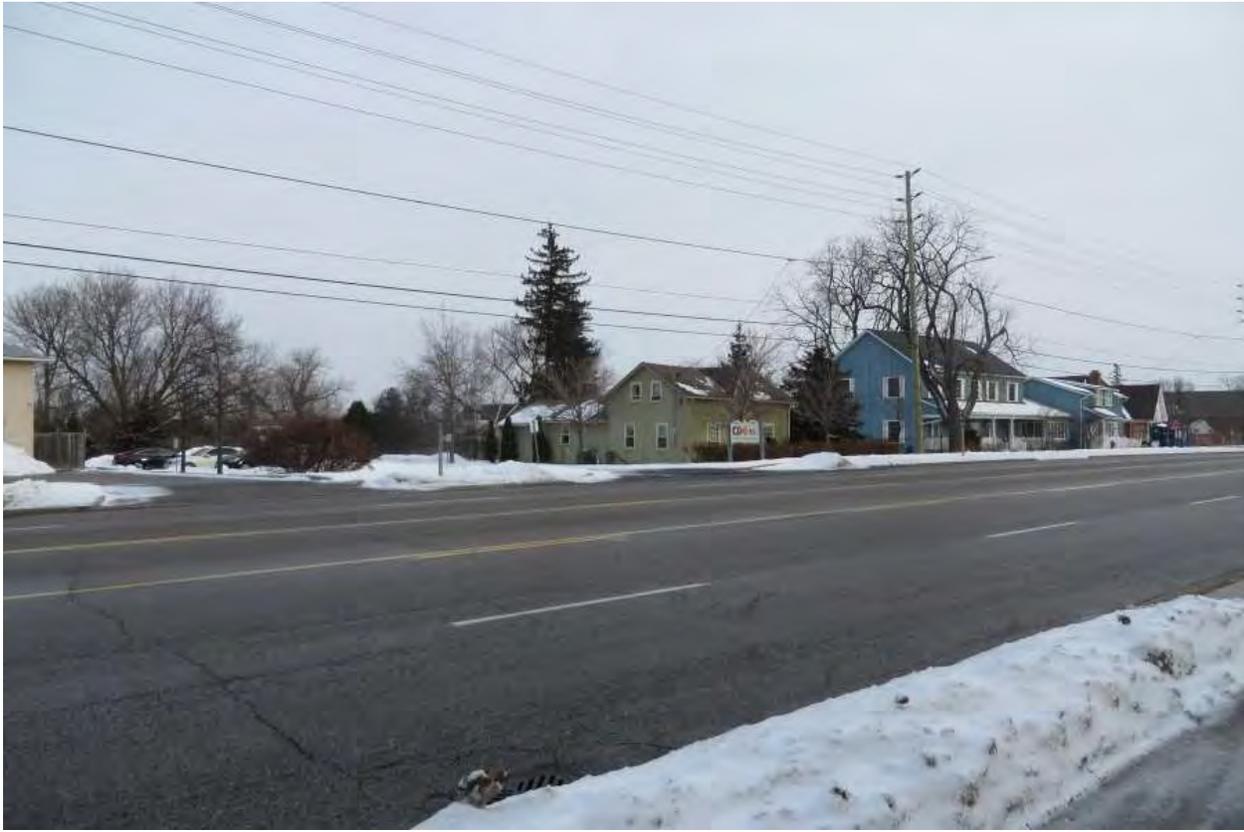
Adjacent Properties to the South

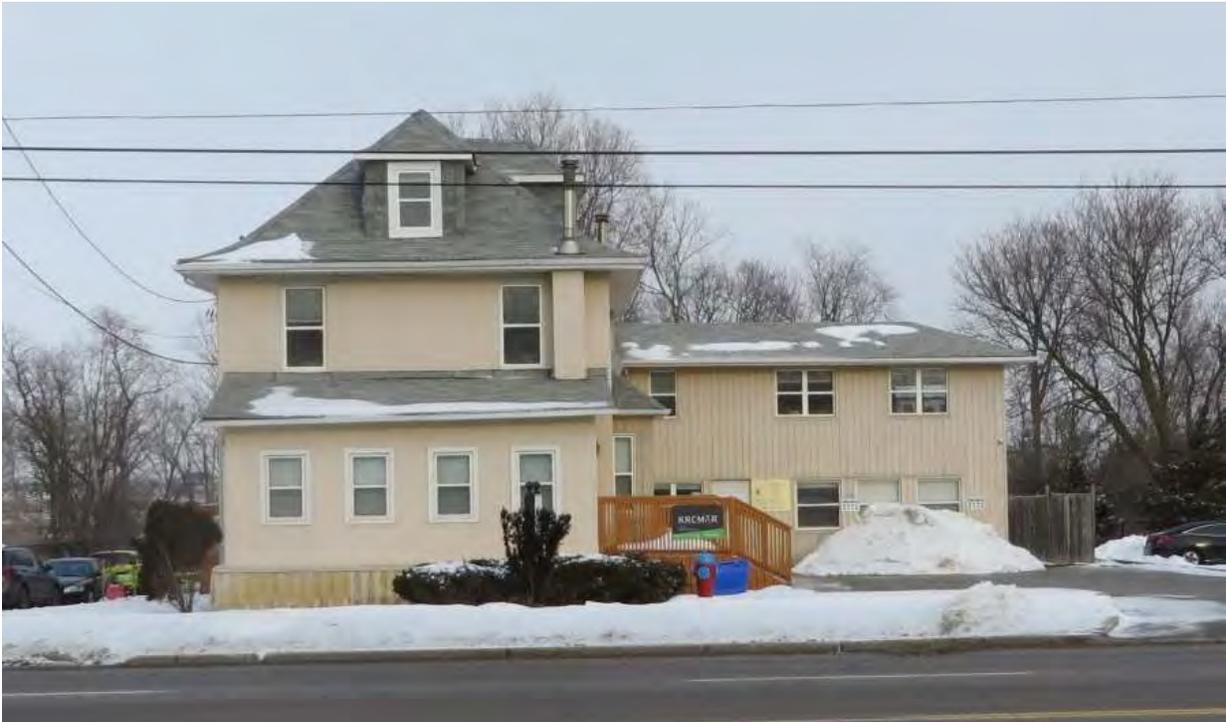
The contemporary wood entry stairs and platforms at the main entrance and the north exit are in fair condition but not original to the building.

West (Front) Elevation

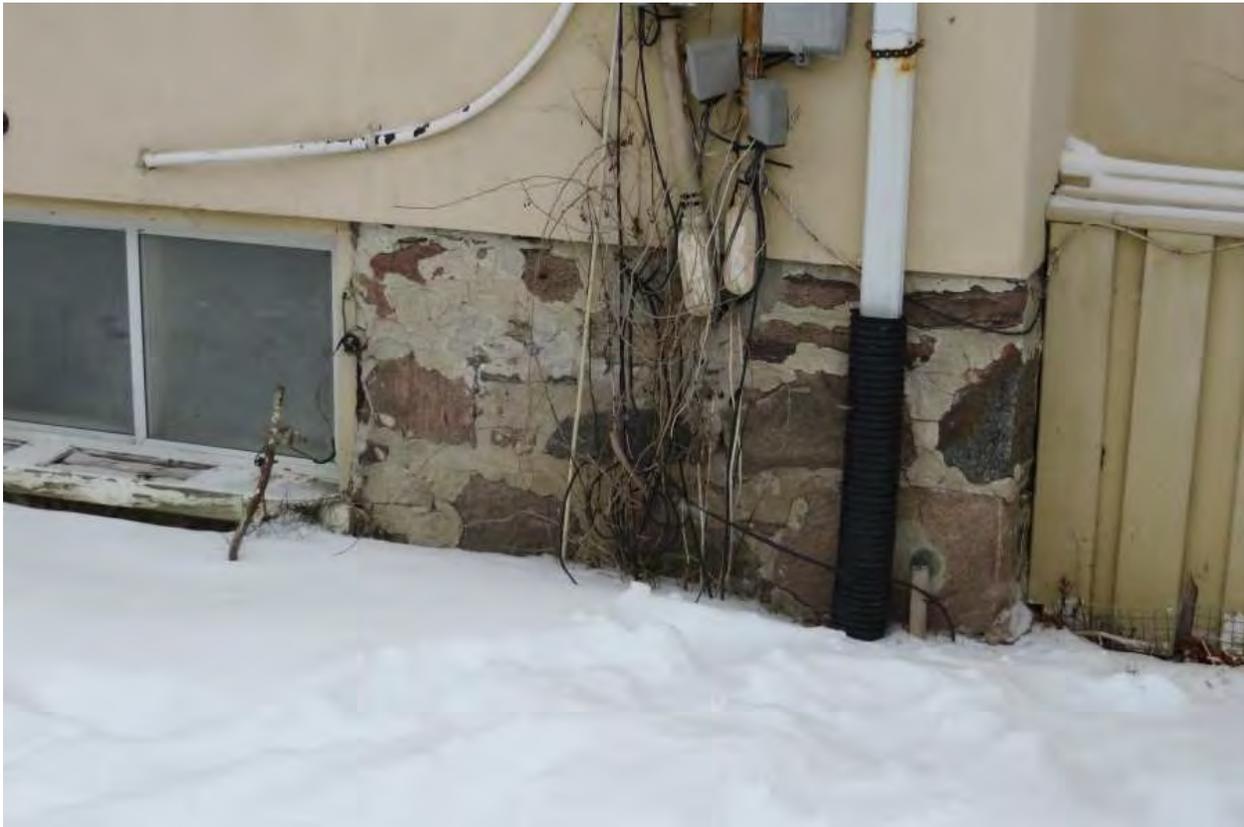
The fieldstone foundation wall has been altered to accommodate the exterior door access. It is not clear if the window openings are modifications, or if it was the exterior grading which was revised, causing the need for the current window wells. There are open joints between the stone foundation and the wood framing of the basement windows.

Fieldstone Foundation and Basement Window (North)

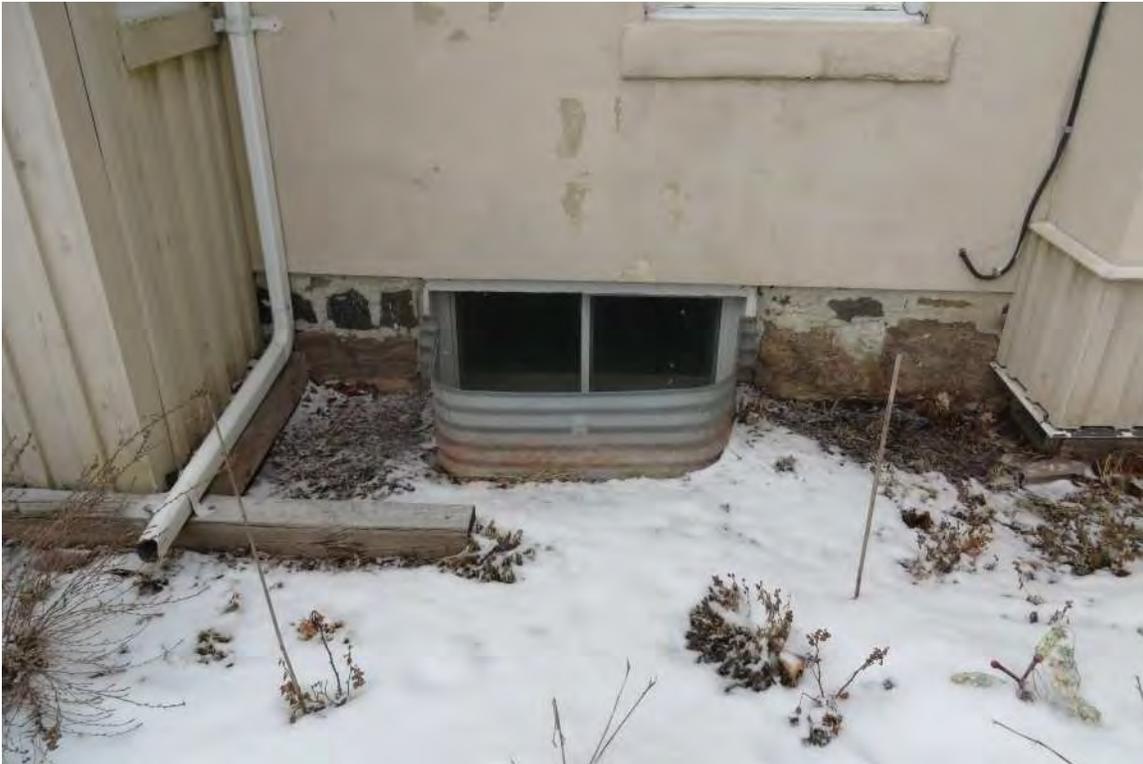
Fieldstone Foundation and Basement Window (South)

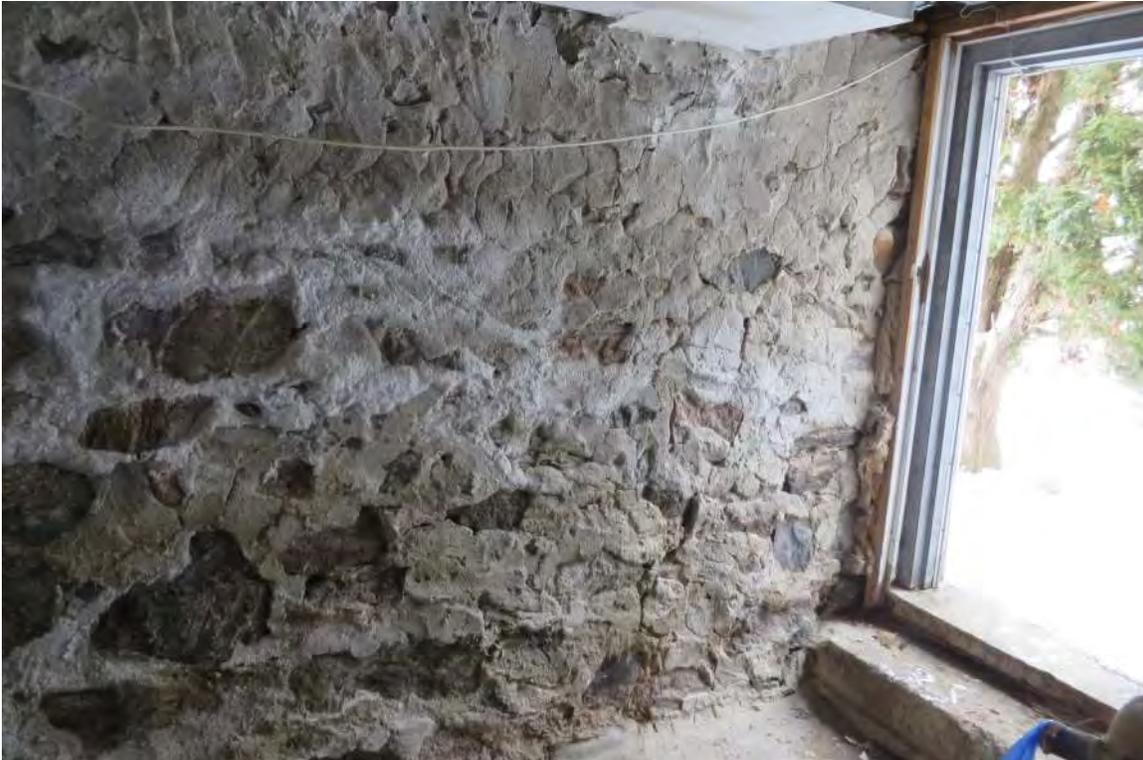
Where visible, the mortar of the fieldstone wall appears to be in fair condition. The basement/crawl space is dry, but a significant amount of efflorescence was observed on the interior. It is likely that there is no damp proofing or foundation drainage at the perimeter of the c. 1909 building.

Fieldstone Foundation (interior) with Significant Efflorescence

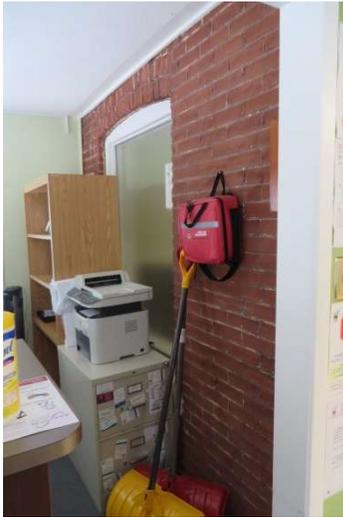
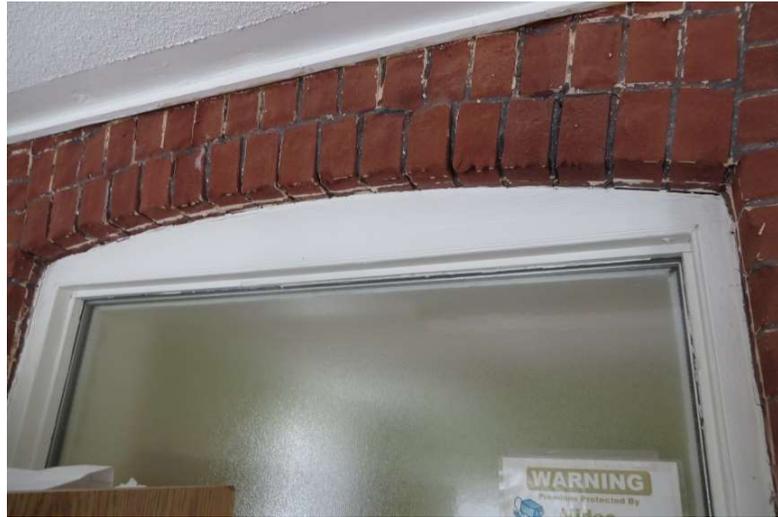
Where exposed within the verandah, the bricks are pointed with dark grey mortar and the brick faces are severely weathered. There is off-white coating material remaining on portions of the mortar joints, and it is not clear if the weathering of the bricks occurred prior to the coating application, or as part of the process of the coating removal.

Original Red Brick Wall Exposed Within the Verandah

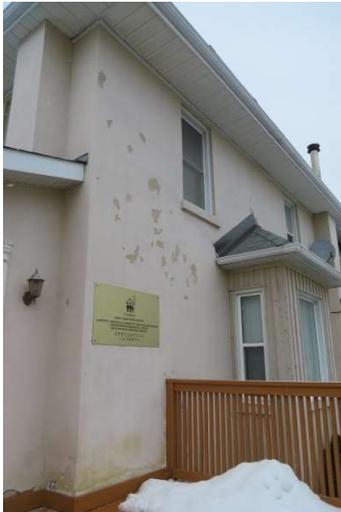
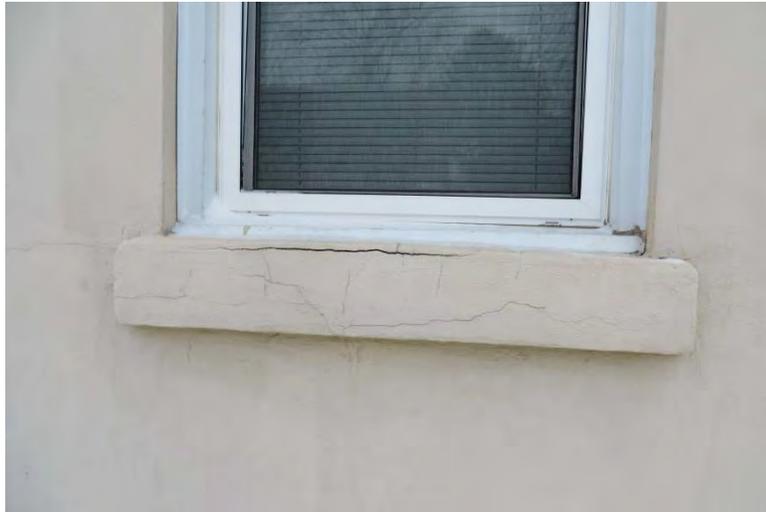
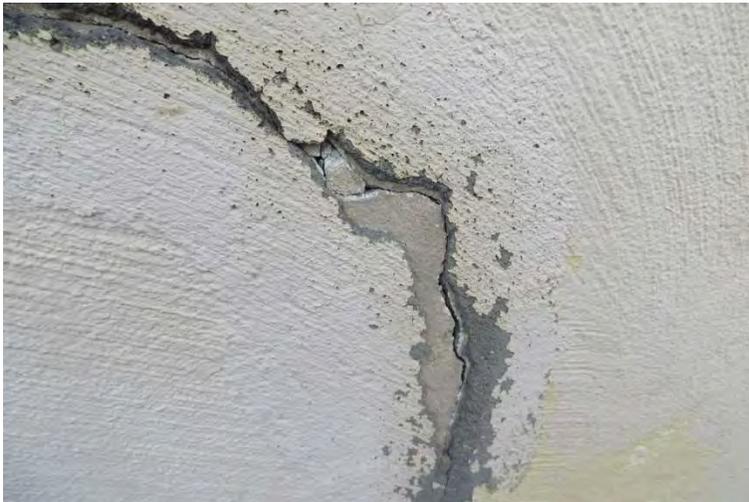
The exterior cementitious plaster surfaces are in poor condition with the outer layer and paint failing and flaking. There are movement cracks visible in multiple locations adjacent to the foundations and above window/door openings. It is assumed that the masonry beneath has similar crack patterning. The cementitious plaster on the window sills (assumed wood) is in poor condition with severe cracking visible.

*Deterioration of Cementitious
Plaster/Stucco*

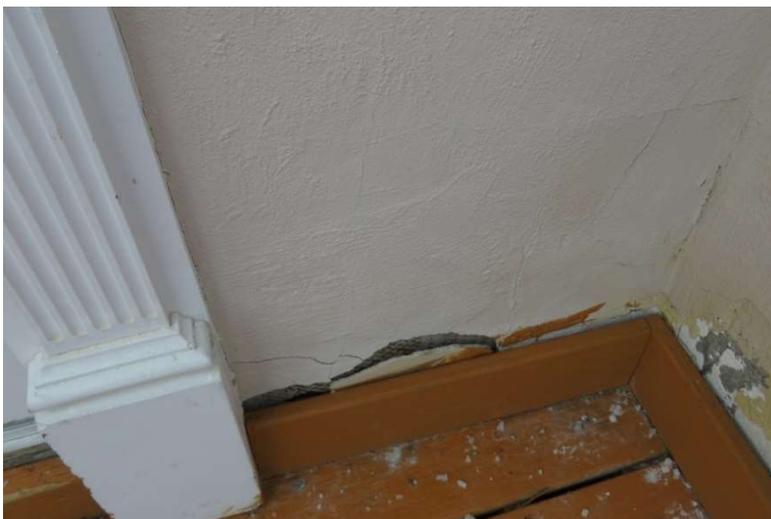
The enclosed verandah is also stucco clad, but there is a metal reinforcing mesh visible at the failed locations. It is assumed that the verandah enclosure is wood framed and is not original to the 1909 construction.

Deterioration of Plaster/Stucco at Verandah

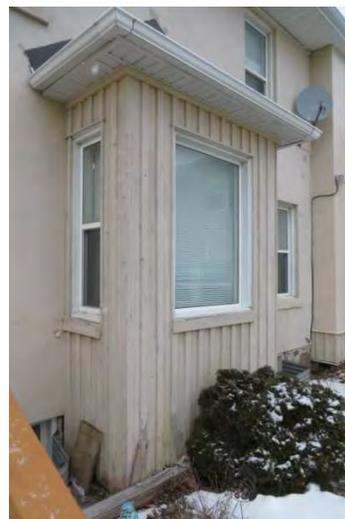
The squared bay window on the south façade is clad with wood board and batten siding which is consistent with the cladding of the side addition. The paint is peeling but the wood appears to be in fair condition. It is assumed that the bay window is not an original feature of the house.

*Squared Bay Window
on South Façade*

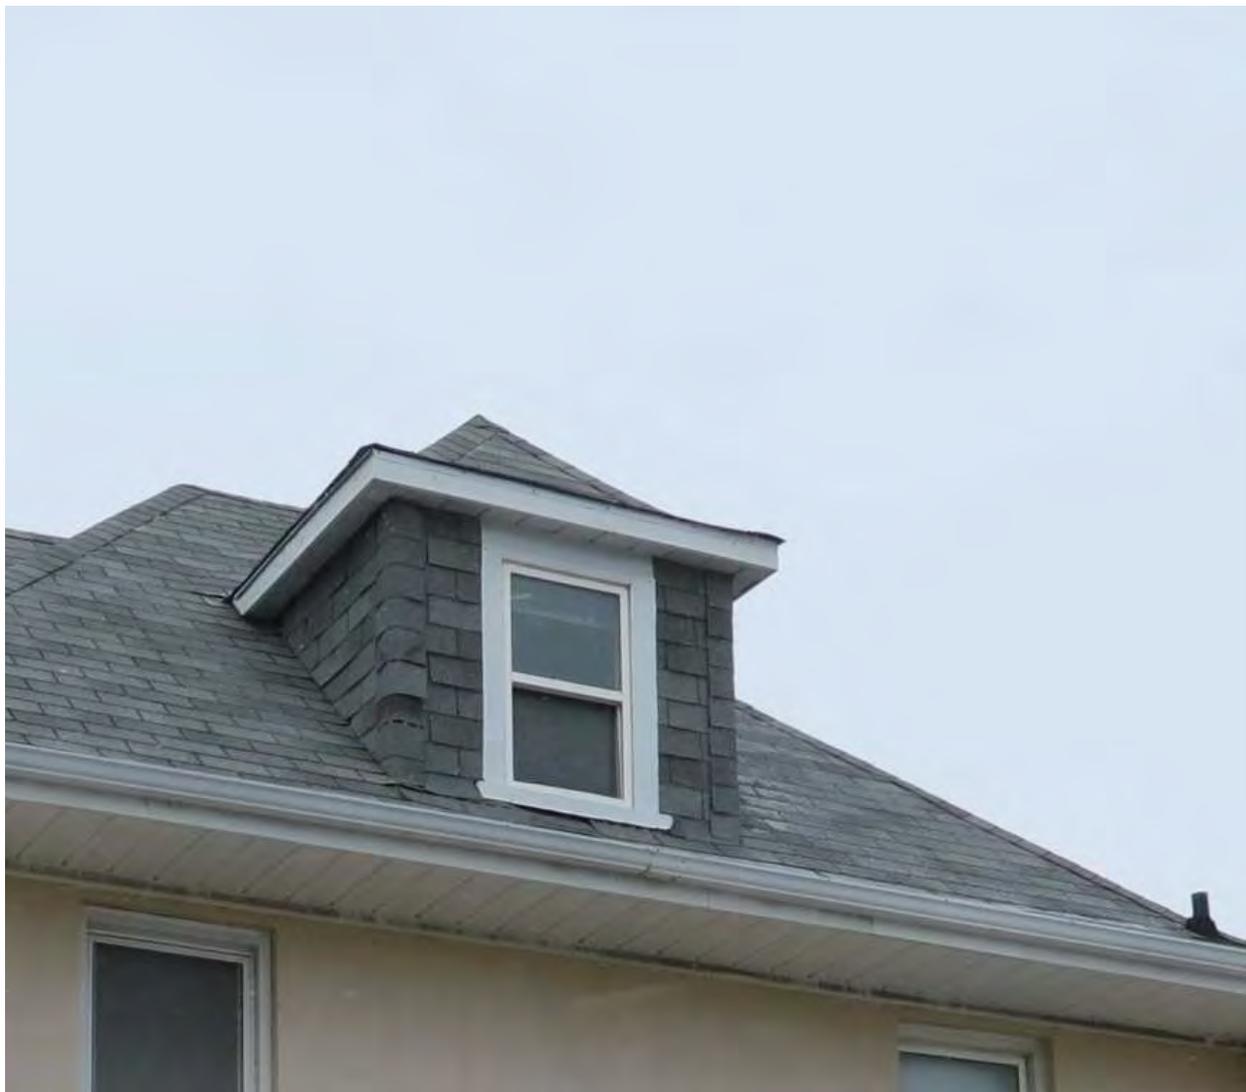
The sloped roofs and the dormer walls are clad with asphalt shingles, which appear to be in fair condition.

The original dormer configuration is not confirmed. It is possible that there was a matching dormer on the North face of the roof, maintaining the symmetry of the building. There is no visible physical evidence to support this hypothesis.

South Dormer

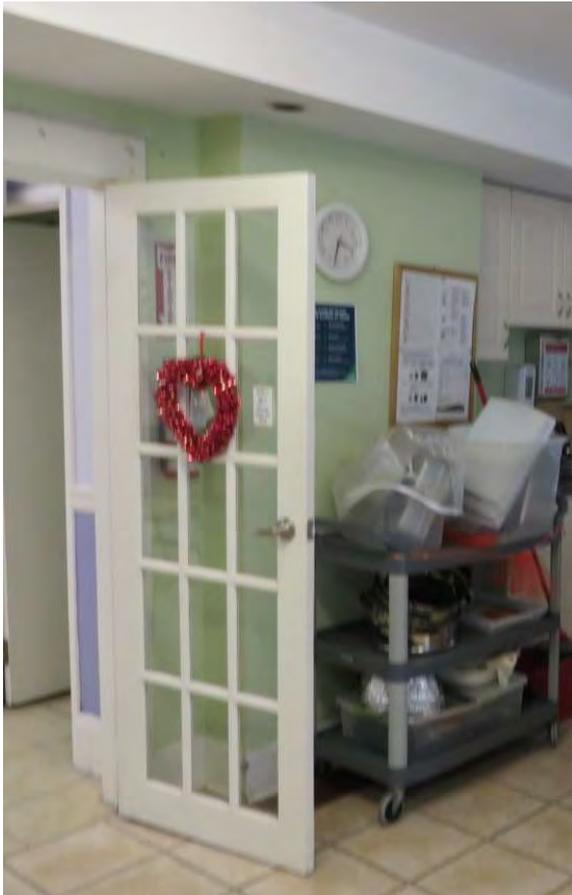
There is no evidence of the original chimney at roof level. Based on the interior build-outs within the north L, it is inferred that the chimney was originally located on the wall between the L and the main building.

Assumed location of Original Chimney within the Current Kitchen

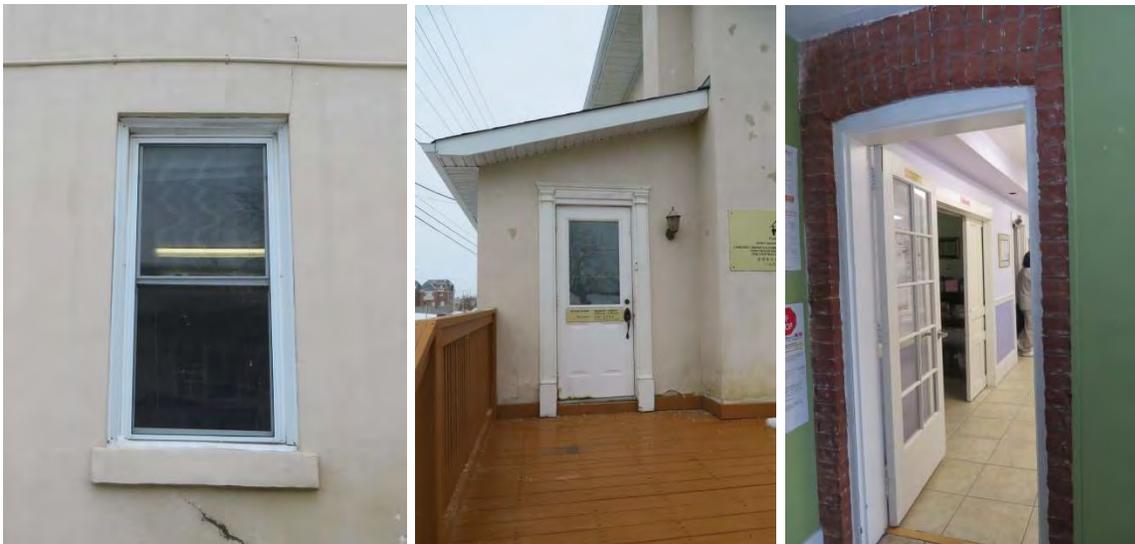
The windows of the building have been replaced with vinyl windows with aluminum clad framing/flashing. It is possible that the original wood window frames remain within the aluminum cladding. The windows appear to be in fair condition, but it cannot be confirmed without removal of the stucco cladding or interior finishes if the original window locations have been altered.

The entry door to the veranda is non-original, and the 10-light glazed door at the original entry from the veranda to the interior of the building is also non-original. The wood door frame between the verandah and the house appears to be original and is in fair condition.

Windows and Doors

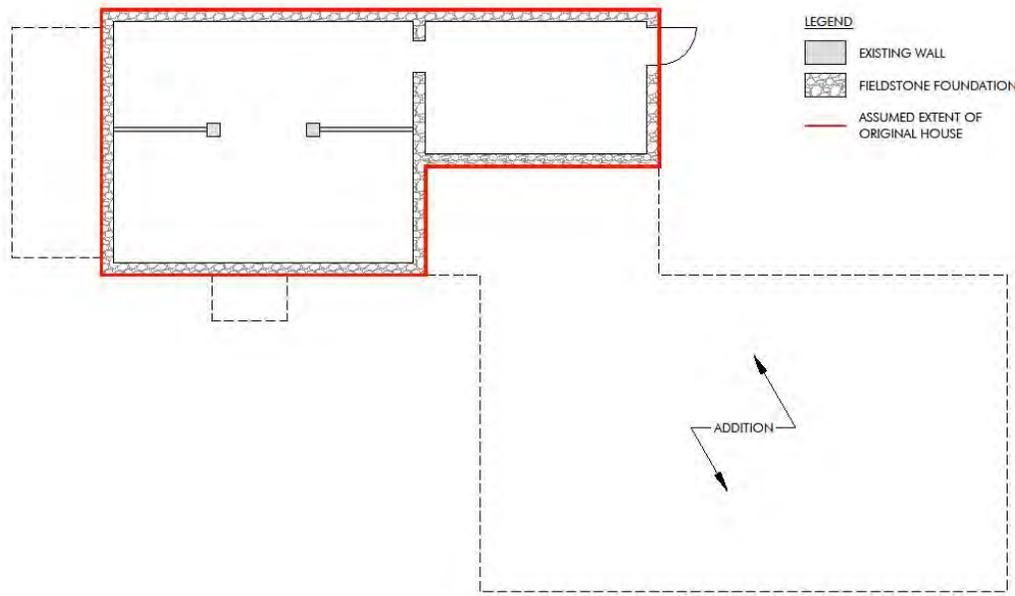
Basement Floorplan

The stair which between the basement and the ground floor has been removed, and basement access is now provided through an exterior door at the east (rear) of the building.

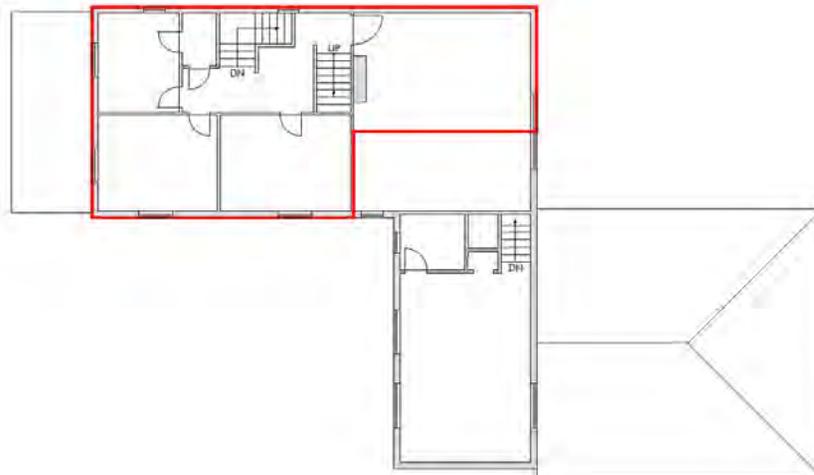
Second Floor Plan

Bulkheads and build-outs have been constructed throughout the building to accommodate a forced air heating system. Within the second floor, the HVAC ductwork remains exposed within the individual rooms.

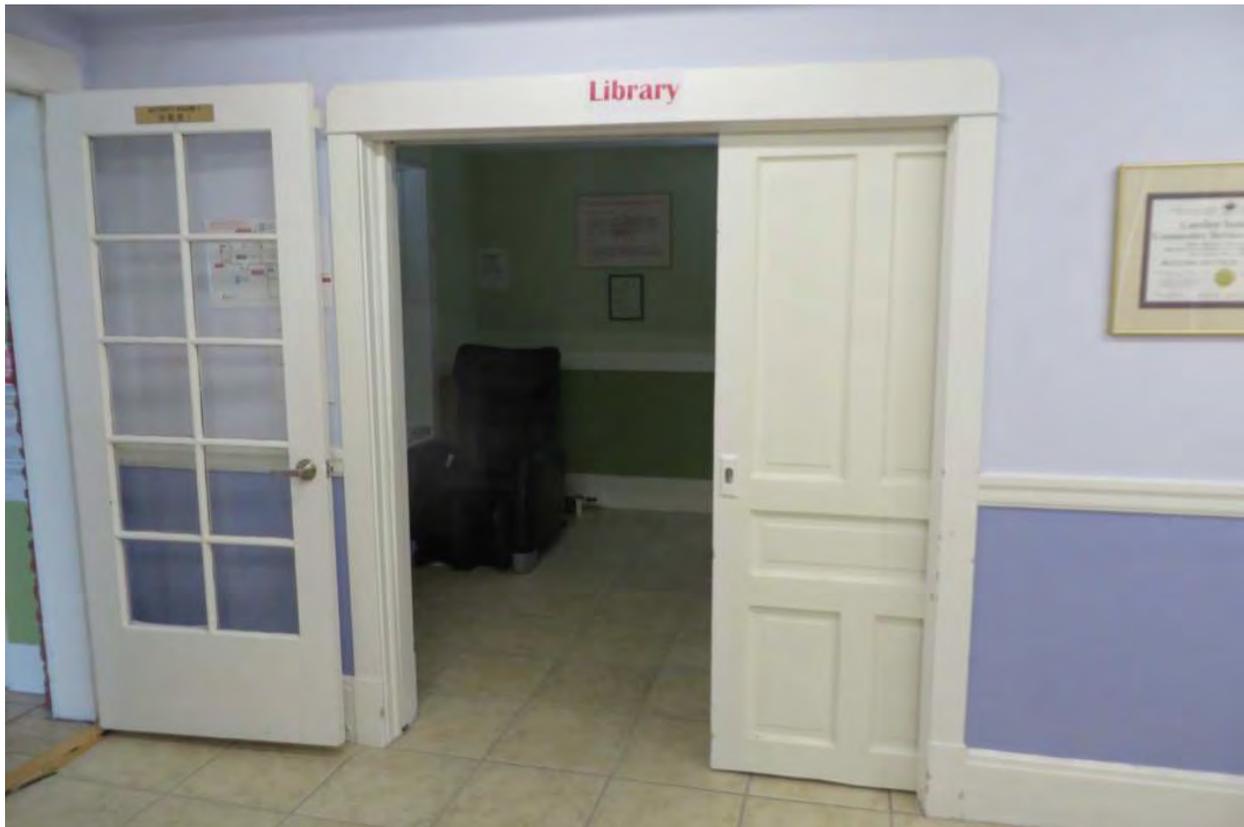
Double Pocket Door at “Library”

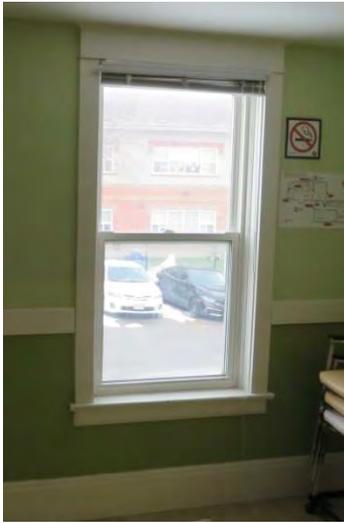
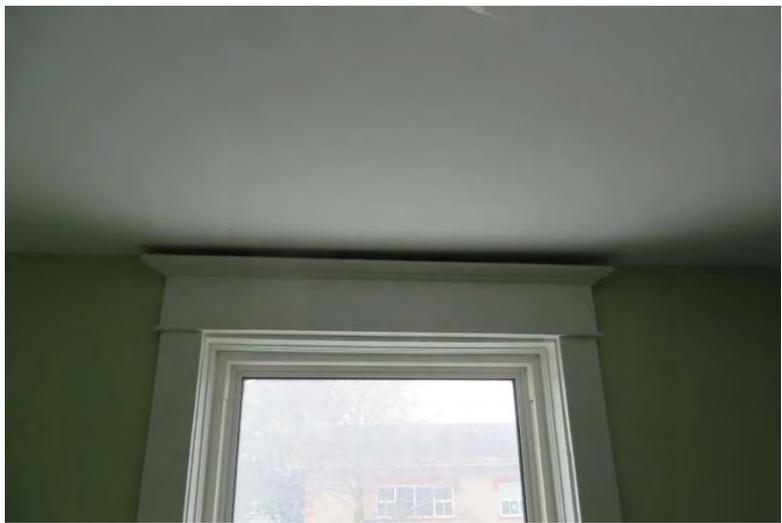
Window Surrounds and Wood Detailing

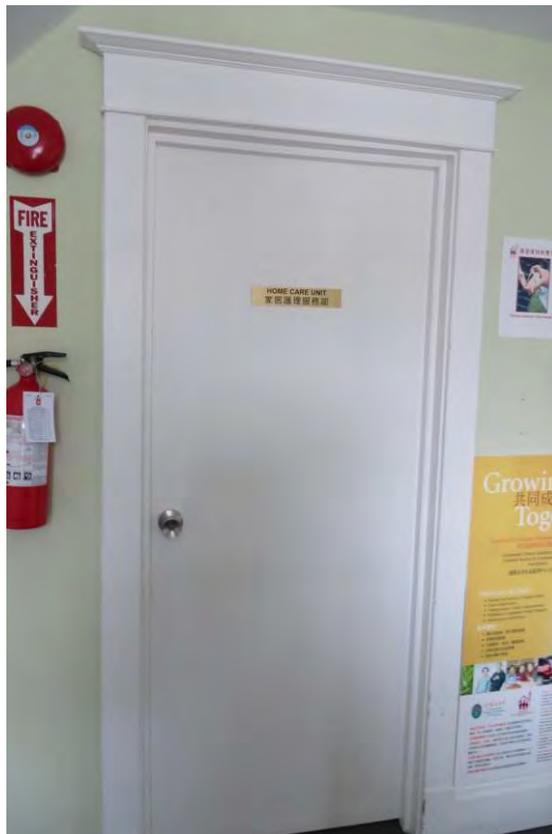
Door framing similar to Window Surrounds

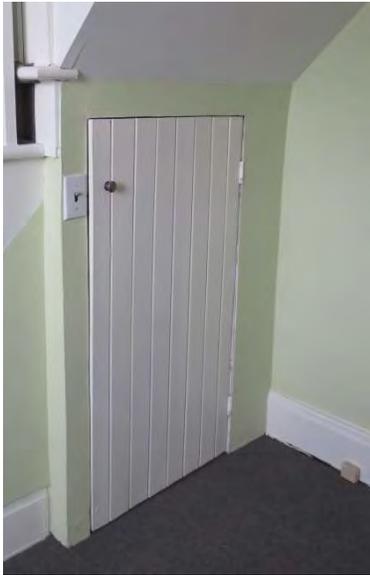
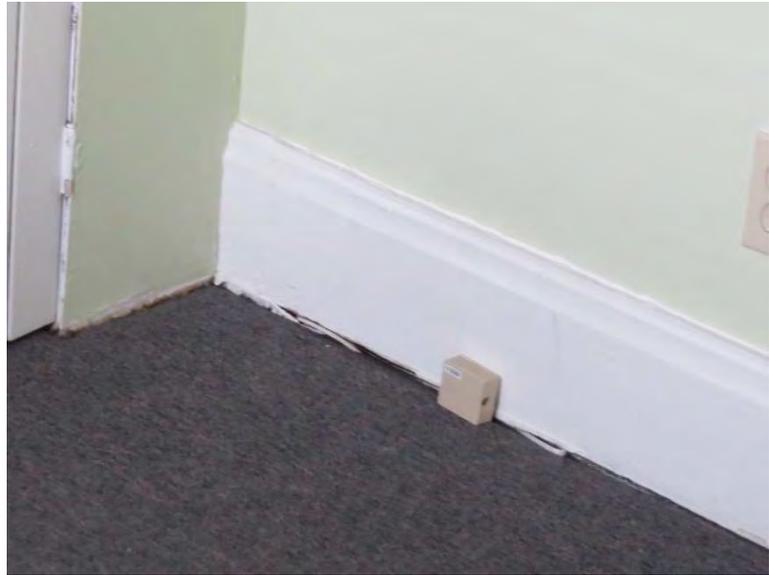
Wooden Door and Typical Baseboards

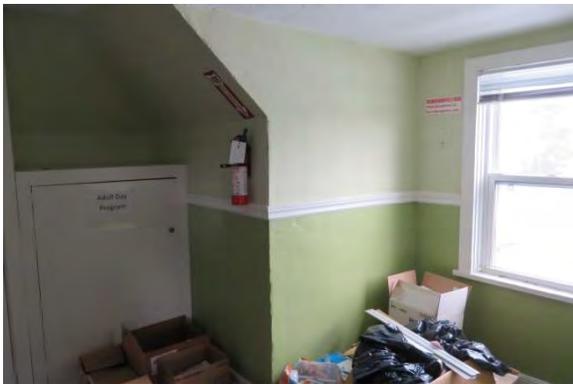
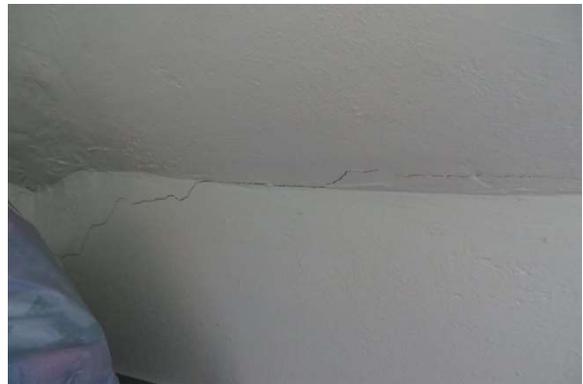
The interior finishes in general are in fair condition with deterioration and general wear from typical use. There is cracking within the plaster wall and ceiling finishes within the attic.

Plaster wall finish in the Attic
