HERITAGE IMPACT ASSESSMENT REPORT

34 Roseview Avenue
City of Richmond Hill

Date:
December, 2019

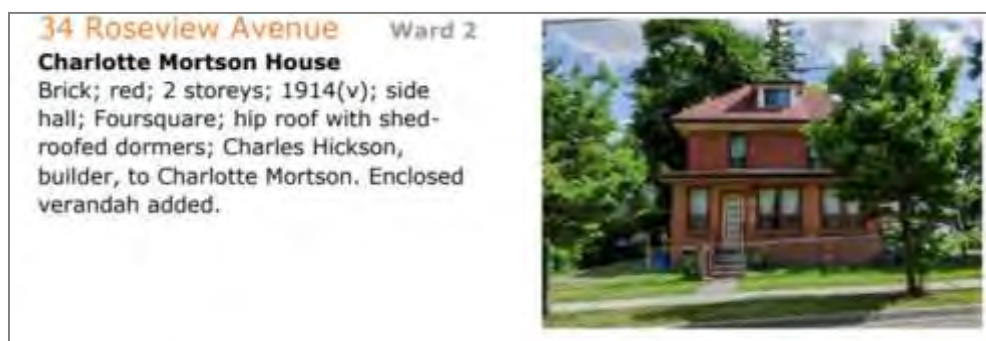
Brick; red; 2 storeys' 1914(v), side hall; Foursquare; Hip roof with shed-roofed dormers; Charles Hickson, builder, to Charlotte Mortson. Enclosed verandah added.

Figure 5 –Excerpt of the Richmond Hill Heritage Inventory for the subject property at 34 Roseview Avenue, (Source: City of Richmond Hill, n.d.)

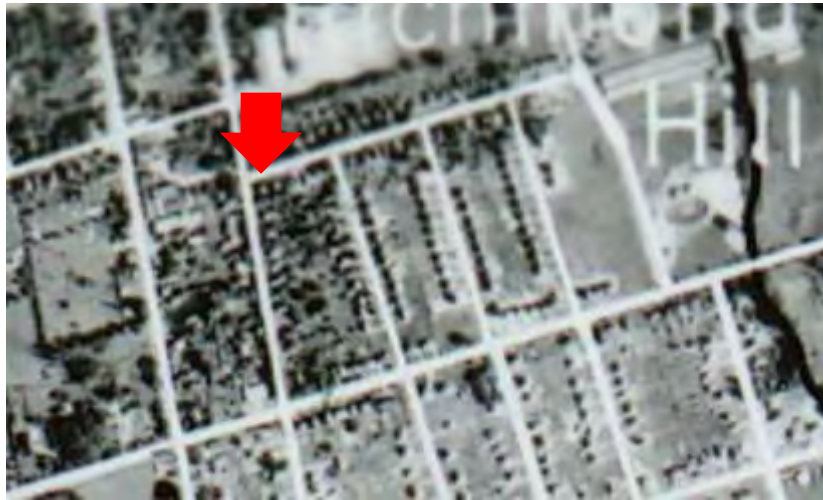
By the mid. 20th century the neighbourhood became more established with a mix of buildings with a range of construction dates and architectural styles. While the individual features of the subject property are difficult to decipher on the 1954 aerial photo, the building is visible and is surrounded by other residential lots facing the either Roseview Avenue or Church Street South.

Figure 17: Detail of the 1954 aerial photograph of the neighborhood located east of Young, north of Major Mackenzie Drive (Source: University of Toronto Map Library)

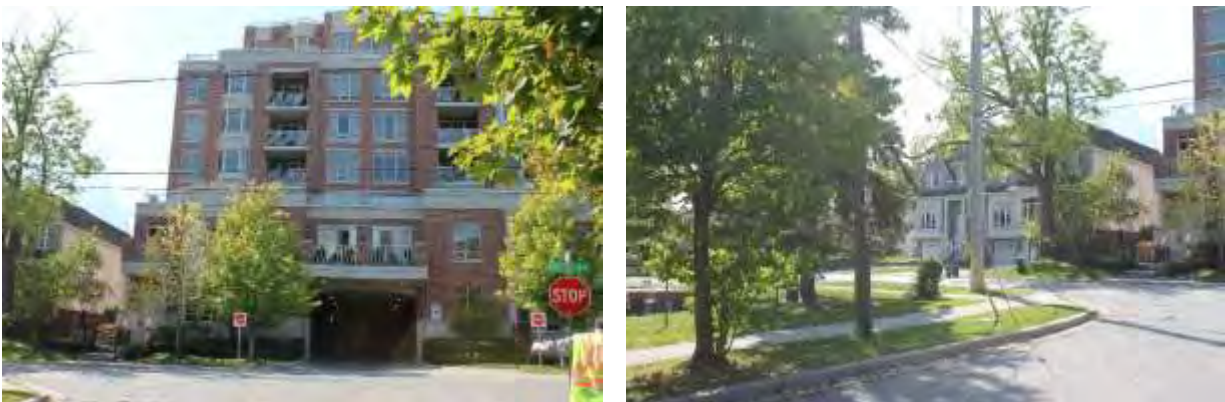
Figures 18 & 19: (left) View of apartment building (rear access) at the intersection of Church Street South and Roseview Avenue, (right) View of townhouses and apartment building looking across the front lawn of 34 Roseview Avenue from the north side of Roseview Avenue (Source: MHBC, 2019)

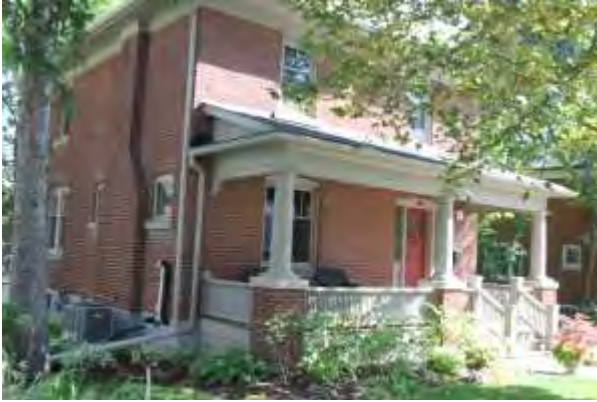
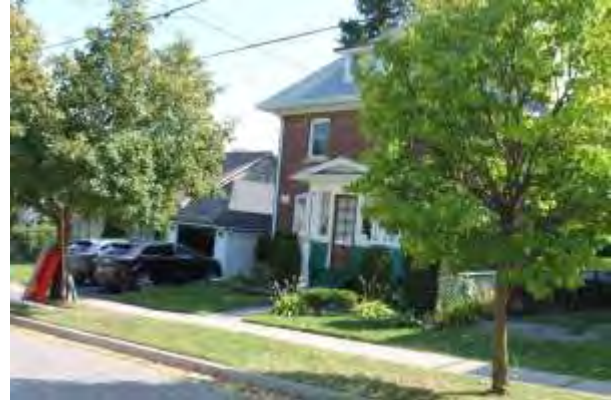
Figures 20 & 21: (left) View of 85 Church Street South, looking south-east from the east side of Church Street South, (right) View of 38 Roseview Avenue, looking south-east from north side of Church Street South (Source: MHBC, 2019)

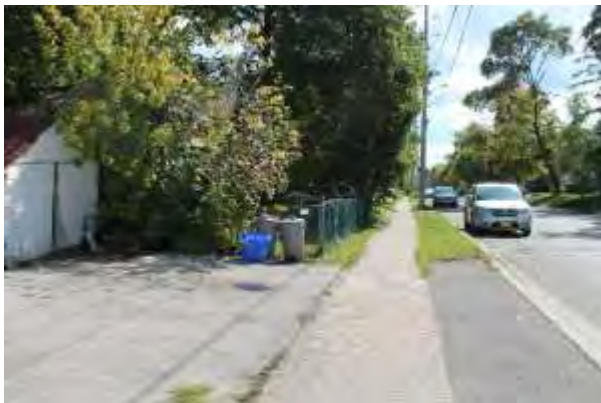
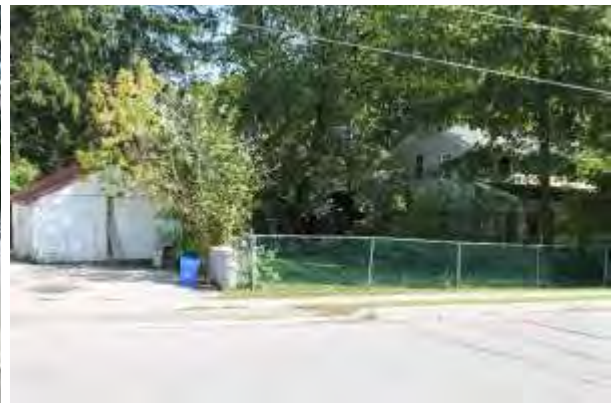
The property located at 34 Roseview Avenue includes a single detached residential building and a detached garage. The dwelling is located at the north-east corner of the lot and fronts onto Roseview Avenue. A large paved parking pad is located to the west of the dwelling. A single storey detached garage is located adjacent to the paved parking pad, fronting west towards Church Street South. The property includes landscaped open space south of the dwelling. Mature trees are located at the south-east corner of the lot including one large conifer.

Figures 22 & 23: (left) View of Church Street South looking south along west lot line of subject property, (right) View of detached garage and landscaped open space at south-west corner of the subject property. Note location of 81 Church Street to the south (adjacent) (Source: MHBC, 2019)

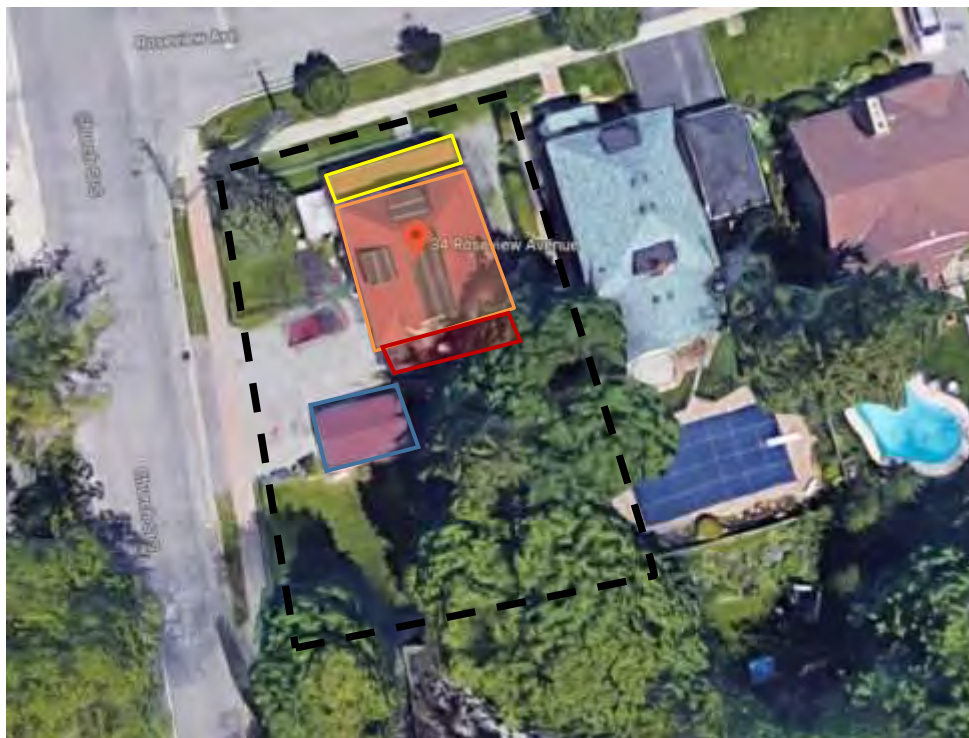
Figure 26: Aerial photo noting location of built features (not to scale). (Source: Google Images, Accessed November 2019)

The existing building located on the subject property includes the original building (noted on the figure above in orange) as well as two later additions at the north and south facades (noted on Figure 26 in yellow and red). Both the north and south additions were constructed at some point between 1950s and 1980s when the building was converted to apartment use. The original portion of the building includes a square-shaped plan with a hipped roof and deep cornices. The property also includes a detached garage (See Figure 26 above, noted in blue).

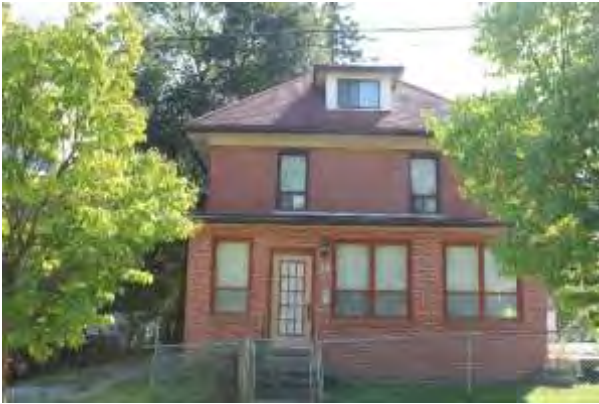
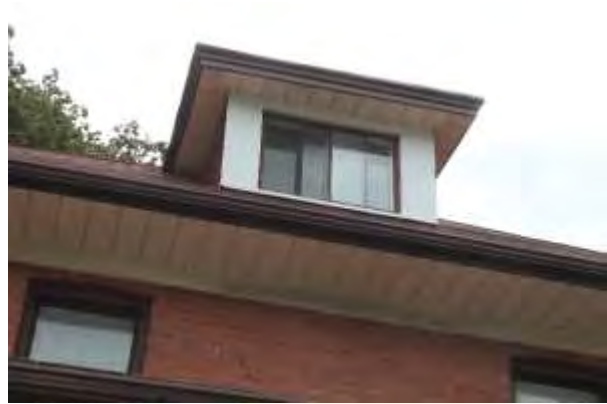
The north elevation of the building provides views of the original portion of the building and the mid. 20th century addition. The original portion of the building includes two rectangular-shaped windows at the second storey. Both windows are modern replacements and respect the original window openings. The dormer window above the roofline includes a deep cornice (similar to the roof of the house) and modern replacement windows.

The addition to the building has resulted in the removal of any original features of the building at the first storey, such as an original porch/verandah, and windows. The addition is constructed of a red brick with light coloured mortar which contrasts with that of the original portion of the house. One rectangular window is located west of the front entrance. Two paired rectangular-shaped

windows are located east of the door. A large sliding patio style door is located at the west end of this addition, facing Church Street South. A pair of rectangular-shaped windows are located at the east end of the northerly addition.

Figures 27 & 28: (left) View of north elevation looking south from north side of Roseview Avenue, (right) Detail view of dormer window at north elevation (Source: MHBC, 2019)

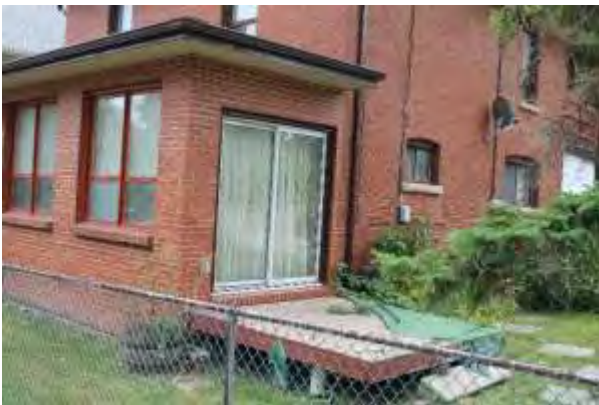
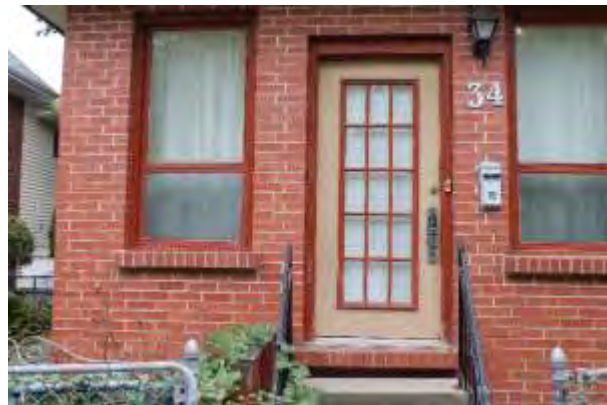
Figures 29 & 30: (left) View of patio style sliding door of the northern addition, facing west (right) View of the front entrance of the north addition, facing north (Source: MHBC, 2019)

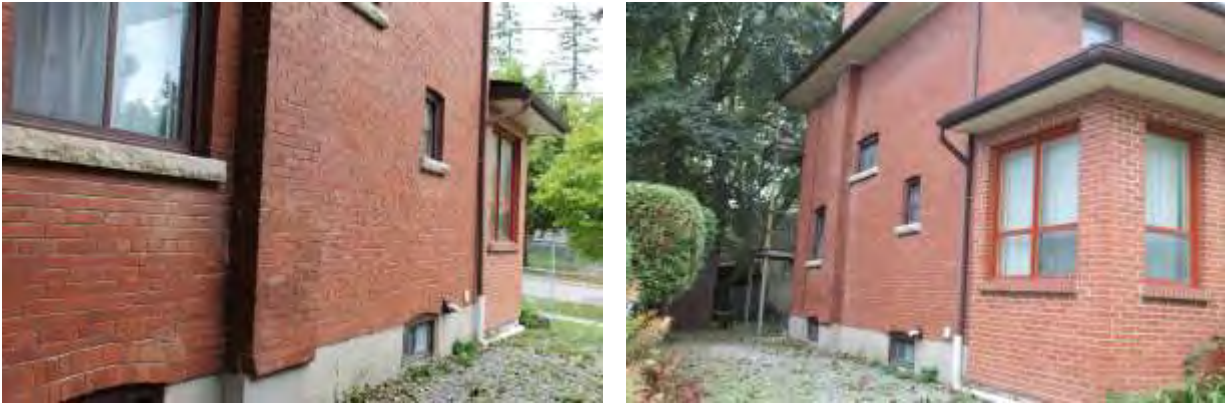
three windows include stone lintels and are separated by a brick chimney. All five window openings at the east elevation have been replaced with modern windows.

Figures 31 & 32: (left) View of east elevation looking north towards Roseview Avenue (right) View of east elevation looking south-west from south side of Roseview Avenue (Source: MHBC, 2019)

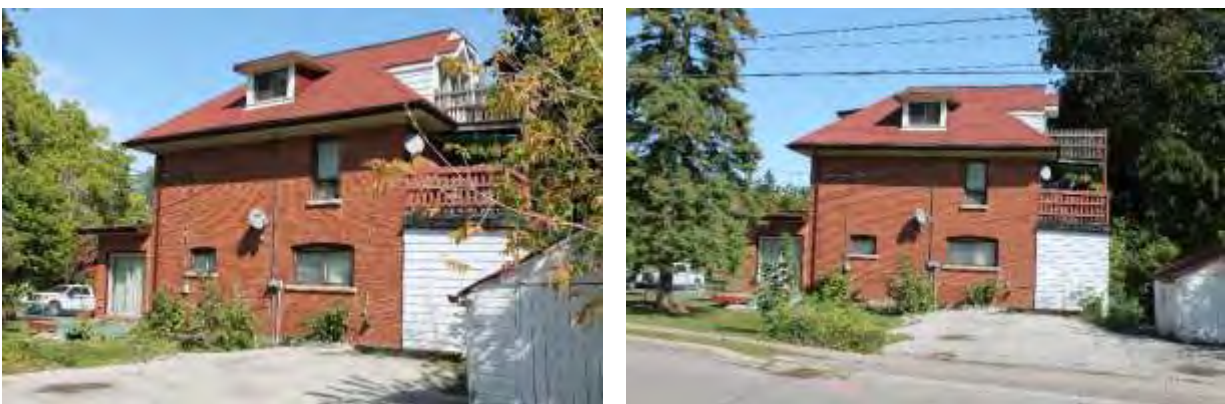
The west elevation of the original portion of the building includes four (4) windows. This includes three windows at the first and second storeys which have stone lintels and simple flush brick voussoirs. The two windows at the first storey are similar in shape, with the southerly window being approximately twice as large. The second storey window is rectangular in shape. The dormer window includes a rectangular-shaped window under the cornice. All windows at the west elevation are modern replacements respecting original window openings.

Figures 33 & 34: (left) View of west elevation looking east from north-west side of Church Street South (right) View of west elevation looking east from west side of Church Street South (Source: MHBC, 2019)

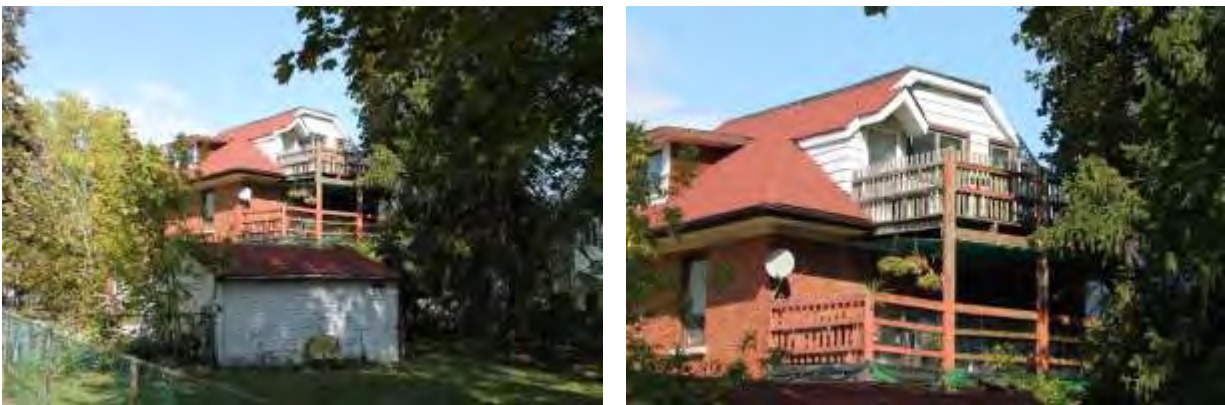
The original portion of the building at the first storey has been obstructed with the construction of a wood frame, vinyl siding clad addition. This addition includes one window at the south elevation. The east side of the original portion of the building includes a rear entrance, where the door opening is likely original to the structure. The external staircase and secondary entrance to the apartments is located adjacent to this entrance at the south elevation. The second storey appears to have had window and door openings added to facilitate its use as an apartment.

Figures 35 & 36: (left) View of east and south elevations (second and third storeys) looking north-east from east side of Church Street South (right) Detail view of third storey apartment (south elevation) looking north-east from Church Street South (Source: MHBC, 2019)

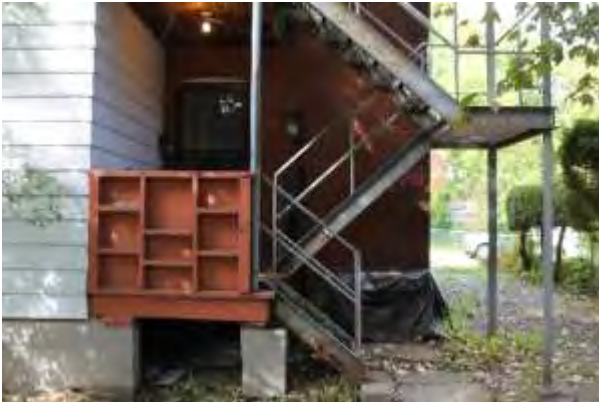
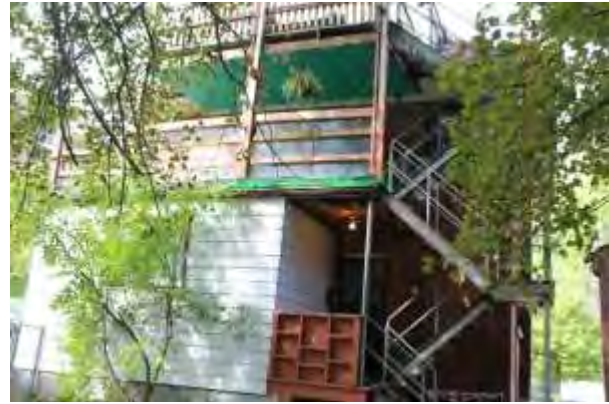
Figures 37 & 38: (left) View of fire escape and south entrance doorway looking north towards Church Street South from rear yard (right) View of south elevation rear addition and fire escape looking north-west from rear yard (Source: MHBC, 2019)

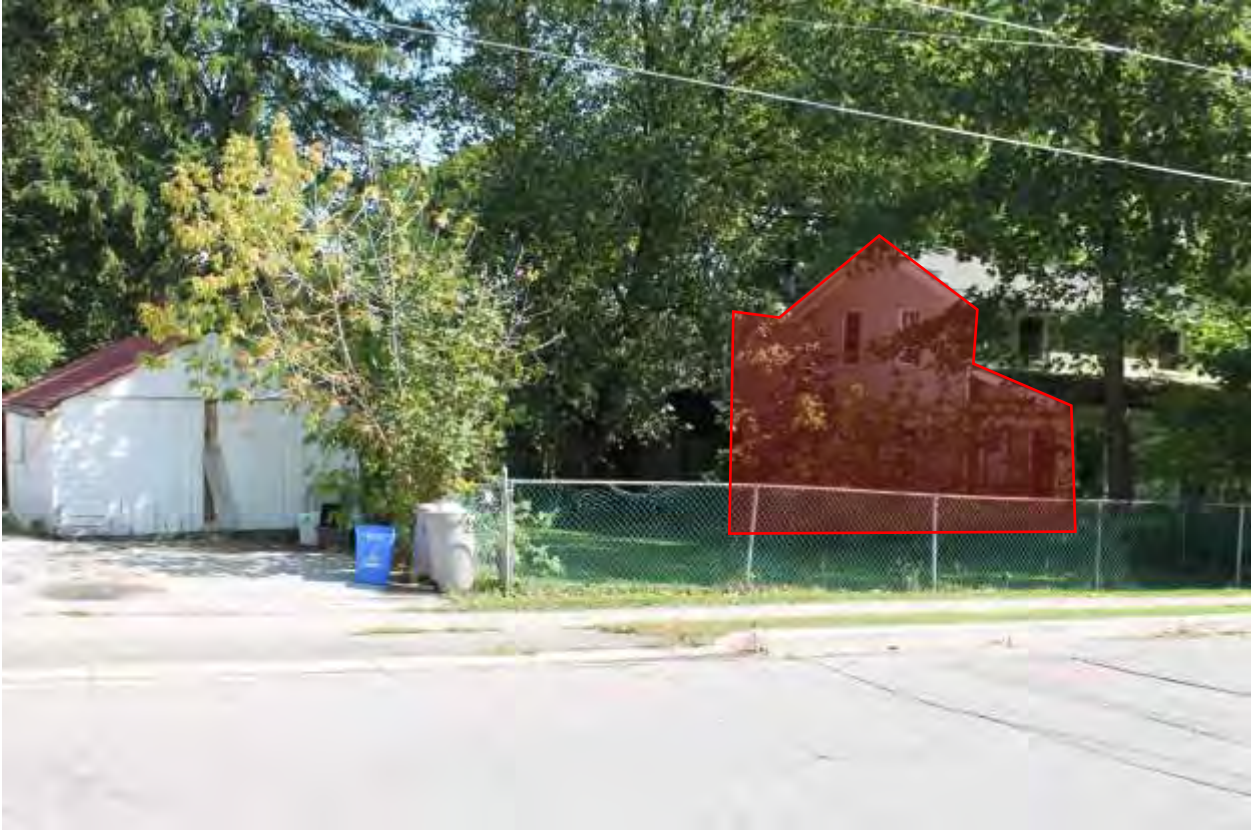
The proposed Plan of Severance or the new building will not result in either the direct or indirect obstruction of views of the primary facades of the buildings located at 81 Church Street South, or 38 Roseview Avenue. The front (north facades) of both residential dwellings at 38 Roseview Avenue will continue to be visible from the public realm along Roseview Avenue and Church Street South. The north façade of the dwelling located at 81 Church Street South will continue to be visible (as existing) from Church Street South. While this is true, the proposed new building on the severed lot will result in the partial obstruction views of the north (side) elevation of the 1 ½ storey dwelling at 81 Church Street South. This is considered a minor or negligible adverse impact as the primary (front) elevation of the dwelling will remain visible from the public realm.

Figure 42: Existing view of rear yard of 34 Roseview Avenue and north (side) elevation of 1 ½ storey dwelling located adjacent at 81 Church Street South
(Source: MHBC, 2019)
