## **Staff Report for Heritage Richmond Hill Meeting**

**Date of Meeting:** April 4, 2024  
**Report Number:** SRPBS.24.032

**Subject:** **SRPBS.24.032 – Heritage Permit for 10184  
Yonge Street (Old Post Office) – D12-07462**

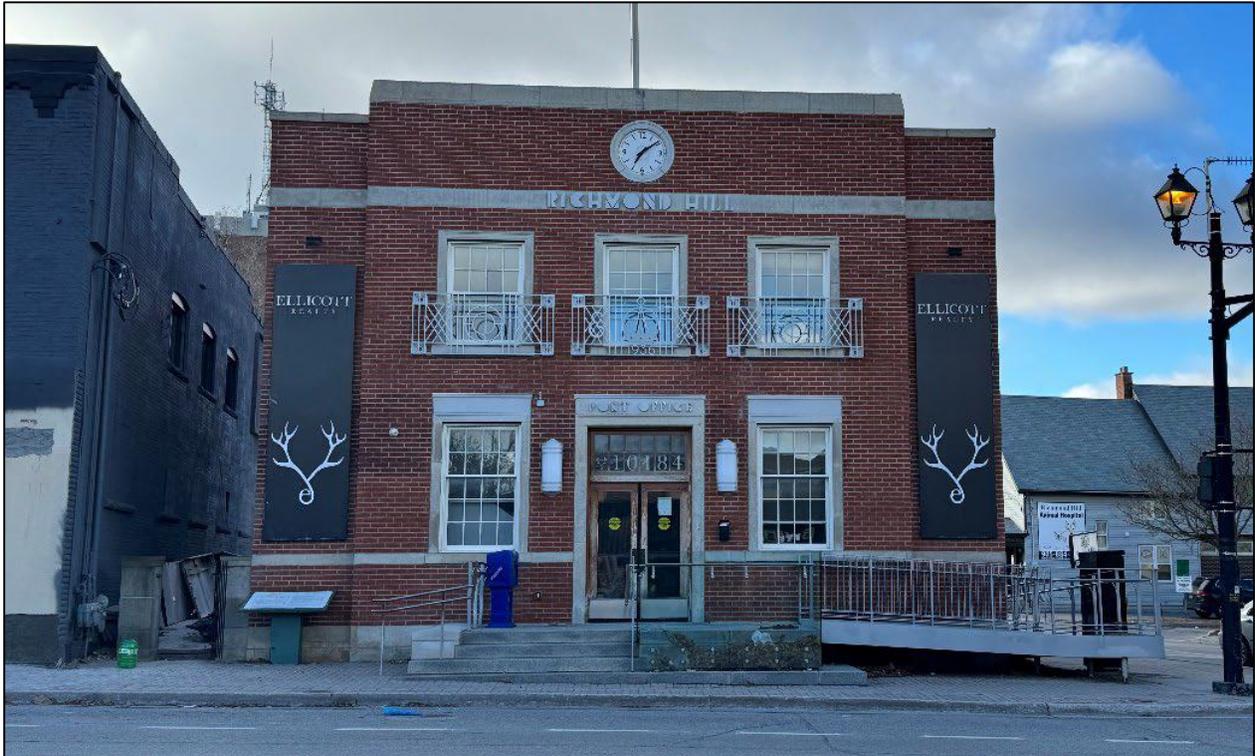
The property located at 10184 Yonge Street (the “Subject Property”) contains the City-owned Old Post Office, which was built in 1936 and blends Art Deco, Georgian Revival, and Edwardian Classical styles of the early 20<sup>th</sup> century (see Figure 1) and designated under Part IV of the Ontario Heritage Act through Designating By-law 199-01.

**Figure 1:** Front façade of the Old Post Office.

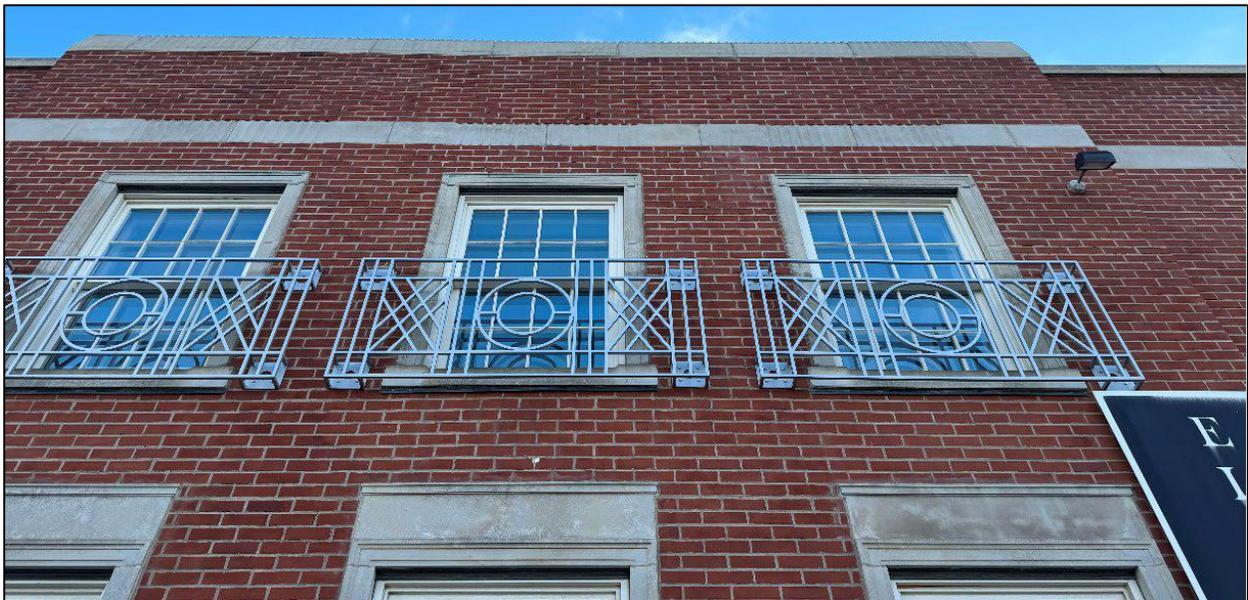
**Figure 2:** Decorative railing on upper storey windows on front façade.

The decorative window railings will be removed prior to the undertaking of the repair work, and will be re-installed once the work has been completed (see Figure 2).

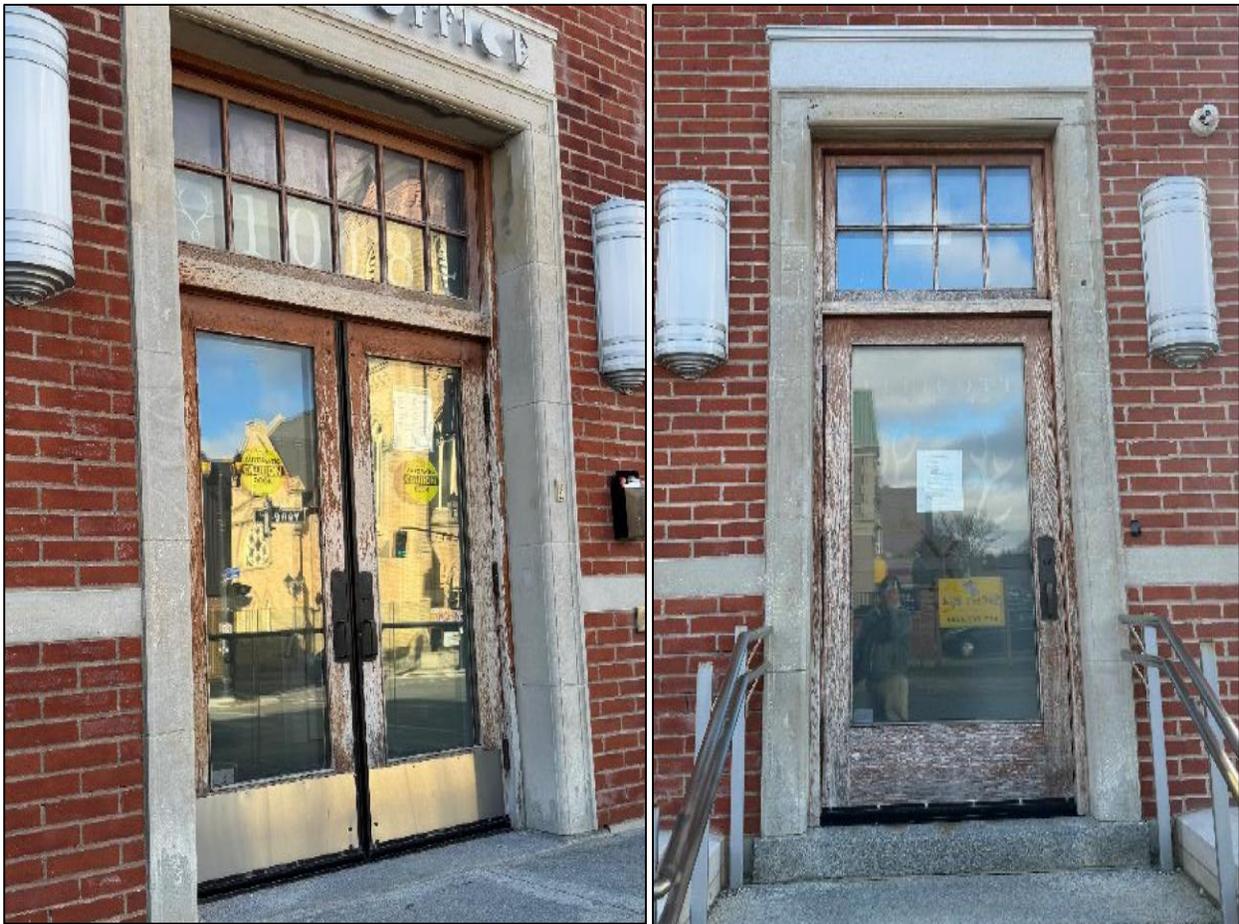
While the existing windows and frames generally exhibit minimal damage requiring immediate attention beyond repainting, the door panels at the south and east elevations exhibit significant weathering (see Figures 3 and 4). Investigation will be done on site to determine the extent of the damage and confirm whether these panels need to be replaced or refinished. The proposed repairs include:

Figures 3 and 4: Front doors (left) and side door (right) exhibiting signs of deterioration.

- Stripping and sanding away paint to assess full extent of damage (see Figure 5);
- Resealing joints between upper and side windows and frames;
- Replacing hardware on doors that exhibit signs of weathering;
- Repairing shallow cracks and hardware holes with epoxy;
- Repairing areas of rot or deep cracks with the Dutchman's patch method;
- Temporarily removing the front door to facilitate comprehensive repairs, or replacing it entirely, if required.

Once the repairs are completed, all windows, doors and frames will be repainted in the existing colour scheme.

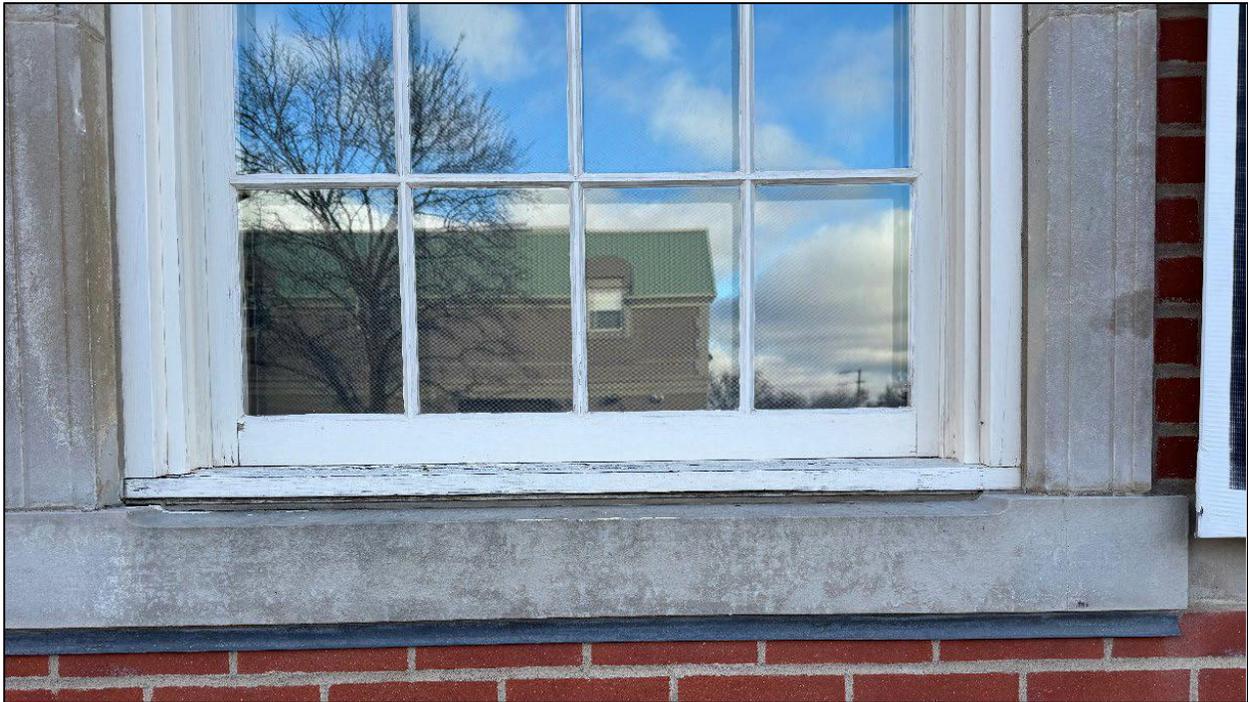
**Figure 5:** Window showing cracks, degraded paint.

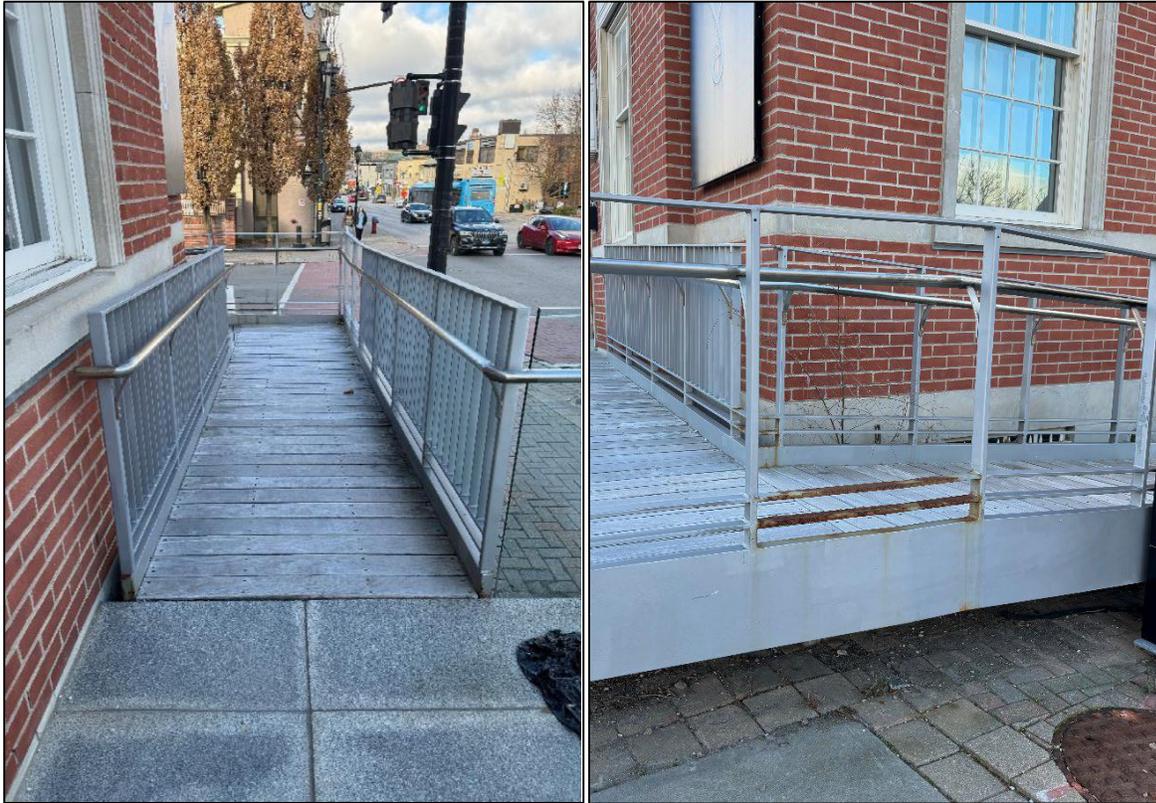
The metal ramp and railing are showing signs of deterioration, including rust, and the wooden planks of the ramp also exhibit signs of damage (see Figures 6 and 7).

Figure 6 and 7: Planks showing areas of damage (left), rusted metal railings (right).

Any extensive damage that is noted on the aluminum ramp and aluminum railing are to be sectioned off and replaced. Wooden planks that show signs of rot or damage will be refinished and replaced.

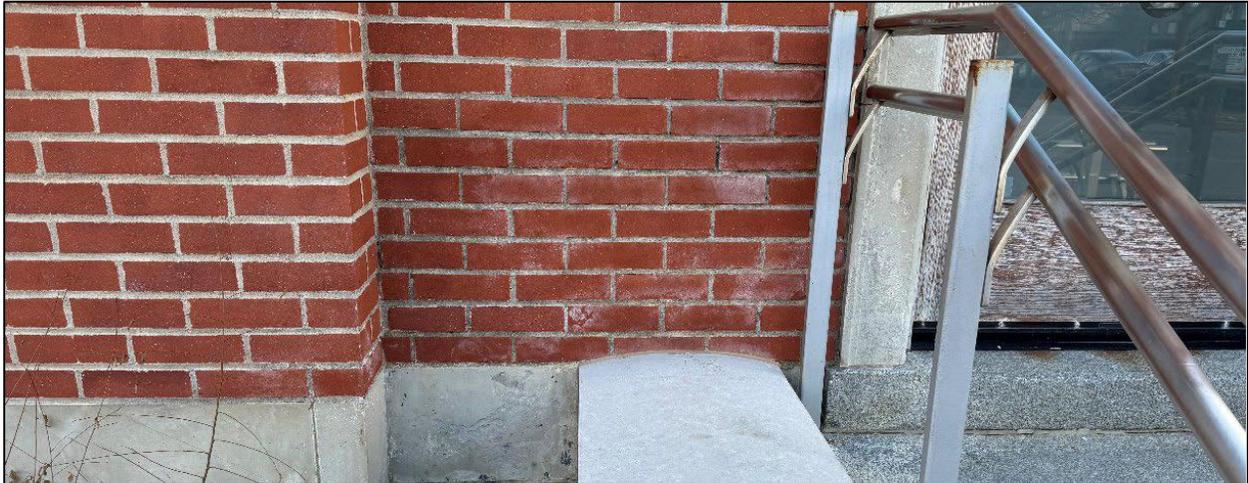
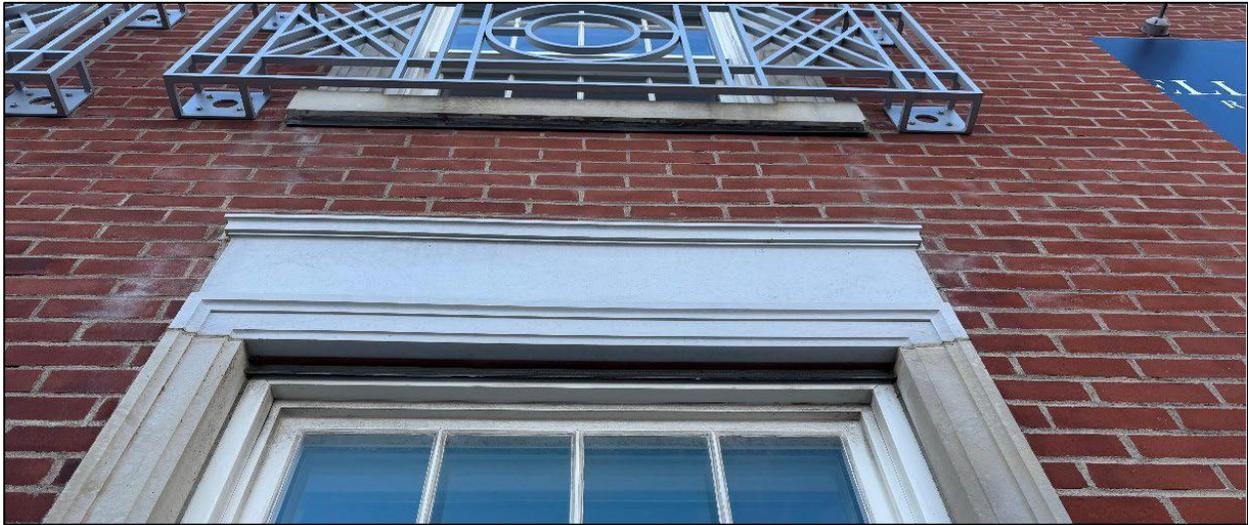
The brick façade and stair slabs exhibit signs of damage, with noticeable issues along joints and the brick itself. Efflorescence (see Figures 8 and 9) and cracks (see Figures 10 and 11) are prominent, and the stair slabs are separating from the stairs which is causing visible gaps in the mortar.

**Figures 8 and 9:** Examples of efflorescence on the front façade.

- Thoroughly cleaning the bricks to remove the efflorescence and grime;
- Removing the deteriorated mortar and replacing it with a matching mortar mix;
- Slabs showing separation will be properly repositioned, and gaps eliminated;
- Irreparably damaged slabs or bricks will be replaced with closely matching slabs or bricks.

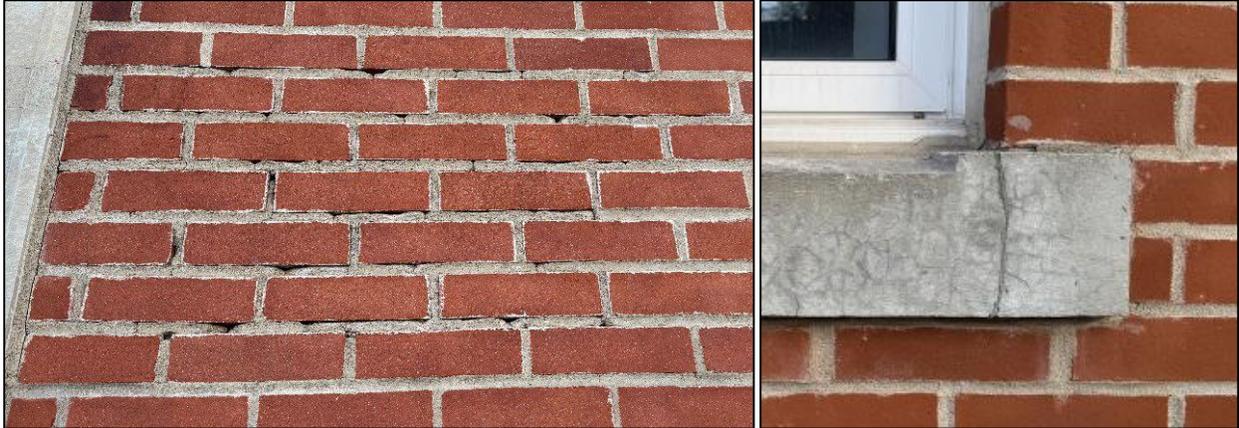
**Figures 10 and 11:** Examples of degraded mortar (left), cracks on window sill (right).
