## Heritage Research and Evaluation Report

### **317 Mill Street – Jesse Good House**

Circa 1885

Prepared by: Heritage & Urban Design, Planning & Building Services, 2024

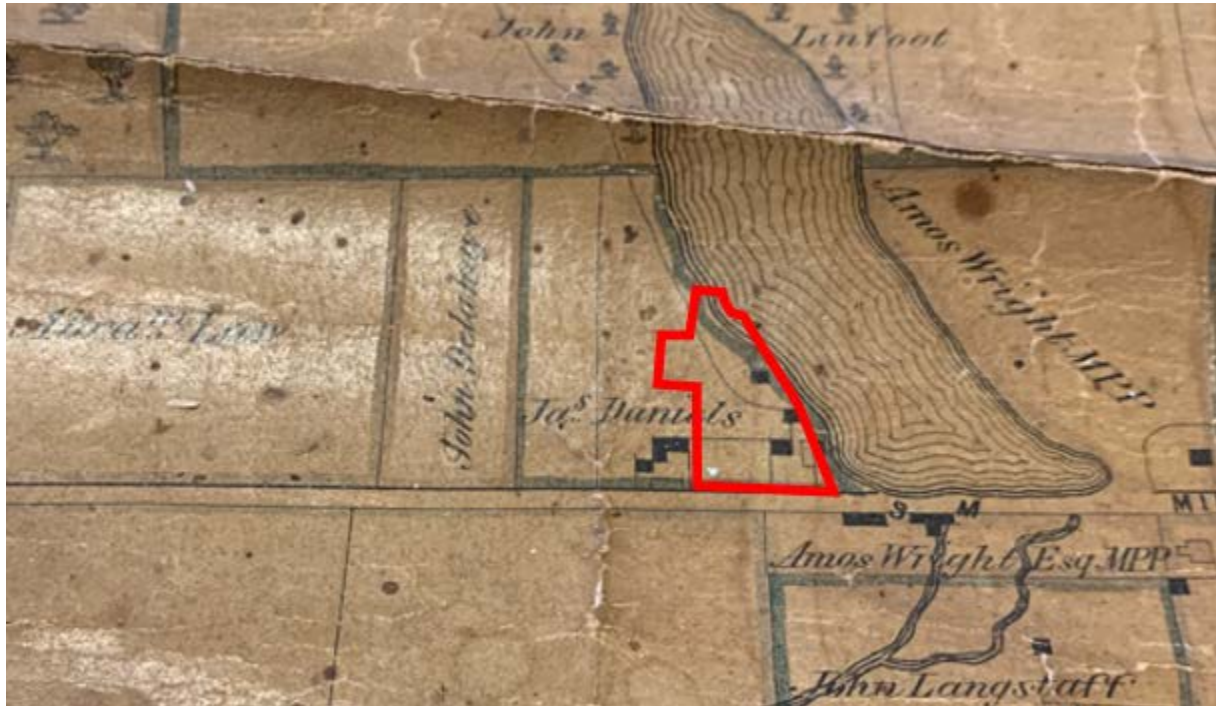
**Figure 1** 1862 Ratcliffe Map showing the approximate location of the Jesse Good House at 317 Mill Street (in red). In 1862, the subject property and its surrounding land was owned by James Daniels, who ran a match factory on the lot. Note the cluster of industrial structures present on Daniels' property, as well as the sawmill located on the south side of the Mill Pond. Over the course of the 19<sup>th</sup> century, there were a number of industrial properties, including mills, tanneries, and factories, scattered around the shore of the Mill Pond. (Source: Richmond Hill Public Library)

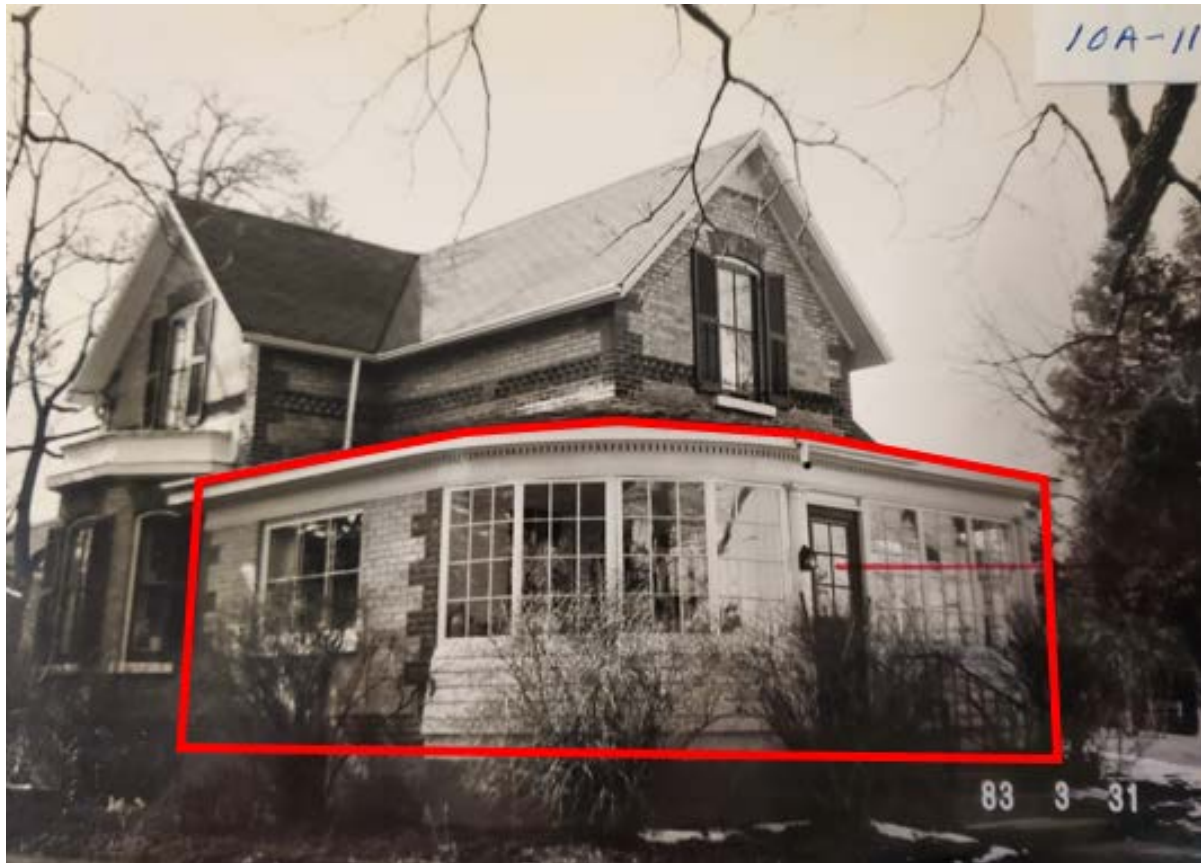
**Figure 2** 1983 photograph of the Jesse Good House at 317 Mill Street facing northwest, showing the approximate location of alterations on the building's verandah (indicated in red). Archival documentation shows that the wraparound verandah was enclosed sometime after 1923. (Source: LACAC 1983)

The Jesse Good House consists of an original structure, built circa 1885, and four additions located on the house's north, northeast, and west elevations. The original part of the building is a two-storey dichromatic brick structure featuring a medium-sloped cross-gable roof and a brick chimney (Figure 2). While the original part of the house has an L-shaped building footprint, numerous additions over the 20<sup>th</sup> century have created an irregular footprint. The house is constructed of yellow/buff brick, with decorative red brick detailing, including quoining, brick banding comprised of two courses of offset, angled bricks ("sawtooth banding"), and voussoirs (Figure 3).

The house features a one-storey rounded and enclosed verandah wrapping around its front (south) and side (east) elevations. The verandah depicted in an archival photograph (Figure 5) was enclosed sometime after 1923, with the enclosure constructed of a mix of dichromatic brick, multi-paned windows, and wood shingle cladding. The dentilated cornice and some of the doric columns of the verandah are also still visible as part of the enclosure. The enclosed verandah also features a

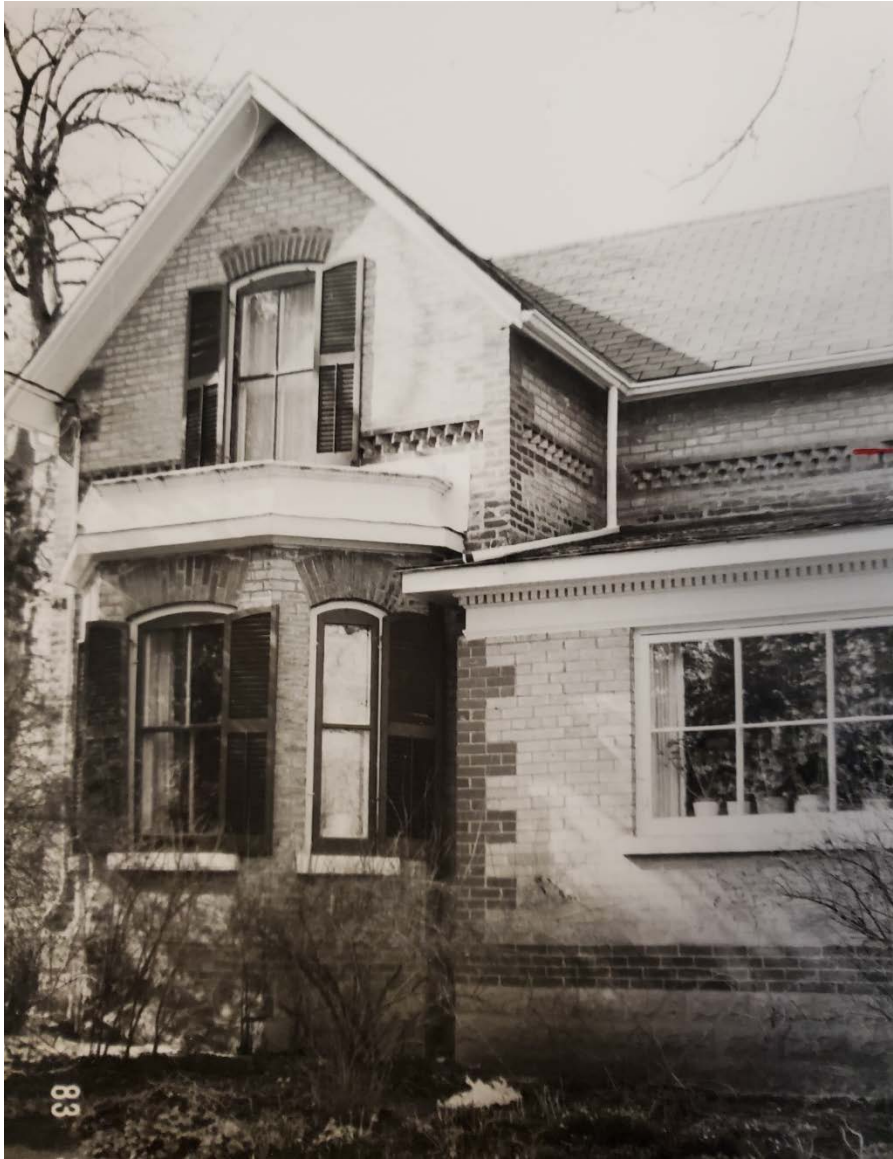
**Figure 3** 1983 detail photograph of the Jesse Good House at 317 Mill Street, showing the house's south elevation. Note the dichromatic brick detailing, including the voussoirs, quoins, and brick sawtooth banding, which is present along the south and east elevations. (Source: LACAC 1983)

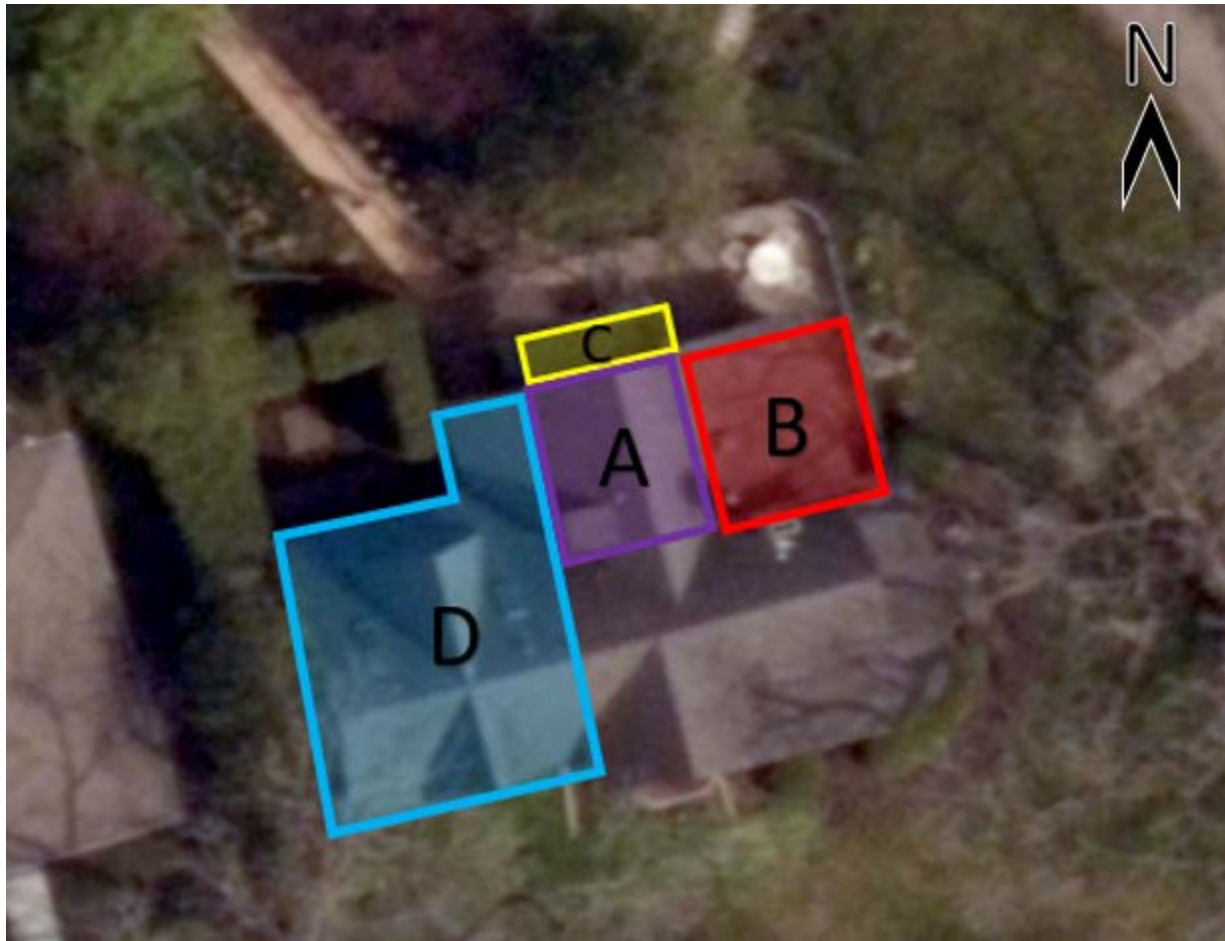
**Figure 4** 2023 aerial photograph of the Jesse Good House at 317 Mill Street showing the approximate locations of additions to the site. Archival documentation shows that addition “A” was added in the late-19<sup>th</sup> or early-20<sup>th</sup> centuries, “B” and “C” were added in the 20<sup>th</sup> century before 1988, and “D” was added in 1991-1992. (Source: York Maps)

The house's original L-shaped plan has seen a number of additions over time. The house's rear (north) elevation now features three additions built between the late-19<sup>th</sup> century and 1978.<sup>23</sup> These additions are illustrated in Figure 9. The original house's north elevation features a two-storey brick addition with a gable roof, which likely dates to the late-19<sup>th</sup> or early-20<sup>th</sup> century. While the roof of this addition is slightly lower than that of the original house, it features similar style and materials to the original building, including roof pitch, dichromatic brick cladding, red brick quoining and voussoirs, and window shape and proportion. This addition's north elevation features a later one-storey brick addition with a hipped roof, while its west elevation features a one-storey addition with vinyl siding and a shed roof. Both of these later additions appear to have been added in the 20<sup>th</sup> century, sometime before 1988.<sup>24</sup> The original house's west elevation also features a two-storey side addition constructed between 1991 and 1992.<sup>25</sup> The west addition features a side-gable roof with a central front gable ("peak"), and is clad in a board and batten exterior (Figure 4).

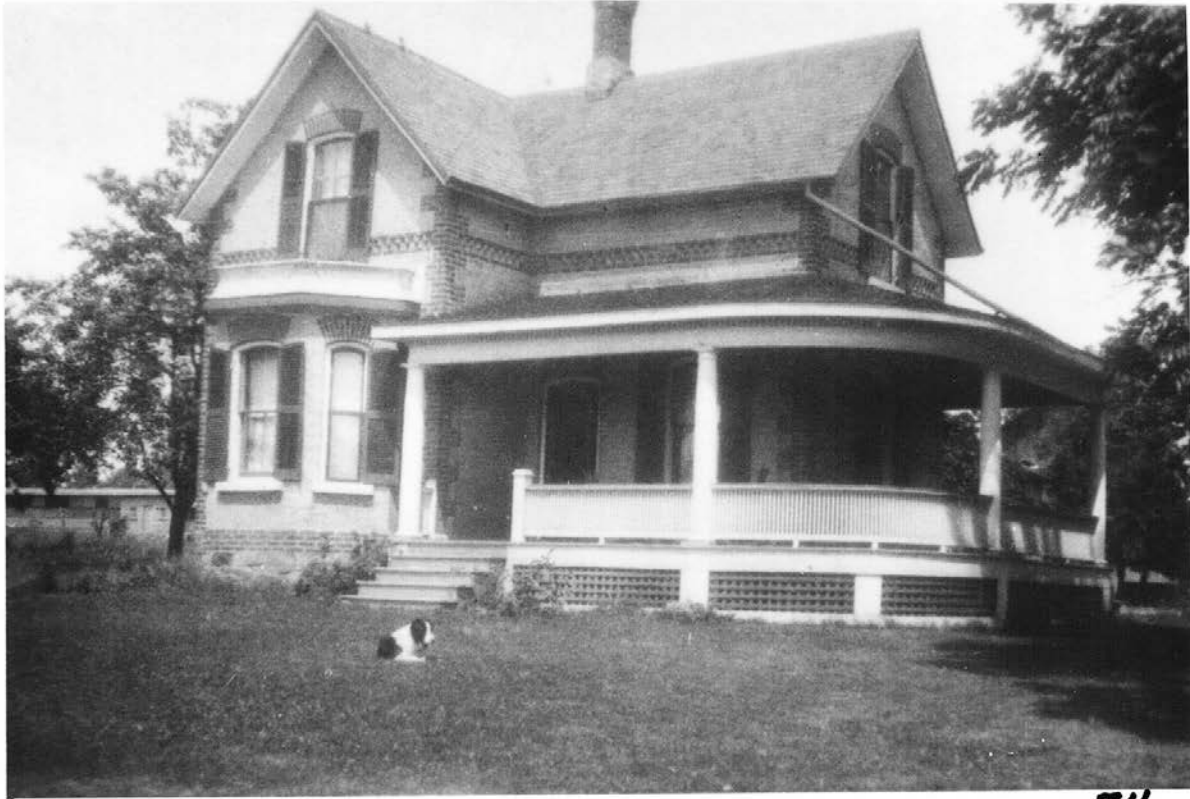
**Figure 5** Circa 1923 photograph of the Jesse Good House at 317 Mill Street looking northwest. Note the building's L-shaped footprint, cross-gabled roof, buff brick construction with red brick detailing, and canted bay window with a mansard roof. Note that the house's wraparound verandah has not yet been enclosed. (Source: Richmond Hill Public Library Digital Archives)

doorway oriented to the east, which replaced the house's original south-facing doorway (Figure 5). Based on the style of the verandah, it was likely built to replace an earlier verandah in the early 20<sup>th</sup> century, although the exact date of construction is unknown.

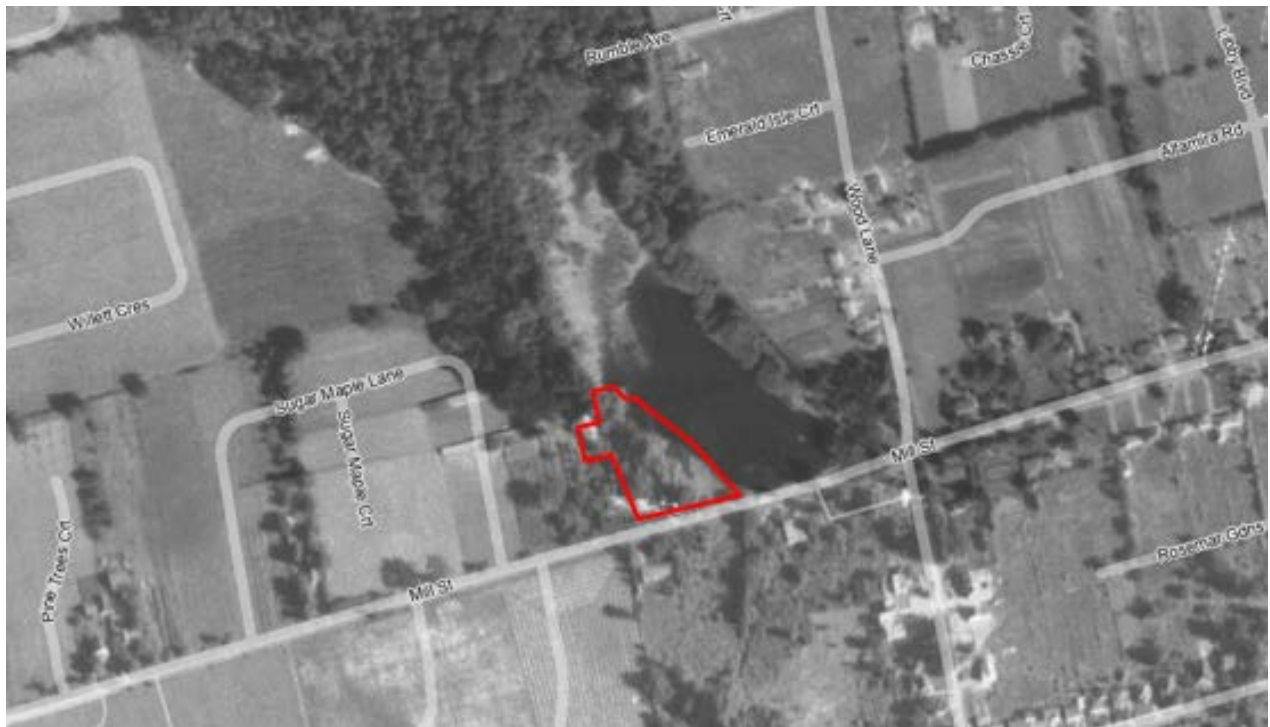
**Figure 6** 1954 aerial photograph of the subject property at 317 Mill Street (in red). Note the surrounding open fields and lack of development to the south and west of the subject property. As the subject property was located on the outskirts of Richmond Hill village, surrounding development did not occur until the latter half of the 20<sup>th</sup> century. (Source: York Maps)

During the 19<sup>th</sup> and early-20<sup>th</sup> centuries, the subject property was located on the outskirts of Richmond Hill village, and was surrounded by relatively large agricultural and industrial properties powered by the Mill Pond and Upper East Don River (Figures 6-11).<sup>26</sup> The semi-rural character of the Mill Pond area well into the 20<sup>th</sup> century can be seen in a 1940s photograph of Mill Street (Figure 9). Since Mill Street featured expansive and sparsely developed lots until the area was subdivided and developed for denser housing beginning in the 1950s, the existing built form character of the immediate vicinity is that of a postwar residential suburb, with some remnant historical buildings dating from the late-19<sup>th</sup> and early-20<sup>th</sup> centuries. The current streetscape is defined by a consistent setback of houses with mature trees in front yards lining the street on both sides. Mill Pond Park wraps around the north and east of the subject property, contributing to the surrounding mature tree canopy. The trees, shrubbery, and picket fence on the subject property also contribute to an enclave of greenspace within the surrounding streetscape.

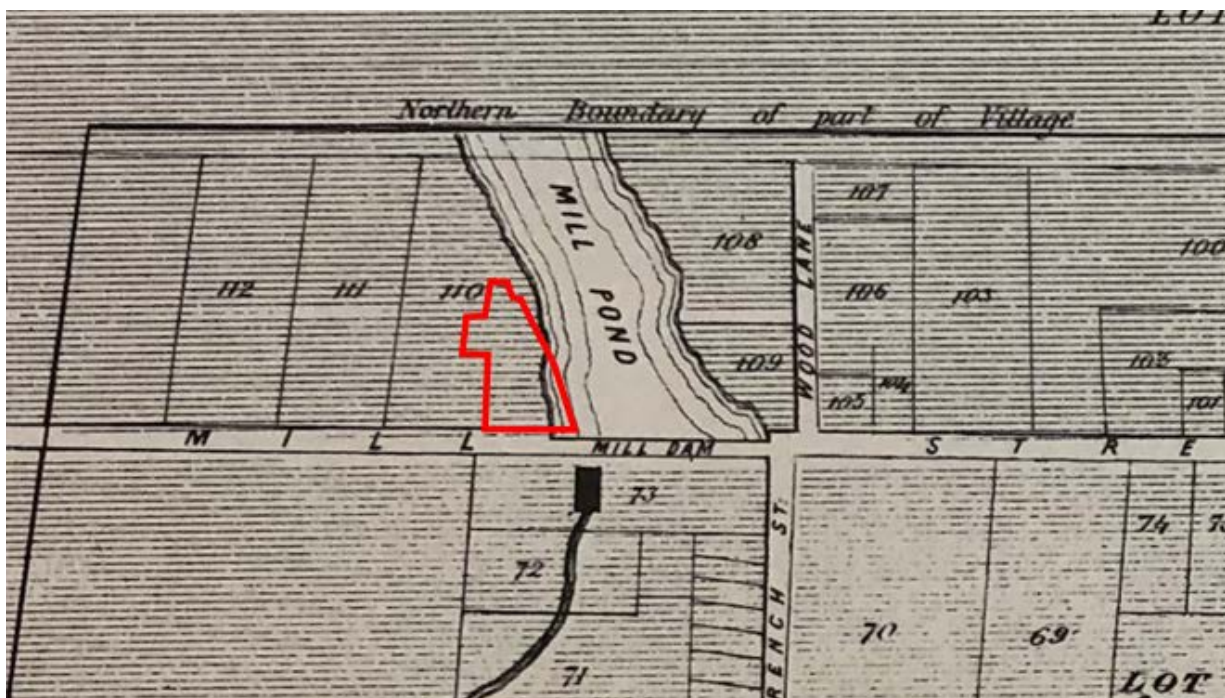
**Figure 7** 1878 Miles & Co. Map of the Village of Richmond Hill showing the approximate location of the Jesse Good House at 317 Mill Street (in red). Note that in the 19<sup>th</sup> century, the subject property was located along the northern boundary of the village, and that it and the surrounding properties had large lot sizes with sparse development. (Source: Richmond Hill Public Library)

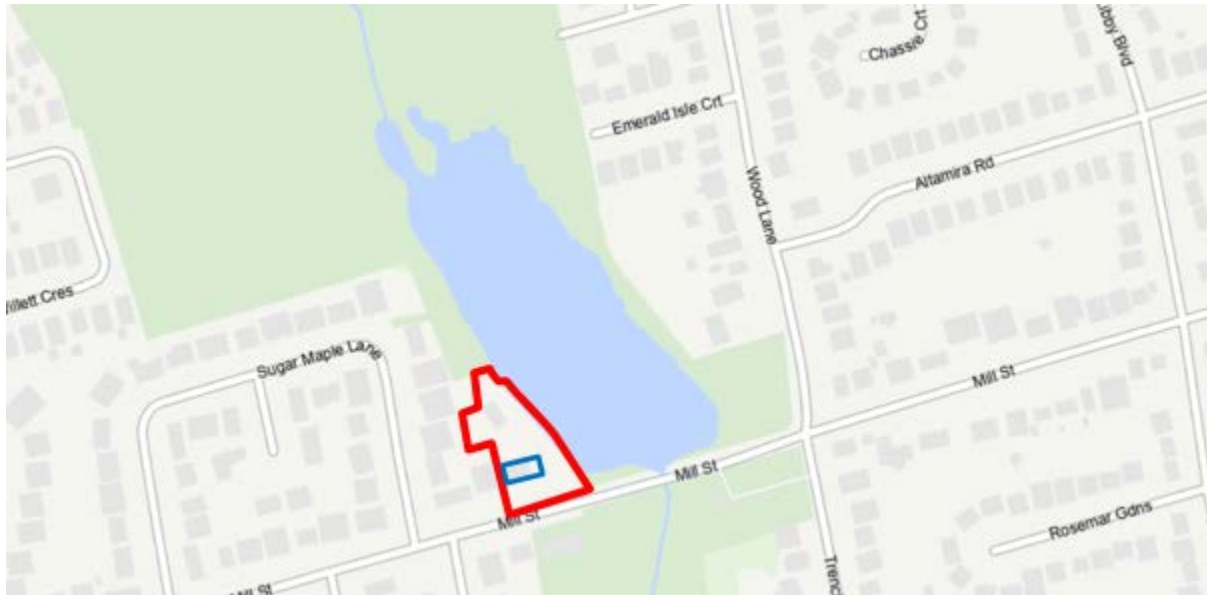
**Figure 12** 2024 map of the subject property at 317 Mill Street (in red). The subject house (indicated in blue) has retained its significant visual and historic links to the adjacent Mill Pond to the east. (Source: York Maps)
