Staff Report for Heritage Richmond Hill Meeting

Date of Meeting: April 4, 2024
Report Number: SRPBS.24.033

Subject: SRPBS.24.033 Heritage Permit for 528 Carrville Road (Burr House) – D12-07078

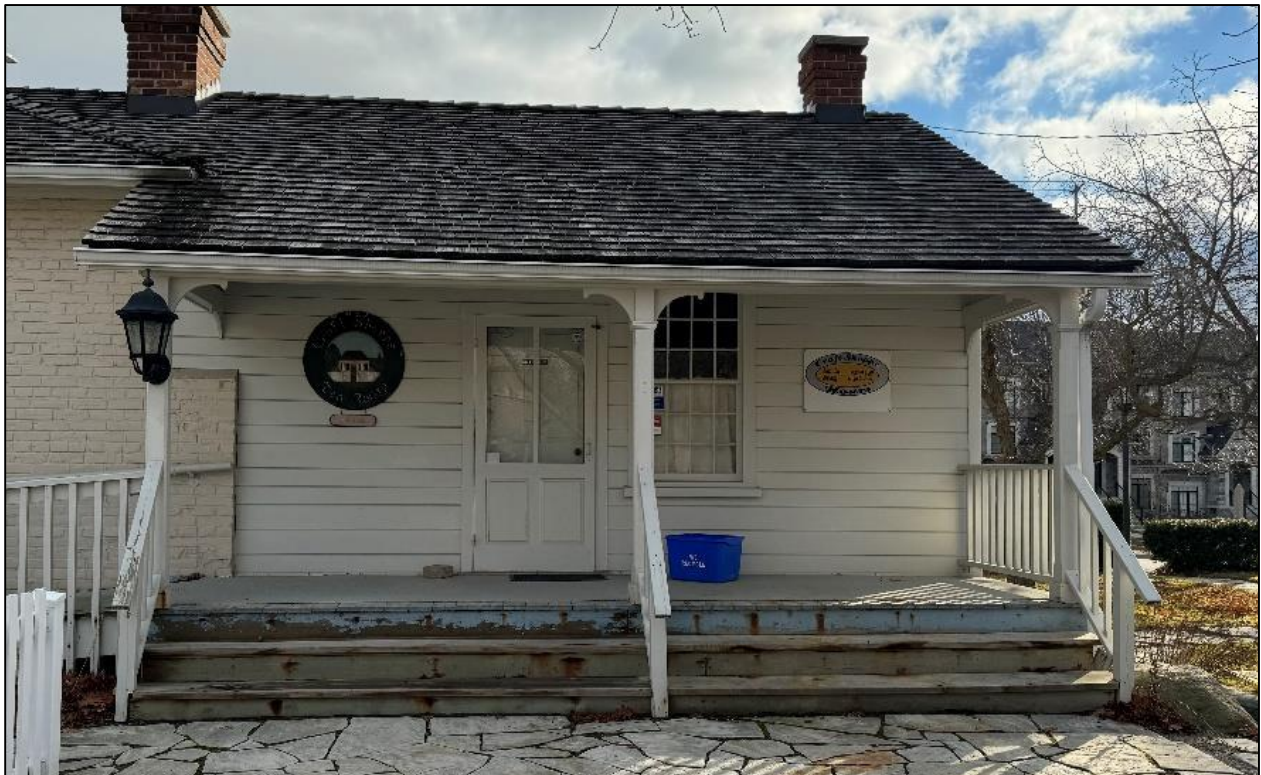
All wooden components, including windows, doors, wood siding, trims, moldings, soffits, frieze boards, and fascia, along the north and west elevations will be repainted where the existing paint is worn or weathered (see Figures 1 and 2), and the new paint will match the existing paint colour. This work will include:

Figure 1: Rear (north) elevation of the Burr House at 528 Carrville Road.

- Stripping the existing paint down to the base wood to determine the extent of damage underneath;
- Pressure washing on low setting to remove dirt and grime;
- Hand-scraping and sanding.

Applying a new coat of paint to these wooden elements will revitalize the building's appearance and will protect the exterior elements from further degradation due to the weather and due to moisture.

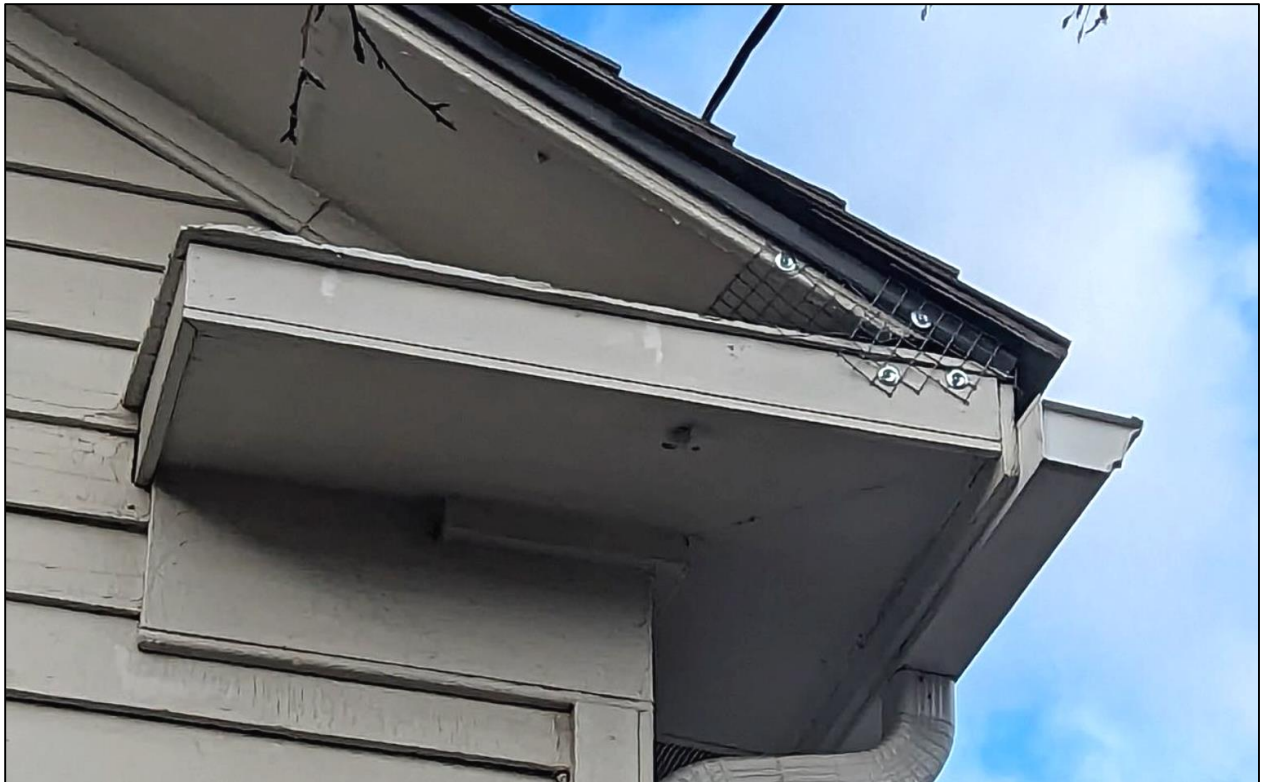
Figure 2: Area on west elevation showing deterioration and “alligatoring” paint.

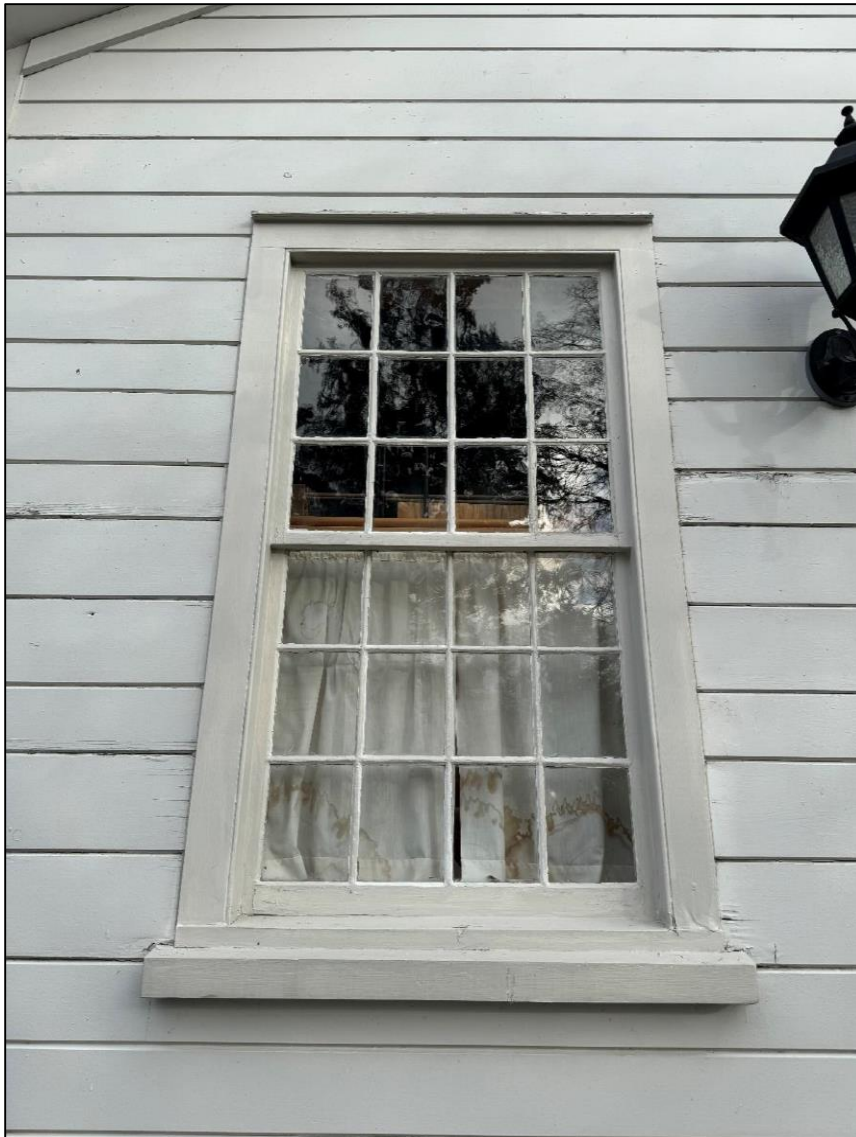
The wooden window and door frames are exhibiting signs of deterioration, including separation and cracking (see Figure 3). The restoration of these elements will comprise:

Figure 3: Typical window on south elevation showing areas of cracking, peeling paint.

- Re-sealing joints between upper and side windows and frames;
- Replacing sections of rot using either epoxy or the Dutchman’s patch method;
- Filling in any holes in window frames and sills with an epoxy repair system;
- Replacing door sill;
- Temporarily removing the front door to complete repairs off-site. A temporary door will be installed during this time.

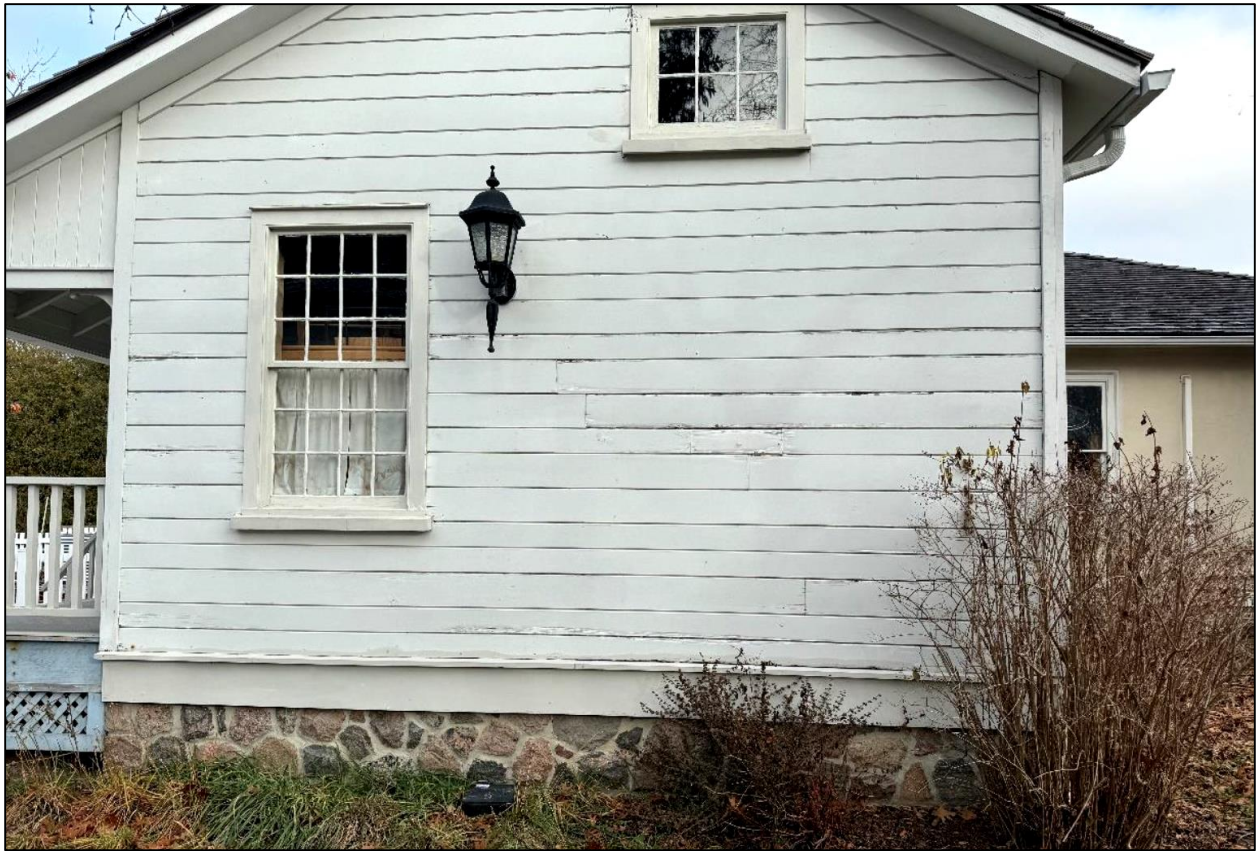
The restoration of the wooden siding on the north and west facades are exhibiting signs of deterioration, including peeling paint and damaged frames (see Figure 4). The repair of the wood siding will comprise:

Figure 4: Siding on west elevation showing areas of wood rot and failing paint.

- Patching any cracks, hardware holes or damaged frames;
- Removing areas with more extensive damage and squaring the area off with a new wood board and then installing and securing in place to match the profile of the existing siding.

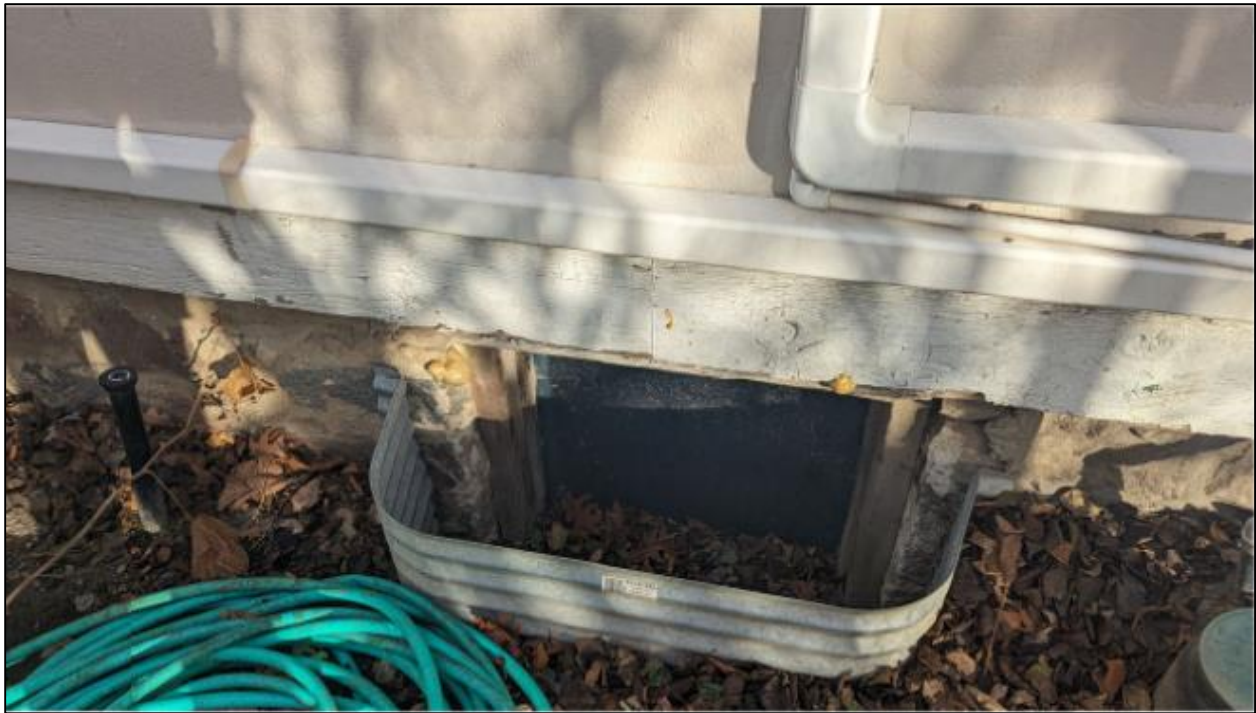
The wooden skirting boards and trims are exhibiting signs of damage and weathering, including rot and cracking (see Figures 5 and 6). The restoration of the wooden skirting boards and trims will comprise:

Figure 5: Trim along east elevation showing damage and failing paint.

- Sanding the entire surface to ensure an even texture before proceeding with any repairs;
- Applying a wood filler for minor imperfections;
- Replacing the affected portions with new, treated wood for areas of rot.

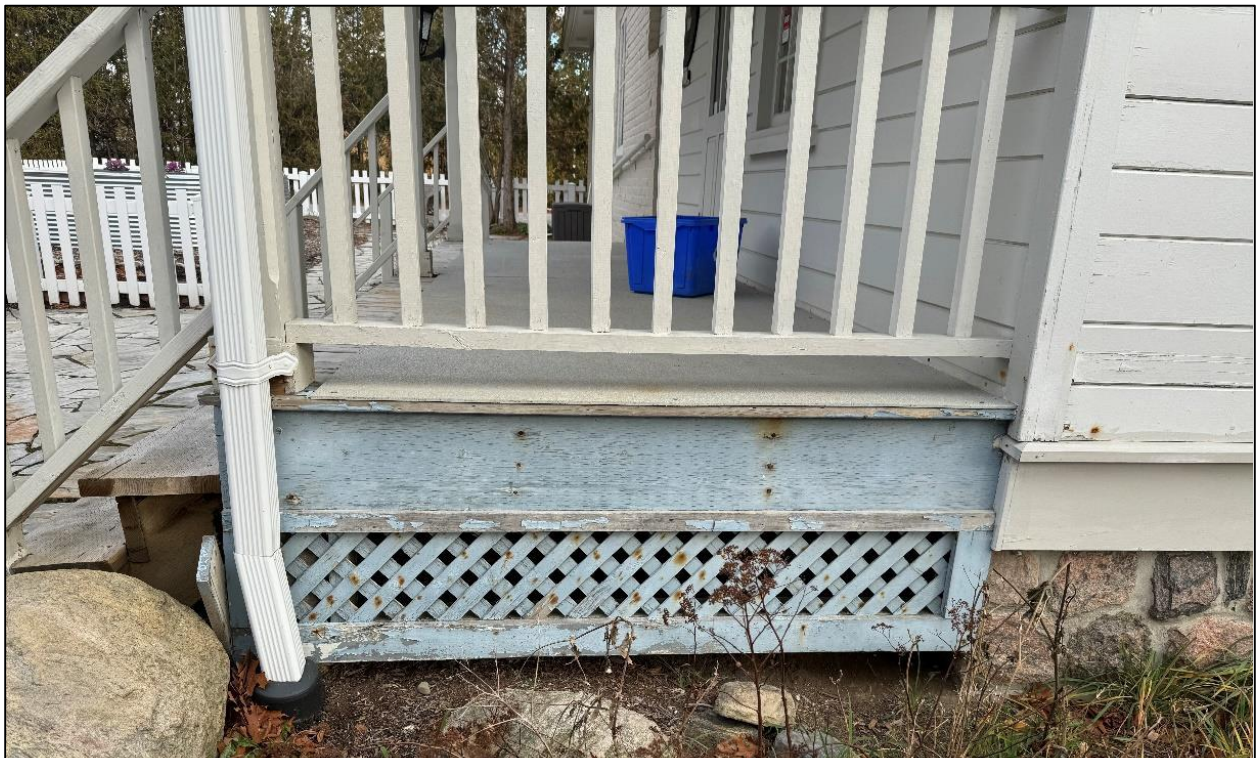
Figure 6: Skirting board showing areas of peeling paint, rusting nails.

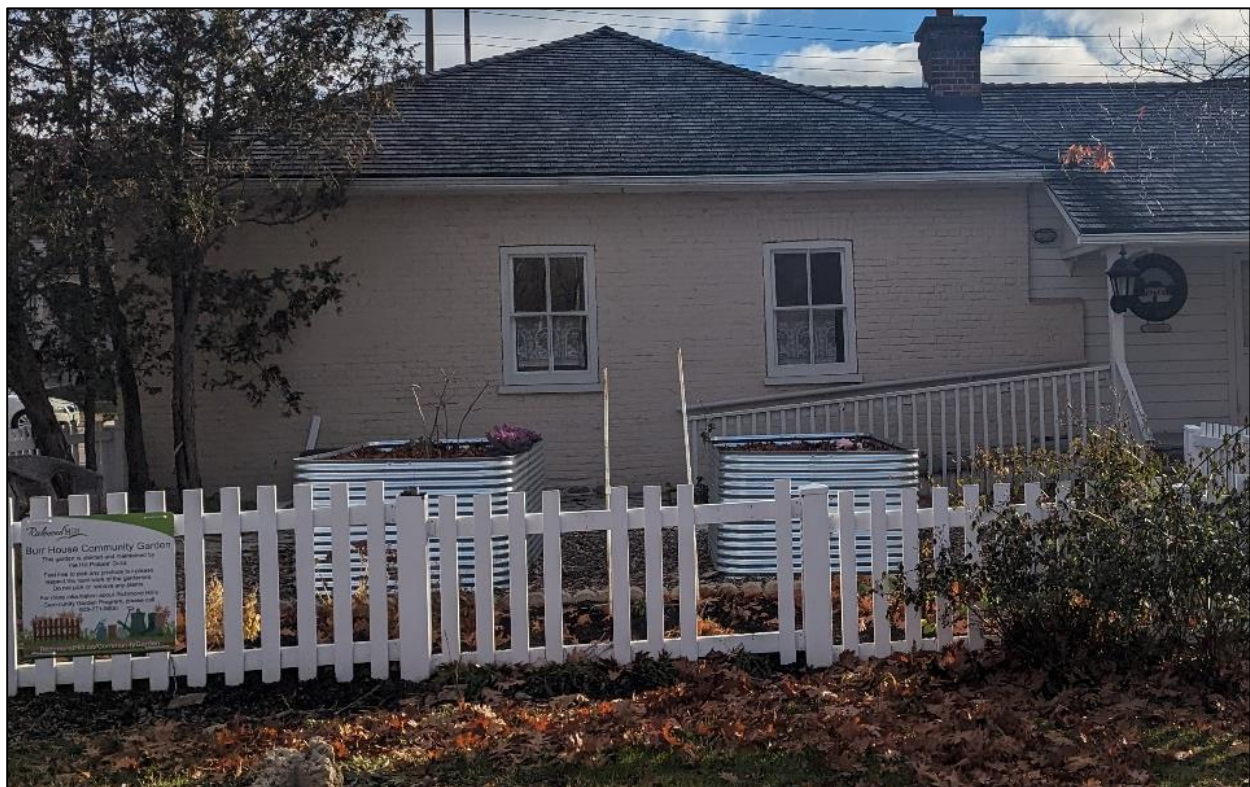
Areas with painted brick are exhibiting signs of deterioration in its mortar (see Figure 7). In order to repoint the brick, the paint must be removed prior to any repairs being completed. The repairs to the brick work will comprise:

Figure 7: Area of north elevation showing degrading paint, deteriorated mortar.

- Power washing surface to remove dirt building;
- Stripping paint to the base brick;
- Patching and repairing any cracks in the brick;
- Removing mortar showing signs of deterioration or damage;
- Repointing with mortar that matches existing mortar.

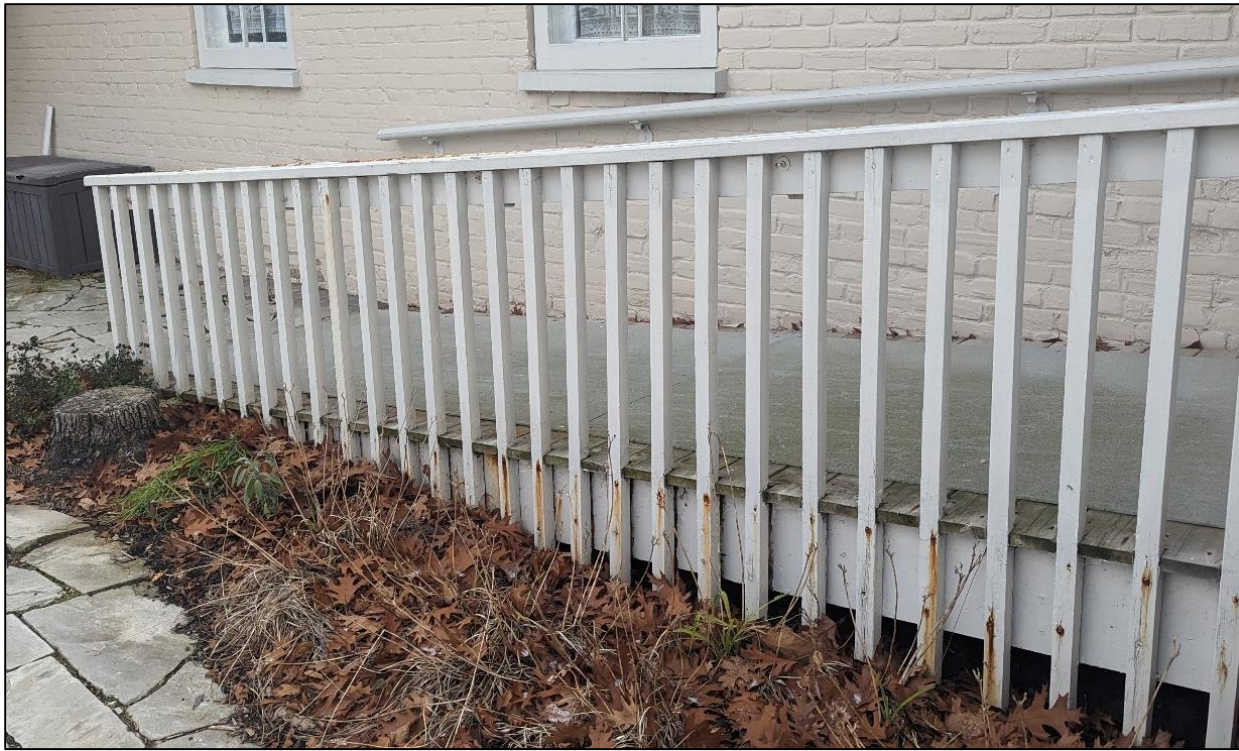
The rear ramp is exhibiting signs of degradation, including peeling paint, rusted nails, and rotting planks (see Figures 8 and 9). The repairs to the wooden ramp and guard railing along the northern façade will comprise:

Figure 8: Ramp along northern façade showing flaking paint, rusted nails, degrading wooden planks.

- Replacing sections of guardrails and planks that have extensive damage;
- Removing rust marks
- Refinishing wooden steps and stain with natural stain;
- Repairing wooden porch;
- Repainting to match existing colours.

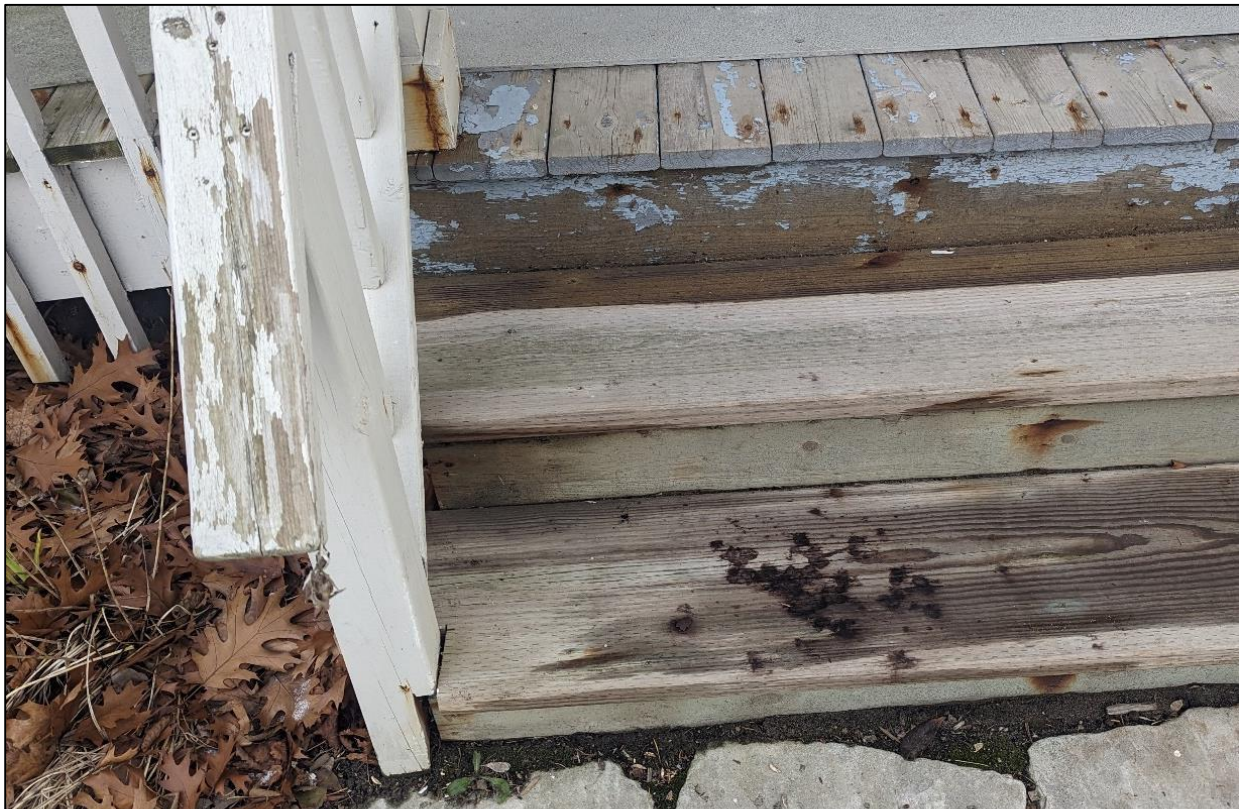
Figure 9: Wooden steps and porch showing degraded wood, chipping paint, rust stains.
