## **Staff Report for Heritage Richmond Hill Meeting**

**Date of Meeting:** April 4, 2024  
**Report Number:** SRPBS.24.030

**Subject:** **SRPBS.24.030 – Heritage Permit for 530  
Carrville Road (Guild Hall) – D12-07079**

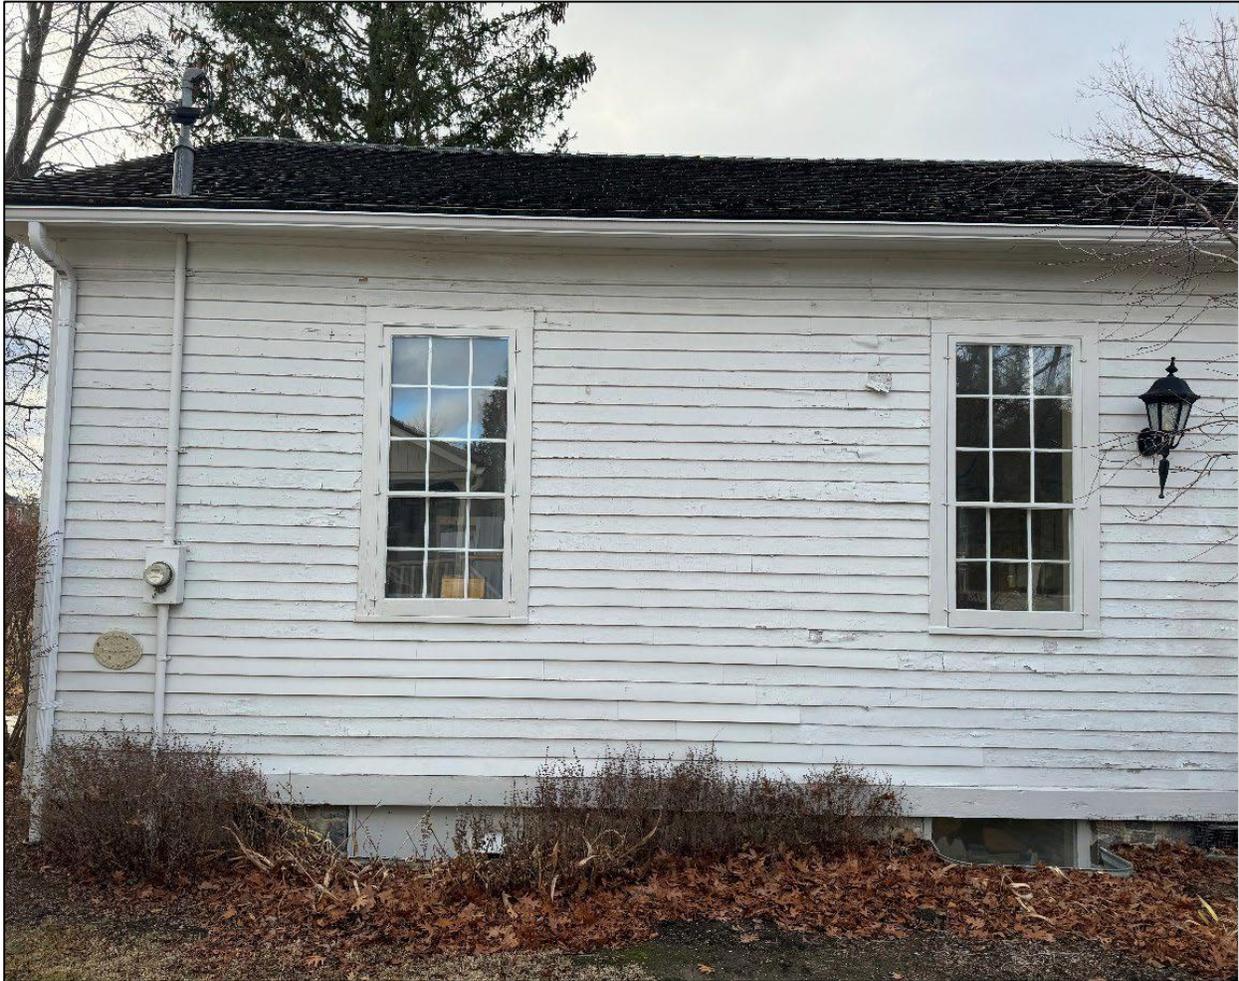
**Figure 2:** East elevation showing peeling paint

All exterior wooden elements displaying signs of wear or weathering will be repainted to match the existing colour scheme. The components that are proposed to be painted include windows, doors, wooden siding, trims, moldings, soffits, frieze boards, and fascia.

In order to allow this repainting to be done, existing shrubs in the immediate vicinity will be removed. These shrubs are not considered heritage attributes. A low-pressure power wash will be used to remove any dirt, and the existing paint will be stripped down to the

base wood through meticulous scraping and sanding. Extra precautions will be taken to prevent damaging the underlying wood.

A fresh coat of paint that matches both the type, texture, and colour of the existing paint will then be applied.

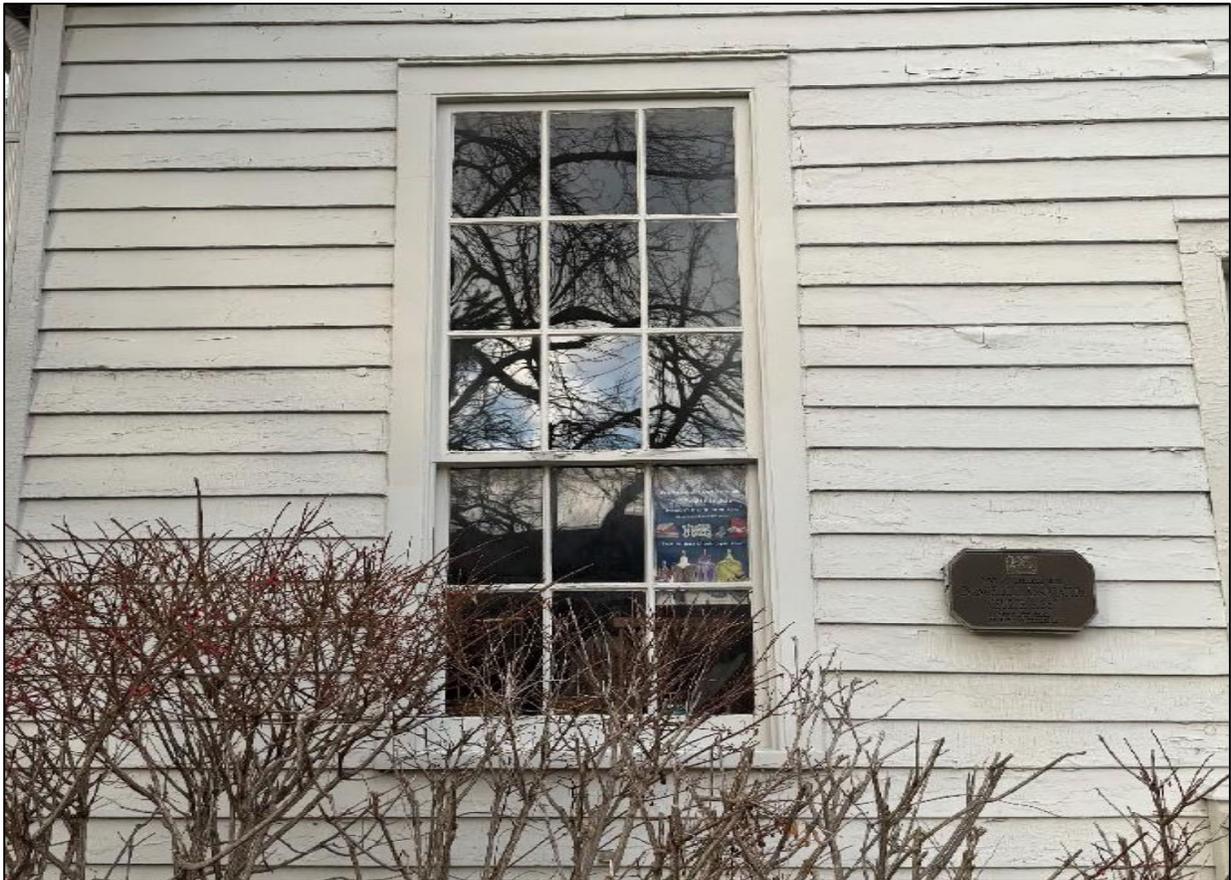
**Figure 3:** A typical window showing cracks and peeling paint.

Areas of the window and door frames and trims that exhibit signs of deterioration will be repaired. This work will include re-sealing joints, repairing minor cracks and holes with an epoxy repair system, and using the Dutchman's patch method to repair areas with more extensive deterioration. The door sill will be replaced.

The front door will be temporarily removed to be repaired off-site. While the front door is off-site, a temporary door will be installed.

Once the repairs are complete, the windows and doors will be painted.

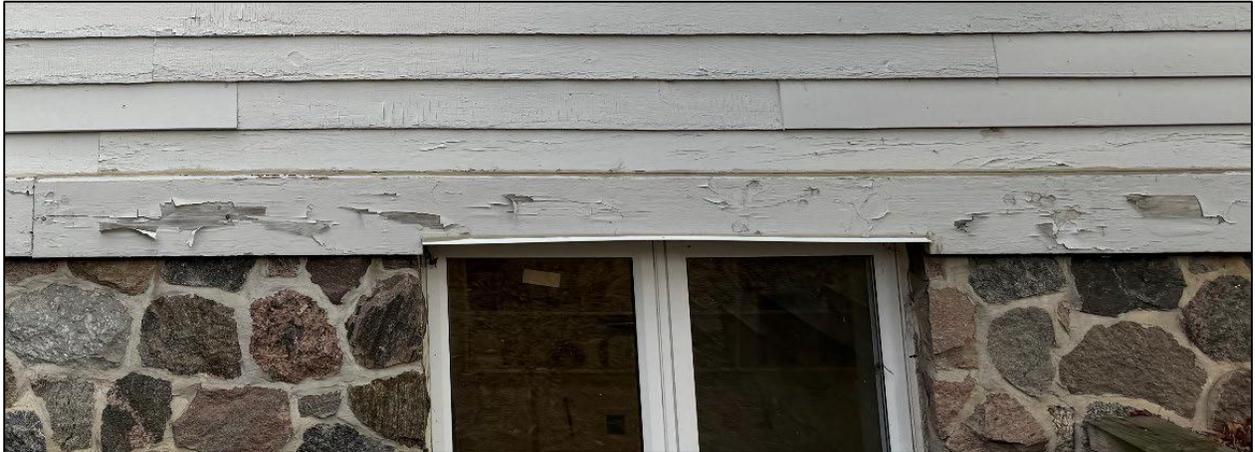
Wooden surfaces have sustained damage and wear due to the materials' use and exposure to the elements. Before initiating any repairs, the entire surface will be sanded to create a uniform texture. Minor imperfections like scratches or dents will be repaired with wood filler. Areas with more substantial damage and rot will be replaced with new, treated wood that matches the look and structural integrity of the existing material.

**Figure 4:** Typical skirting exhibiting peeling paint, deterioration.

Once the repairs are complete, the skirting boards and trims will be painted.

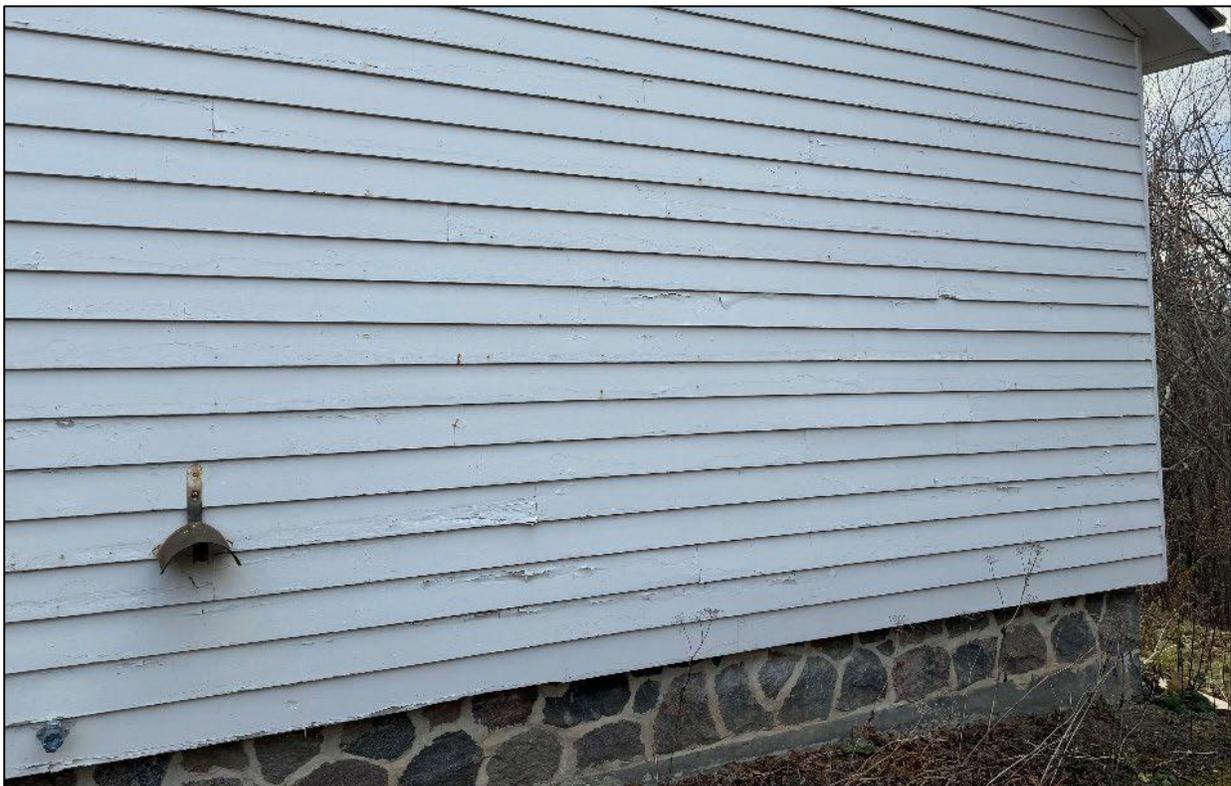
The wood siding exhibits faded and peeling paint, as well as cracks between the skirting board and corner trim. Small cracks or holes will be filled in with a sealant. Sections of siding that exhibit deep or extensive damage will be replaced with new clapboard siding. Areas that were repaired will then be cleaned and sanded down to create a seamless finish and to assist with durability. Once the siding is repaired, a new coat of paint will be applied.

**Figure 5:** Siding along north elevation showing peeling paint, chipped and damaged siding.

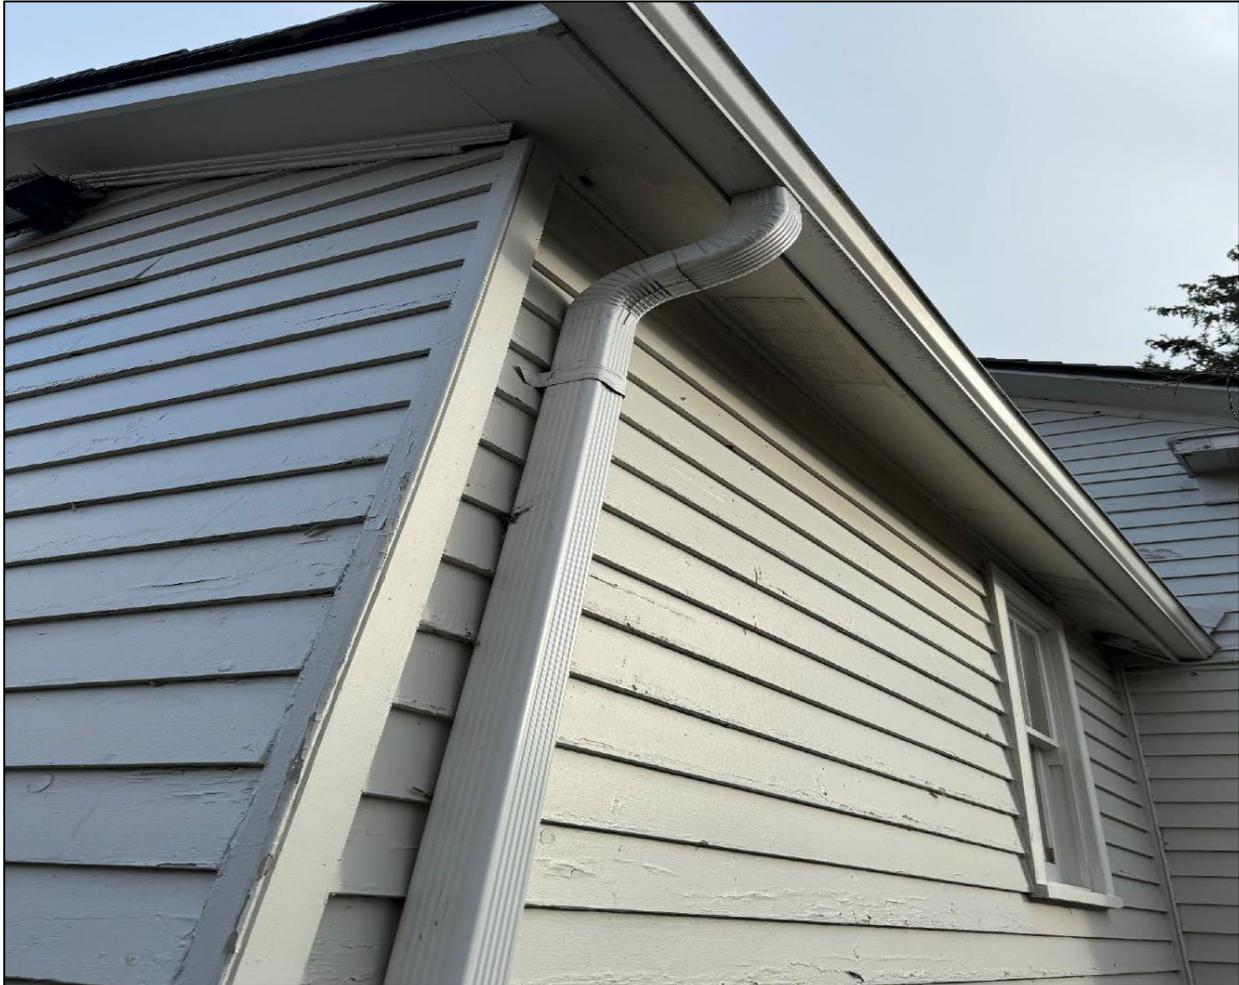
The aluminum soffits along the roof show signs of deterioration due to weather and the collection of moisture. Signs of deterioration include visible rust and fading. Damaged sections will be removed, and new materials will be installed to restore functionality and aesthetics. The soffits will then be repainted.

**Figure 6:** Typical soffit showing rust and fading.

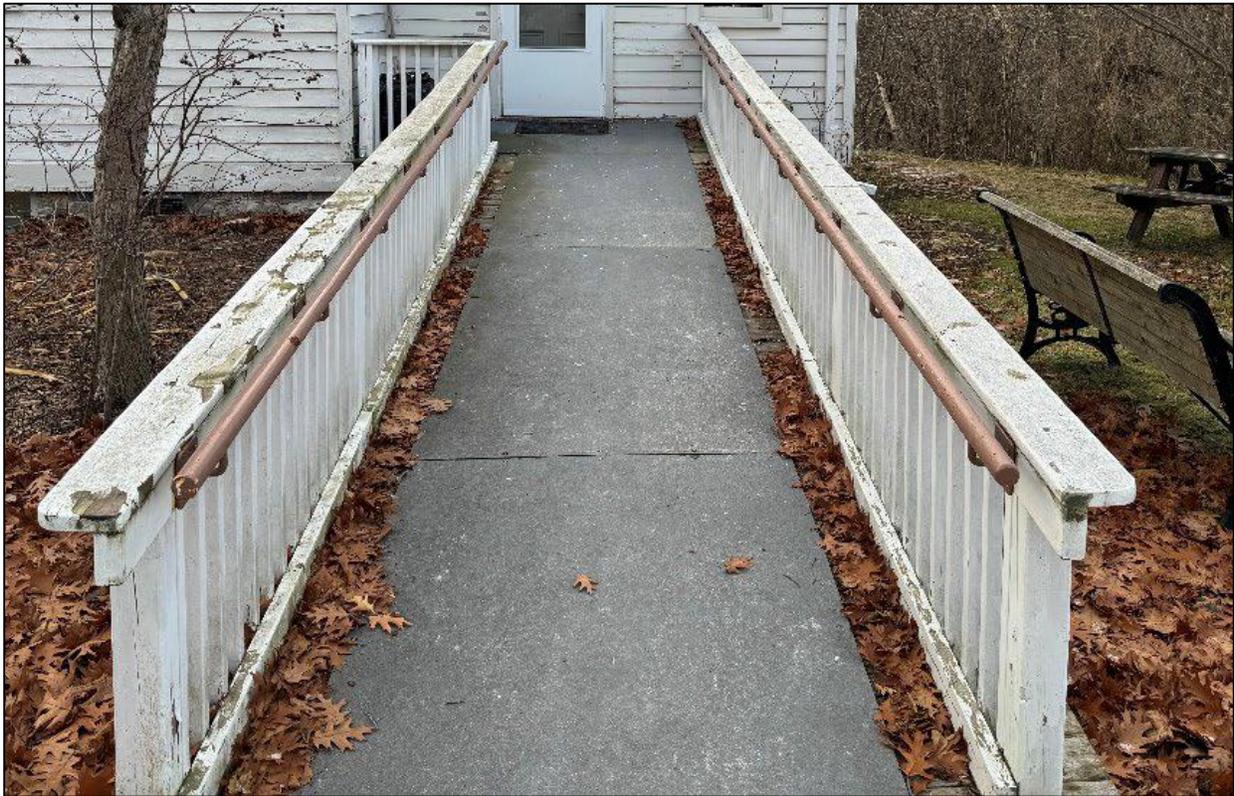
The handrails on the ramp on the south façade and the railings on the east façade exhibit signs of wear and deterioration. Paint is peeling, and metal components are rusted. Areas that have damage will be repaired and then repainted.

**Figure 7:** Handrail showing areas of peeling paint, damage.
