Staff Report for Heritage Richmond Hill Meeting

Date of Meeting: April 4, 2024
Report Number: SRPBS.24.047

Subject: SRPBS.24.047 Heritage Permit for 38 Bedford
Park Avenue (Crosby Hall) – D12-07056

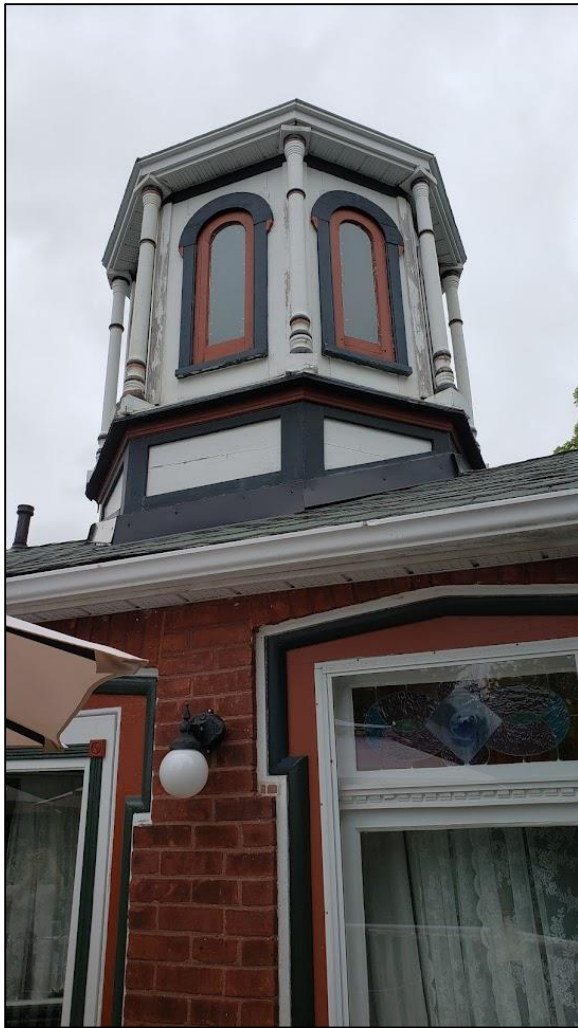
Crosby Hall, located at 38 Bedford Park Avenue, is designated under Part IV of the Ontario Heritage Act through Designating By-law 222-78. Built in 1863, this home built in the Victorian Eclectic style, has a brick exterior, gable roof, and round-headed windows. It is best known for its octagonal domed cupola (see Figure 1).

The exterior of the cupola is showing signs of degradation, and there is evidence of water damage in the interior.

Figure 1: The domed cupola at Crosby Hall.

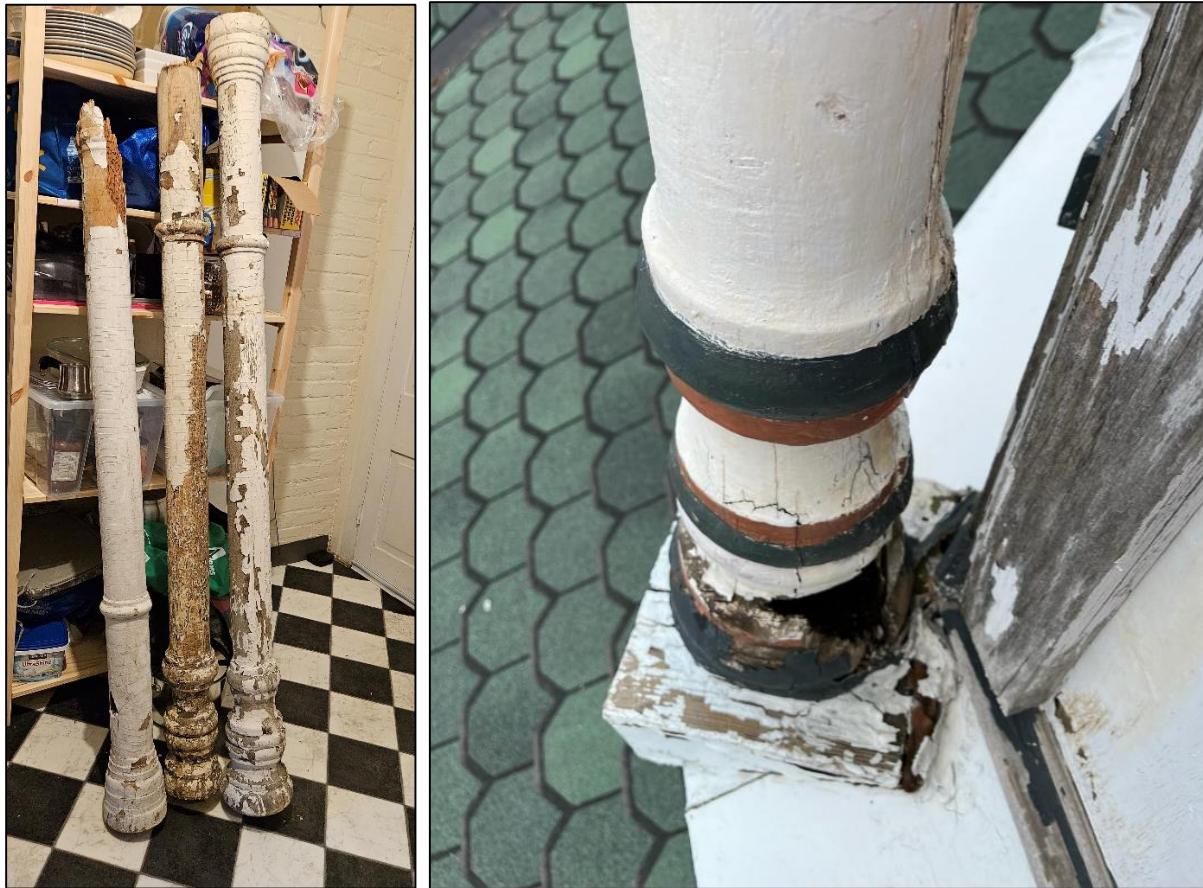
Being exposed to the elements, the wooden components of the cupola have suffered significant decay.

Figures 2, 3: Posts found in the attic of the Crosby Hall garage, believed to be the cupola's original posts (left); the base of a post showing deterioration (right).

- Replacing the eight posts with replicas based on the cupola's original posts (see Figures 2 and 3);
- Replacing the bases and caps;
- Re-fitting and weatherproofing the eight windows (see Figure 4);
- Replacing rotted or missing trim (see Figures 5 and 6);
- Repainting the exterior of the cupola.

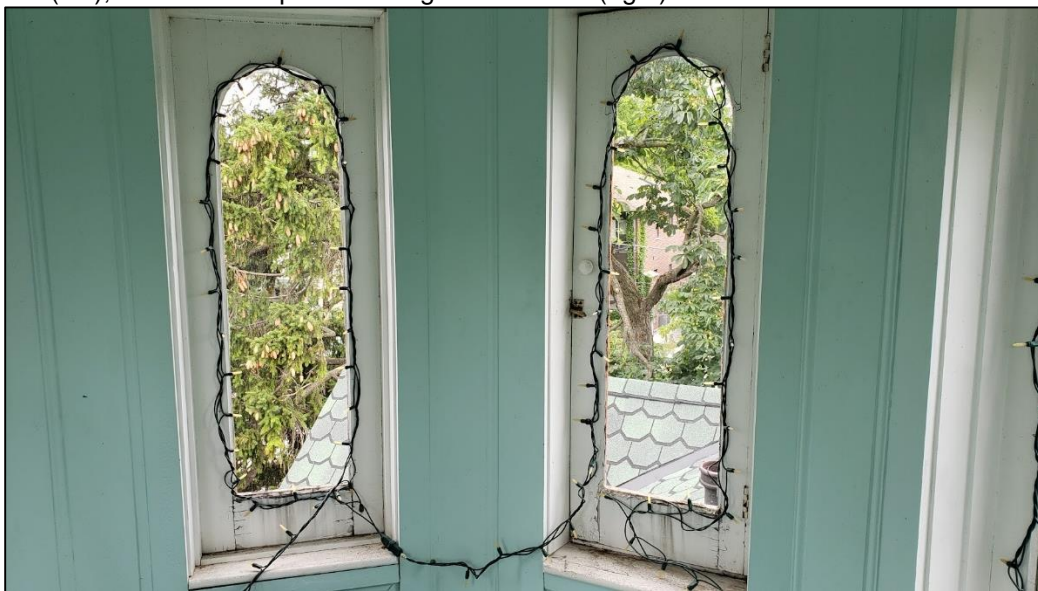
Figure 4: The window interiors showing water damage.

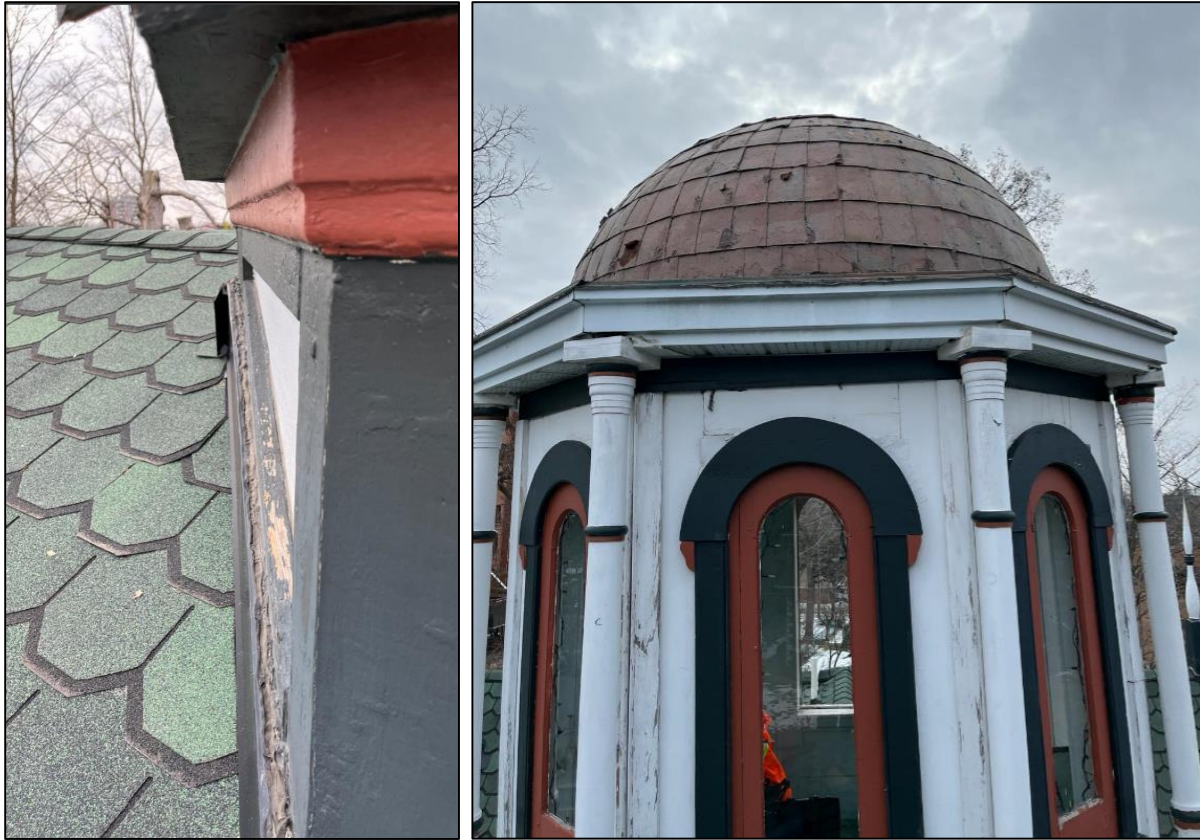
Figures 5, 6: Trim showing peeling paint, wood rot.

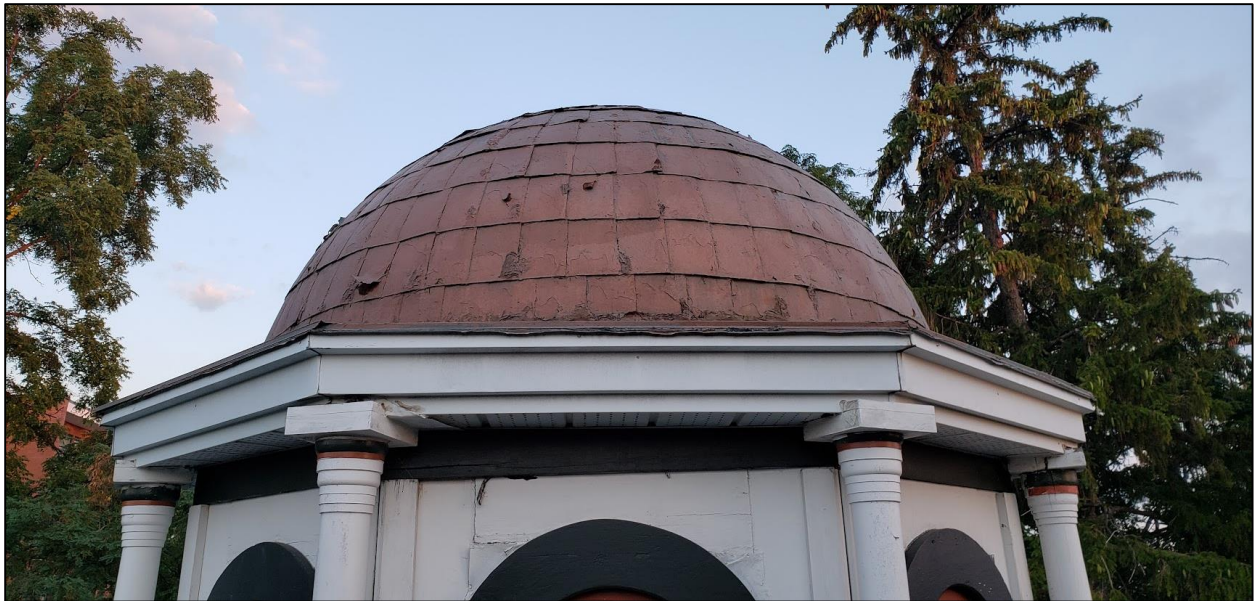
Components of the roof have deteriorated (see Figure 7), which has resulted in the roof no longer being waterproof and causing water damage to the interior of the cupola (see Figure 8).

Figure 7: Components of the roof showing deterioration, including the shingles, flashing, and fascia.

- Replacing the roofing with material that matches the existing roofing colour;
- Repairing or replacing the soffit and flashings.

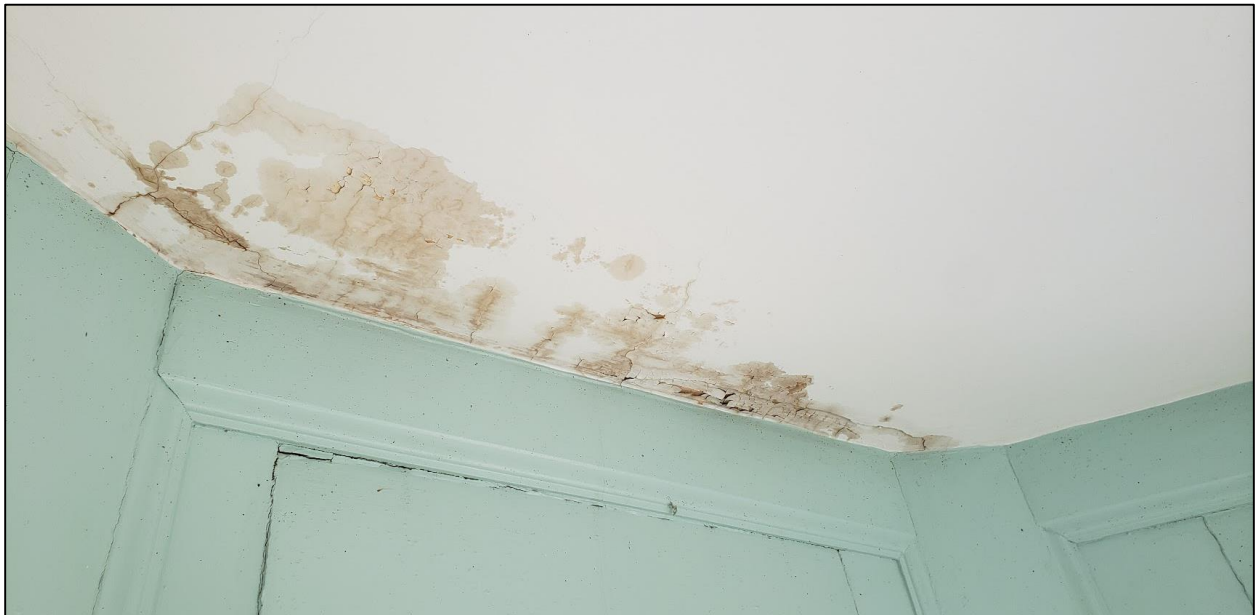
Figure 8: The ceiling of the cupola exhibiting signs of water damage.

As the interior of Crosby Hall is not protected under the heritage designation by-law, repairing the water damage to the interior of the cupola does not require a Heritage Permit and will not be discussed in this Staff Report.
