## DAVID DUNLAP OBSERVATORY & ADMINISTRATION BUILDING CONSERVATION PLAN

City of Richmond Hill  
+VG Architects (Toronto) Ltd.

September 12<sup>th</sup>, 2019

**PROJECT:** David Dunlap Observatory & Administration Building  
CONSERVATION PLAN

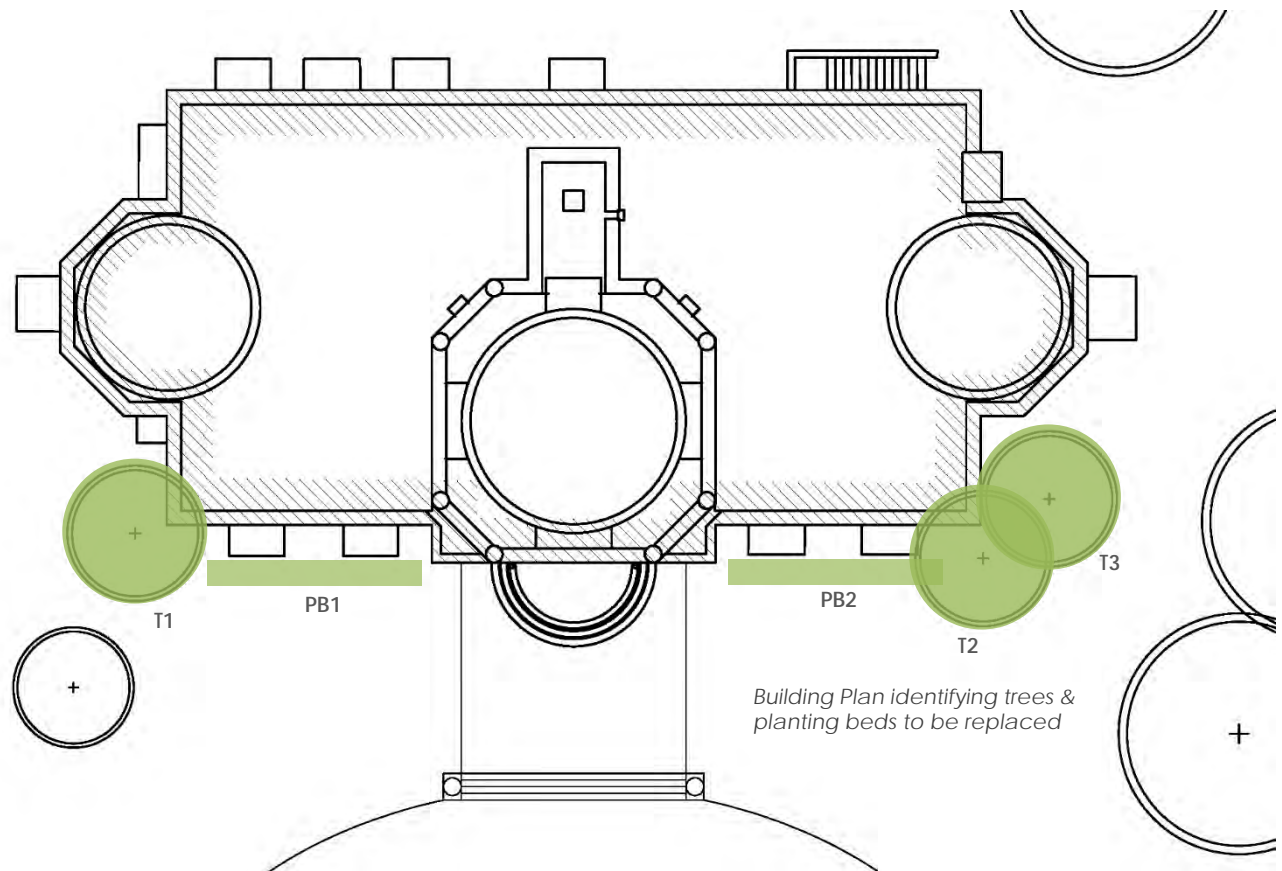
T1 (left)

- Several non-native trees has grown close to the building face and will impact on the new drainage system around the perimeter of foundations
- Planting beds along the west façade are encroaching onto the anticipated excavation zone for the proposed foundation drainage system.

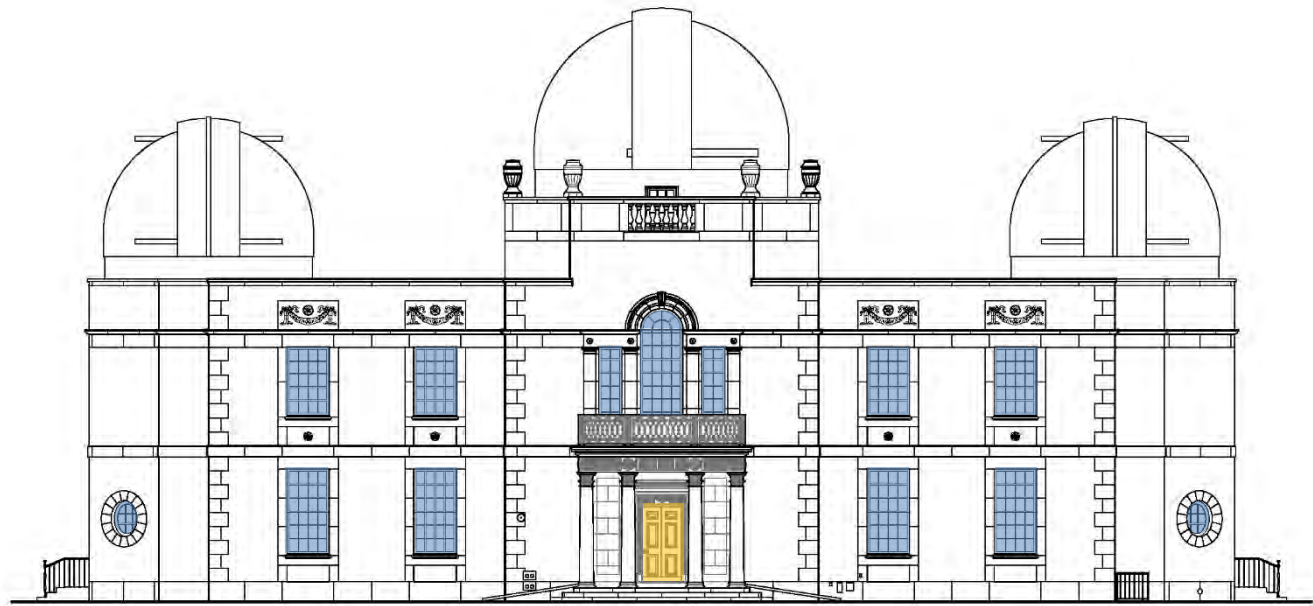
- Extensive deterioration of finishes and sealants
- Most of damaged components are localized to sills and jambs
- Malfunctioning or missing hardware

*West elevation identifying windows and doors to be restored*

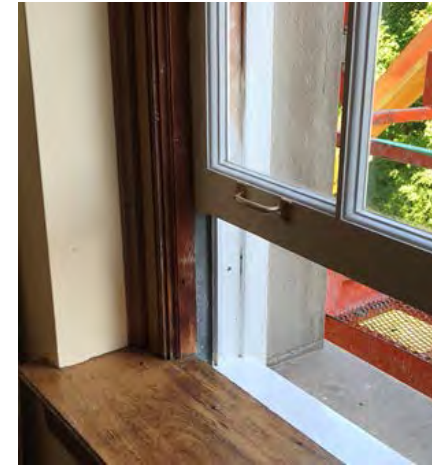
*Restoration of three windows (photo of work in progress)*

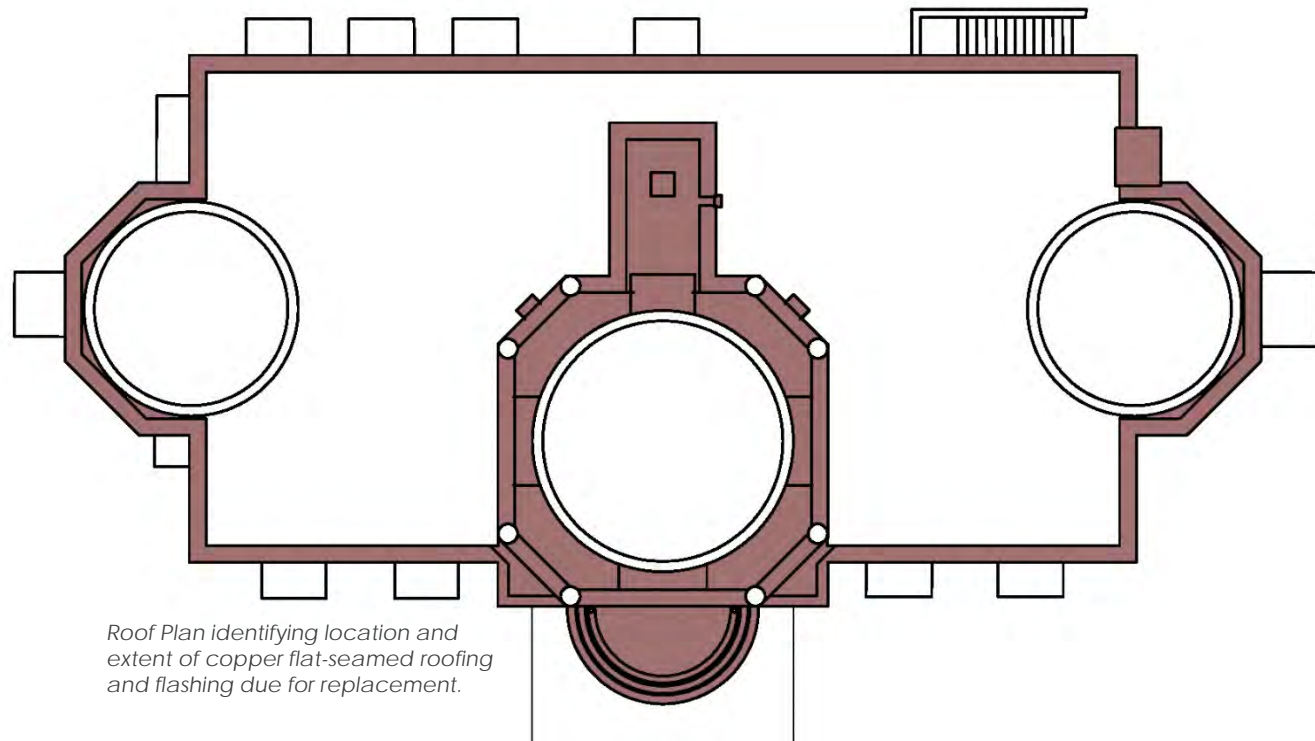
- Copper material and fasteners are extensively deteriorated and at the end of useful life.
- Welded connections have failed. Signs of water infiltration to substrates.
- Previous repairs not sympathetic with the heritage character of the building (sealants, patches, etc.)

*Old and deteriorated asphalt repairs over flat-seamed copper roofing.*

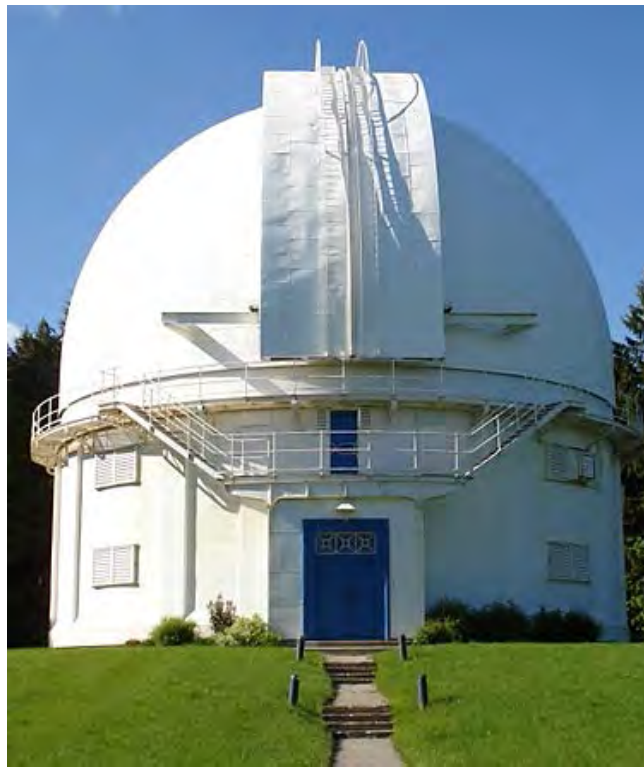
*The Observatory dome*

- Deterioration and rusting of metal surfaces.
- Hardware require repairs and lubrication.
- Failure of sealed joints and gaskets no longer weathertight.

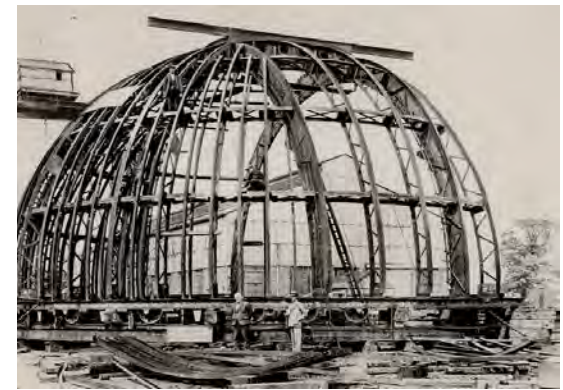
*Steel structural framing at large dome*

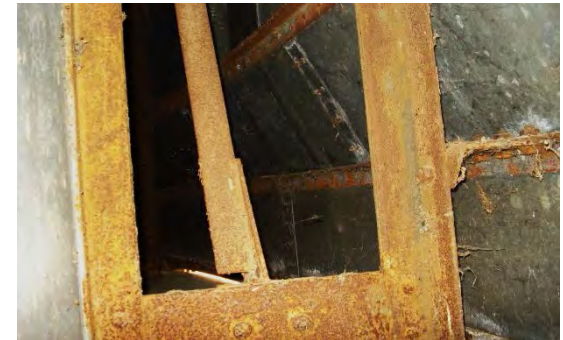
*Interstitial space between ext. and int. skin*

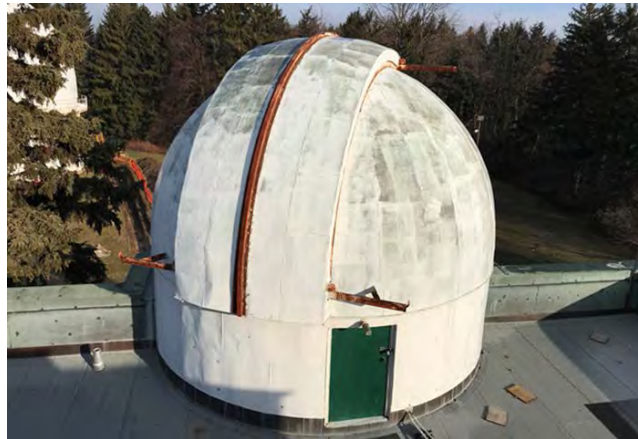
*North dome at Admin. building*
