# 103 RICHMOND STREET, RICHMOND HILL CONSERVATION BRIEF

FINAL  
MAY 17, 2023

PREPARED FOR  
**SAIM MUMAL**

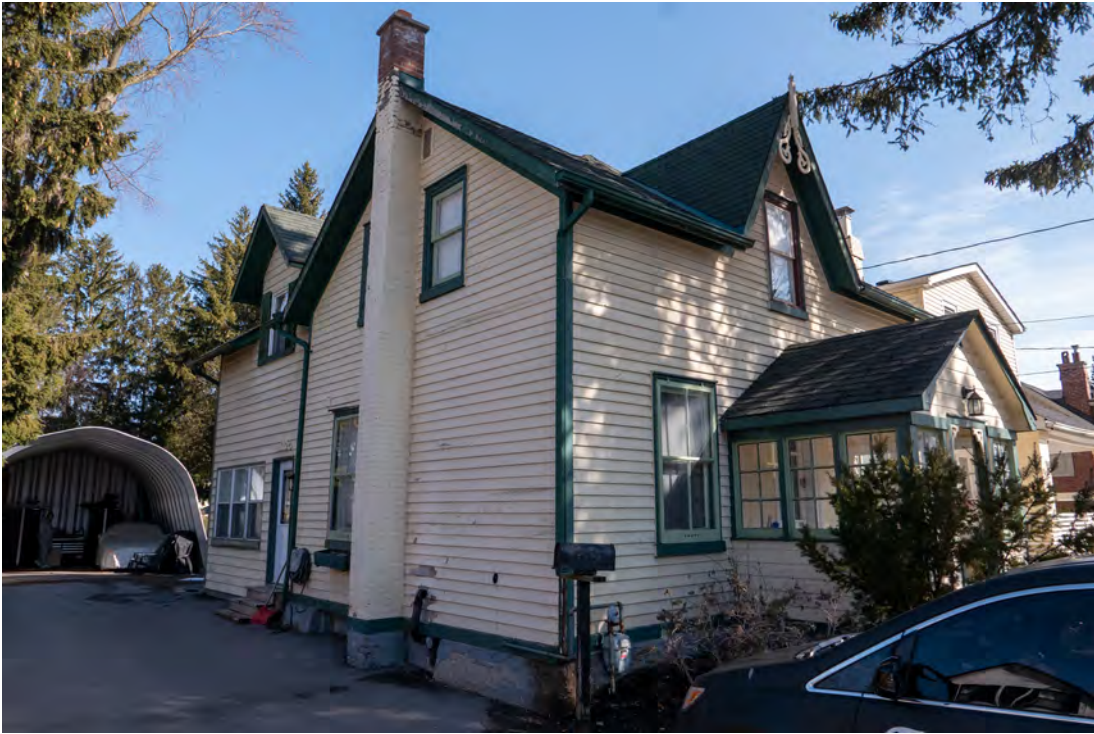
This attribute relates to the form, massing, and composition of the dwelling's main southern portion. It includes the rectilinear plan and side gabled form punctuated by a central cross gable, combined with the symmetrical three bay elevation configuration (see Figure 3). Despite a later enclosed porch addition, the attribute remains in-tact and legible.

Figure 3: View northeast of the dwelling at 103 Richmond Street, with main south portion in front and north extension behind (CBCollective 2023).

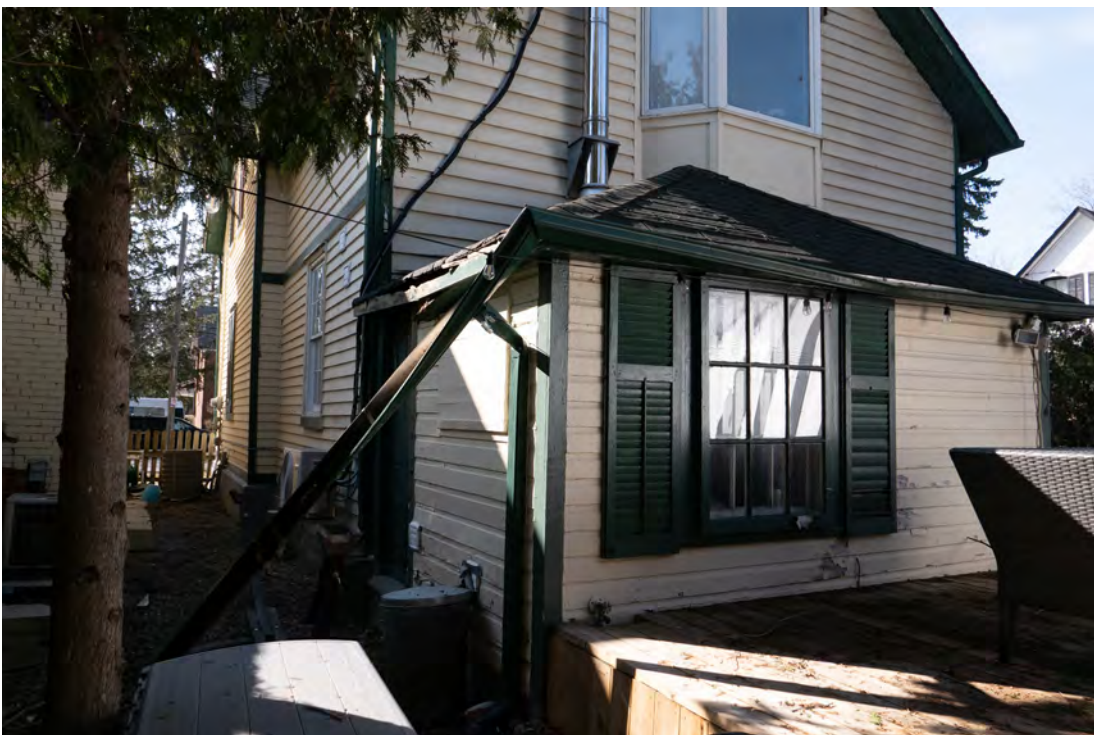
Figure 4: View southwest of the north and east elevations at 103 Richmond Street (CBCollective 2023).

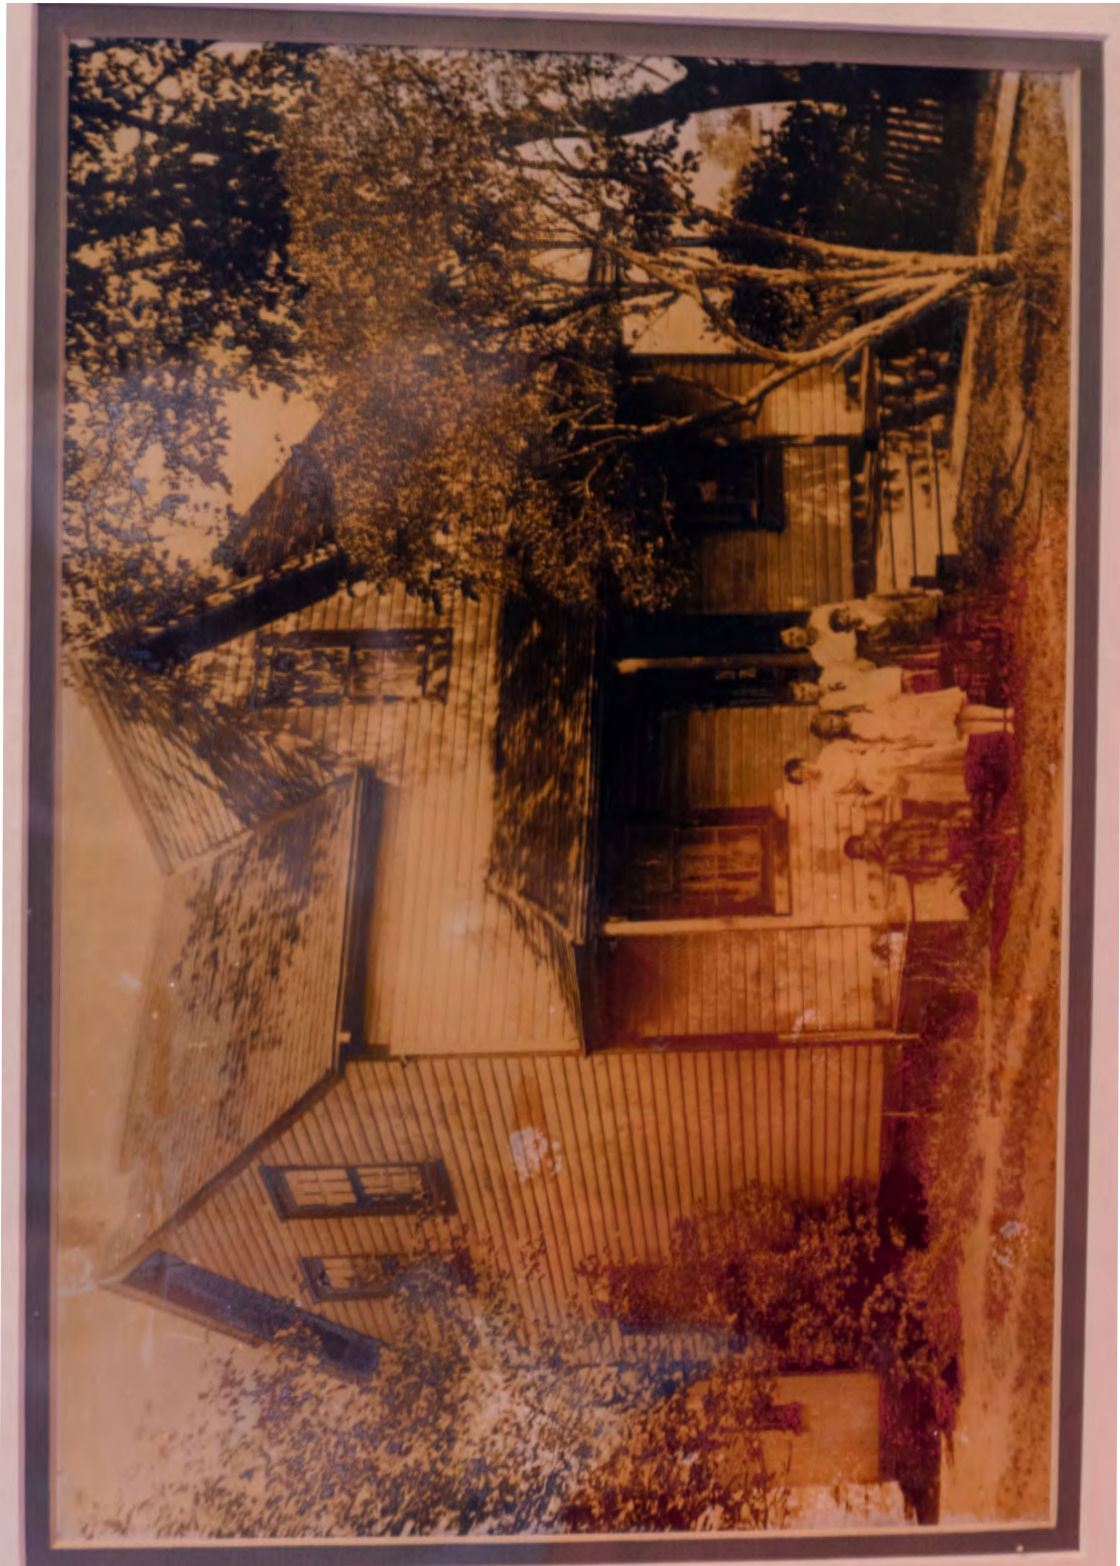
The historic photograph provides a view of the dwelling's south and west sides (Figure 5). The photo is undated, but the clothing of the six people in the foreground suggests it dates from the late 19th or early 20th centuries. The photograph provides some key information about the dwelling's historic, if not original configuration.

Figure 5: Undated archival photograph looking northeast at 103 Richmond Street. Note the smaller north extension, original windows, inset chimney and historic porch design (CBCollective 2023).

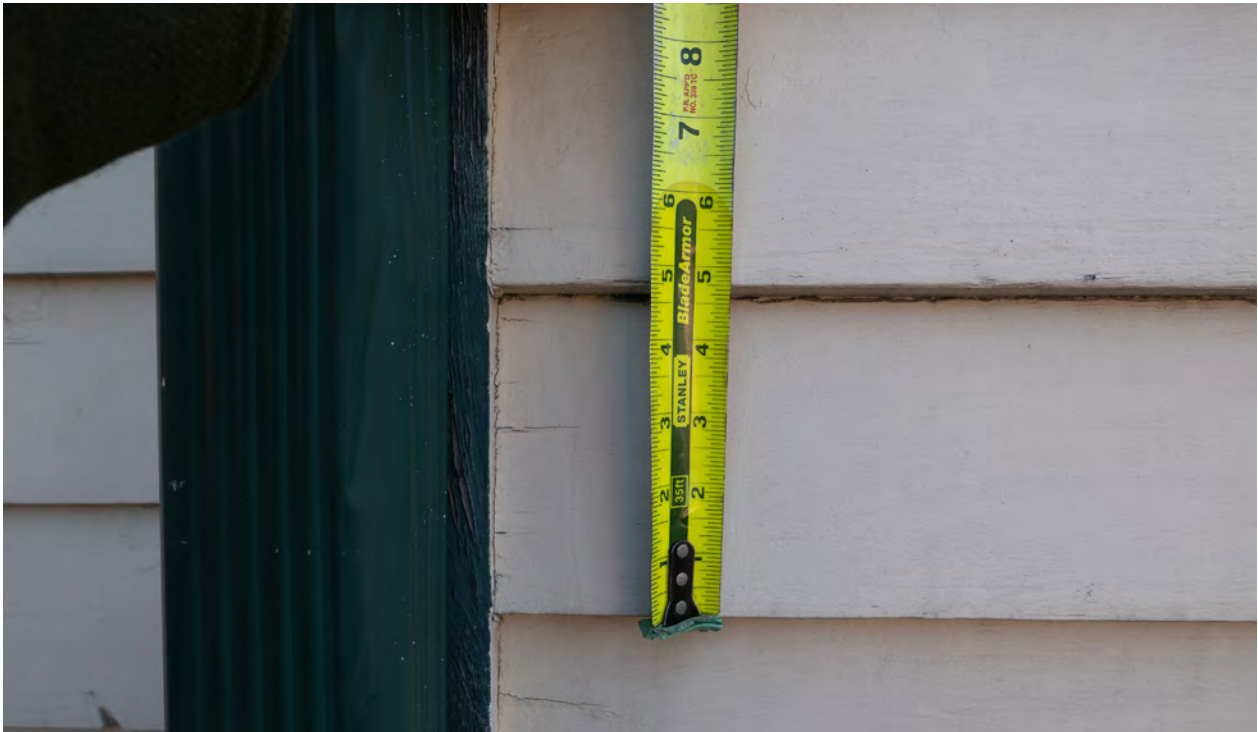
Figure 6: Dimensions of historic siding primarily found on main south portion (CBCollective 2023).

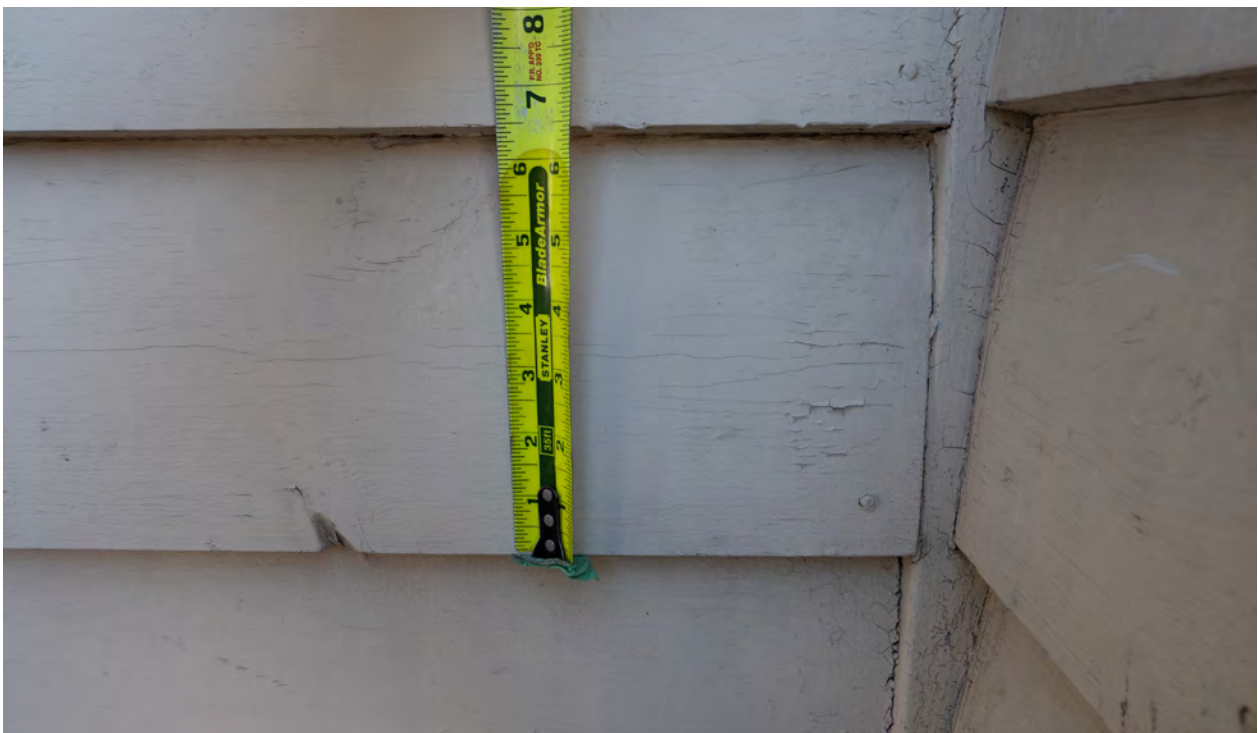
Figure 7: Dimensions of siding attributed to additions, entirely found on the north extension (CBCollective 2023).

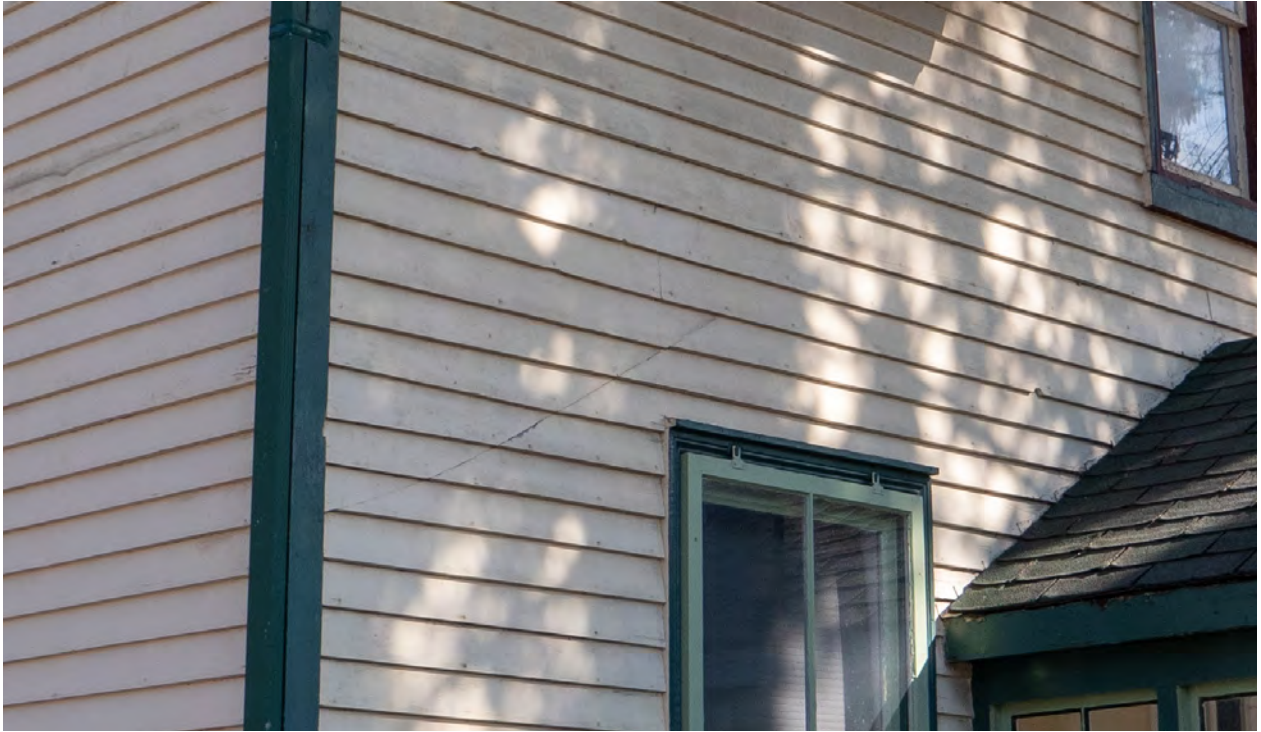
The historic bell-cast porch is seen in the photo, whose roofline remains visibly etched into the siding today (Figure 8). An older chimney is also visible, passing through the house's interior adjacent to the present chimney on the west elevation. The present chimney appears to have been built over the existing siding, which remains in place beneath (Figure 9). A pair of air vents have been added near the top of both side gables of the southern portion.

Figure 8: Detail showing scarring from historic bellcast porch roof on historic siding (CBCollective 2023).

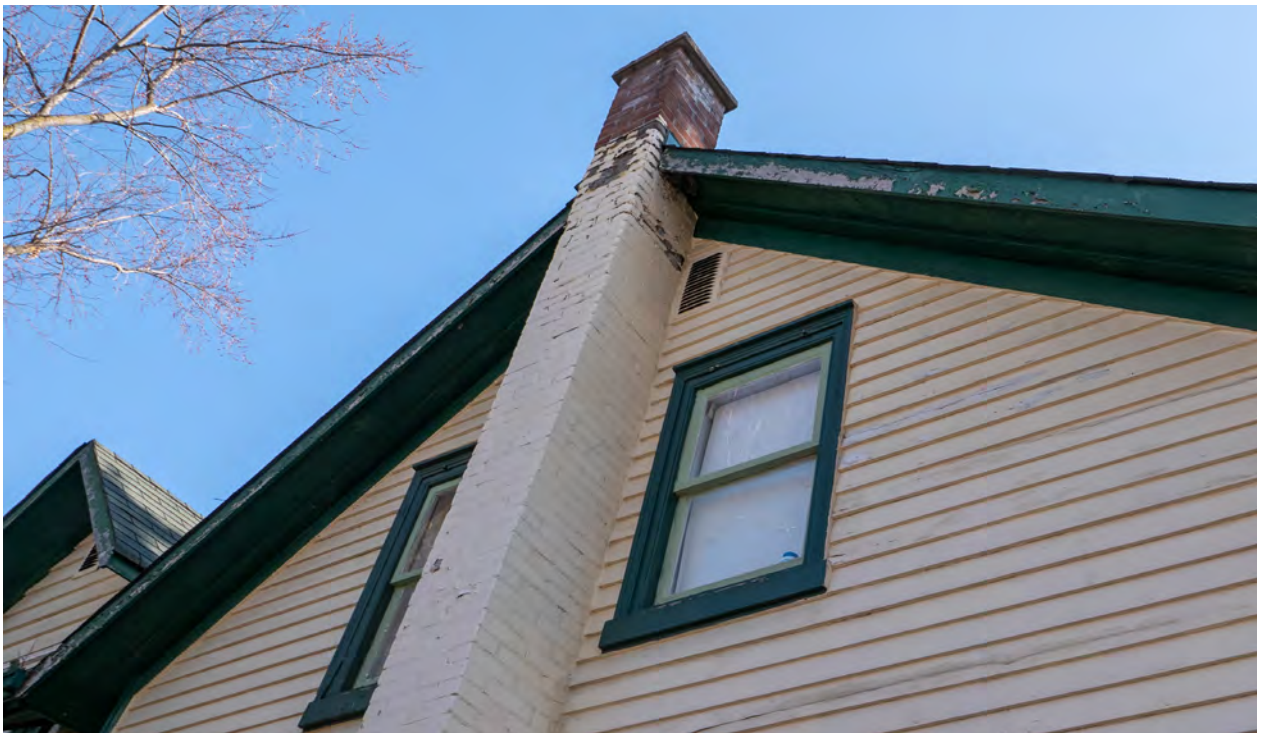
Figure 9: View of the present chimney on the west elevation. The chimney is located over the historic siding (CBCollective 2023).

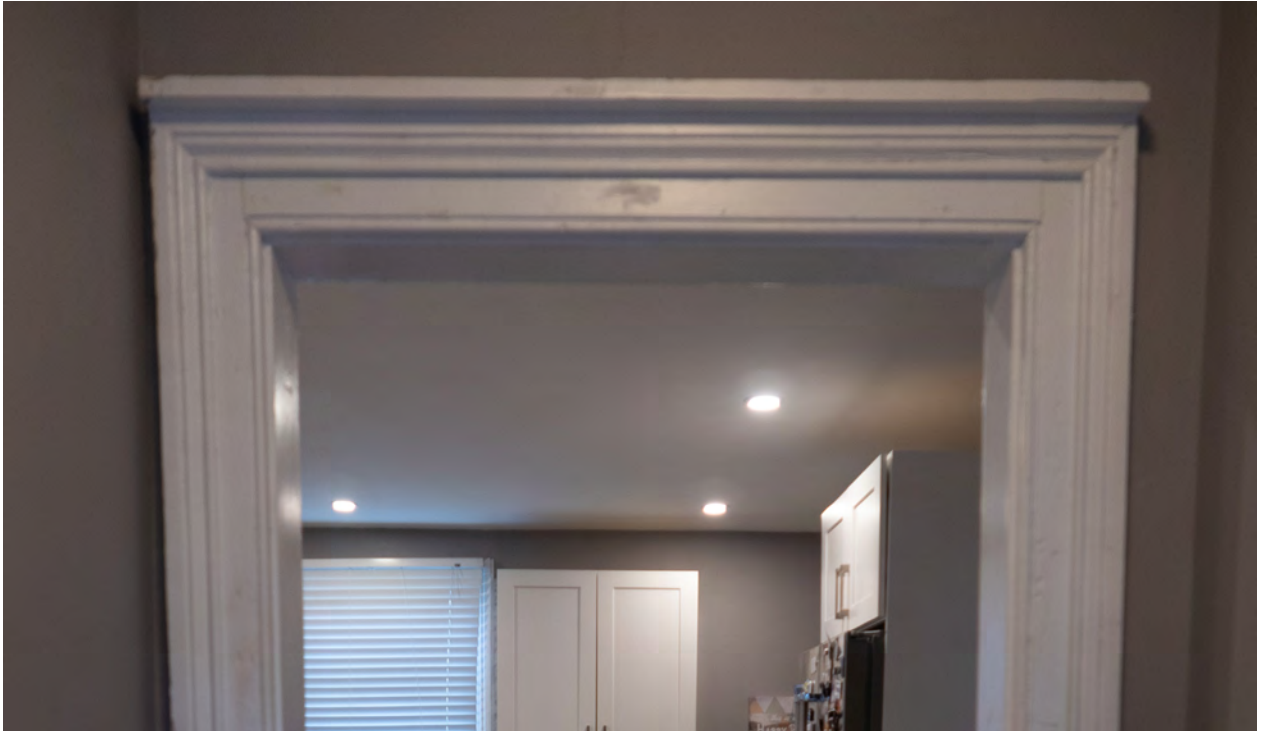
Figure 12: Door casings in the side vestibule contain a drip ledge along the top, consistent with other historic exterior architraves. The opening is likely the historic rear door (CBCollective 2023).

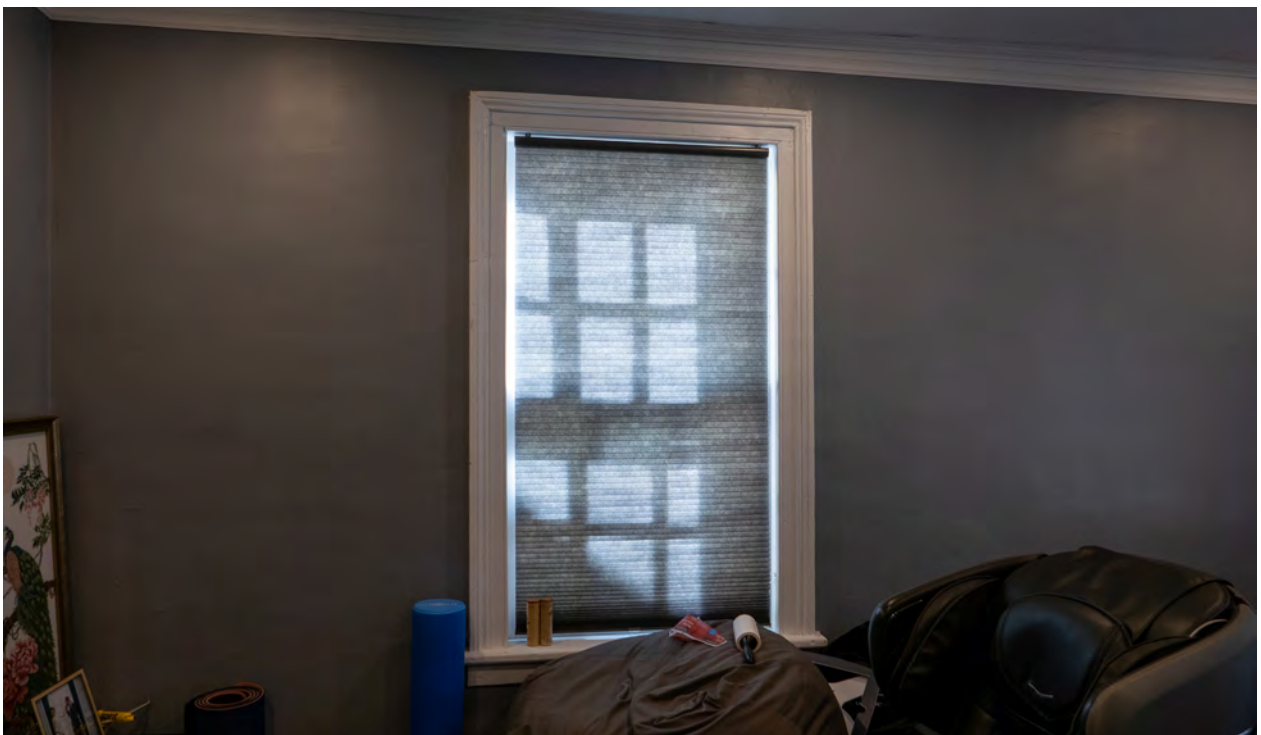
Traditional window and door casings with matching moulding profiles and consistent joining methods are found throughout the first and second floor interiors (Figures 13 & 14). They match the casings found on the exterior of the house's main southern portion (Figure 15). The presence of such casings on the interior suggests the historical

Figure 13: East ground floor window on the main south portion shows architrave profiles and construction methods consistent with other historic openings (CBCollective 2023).

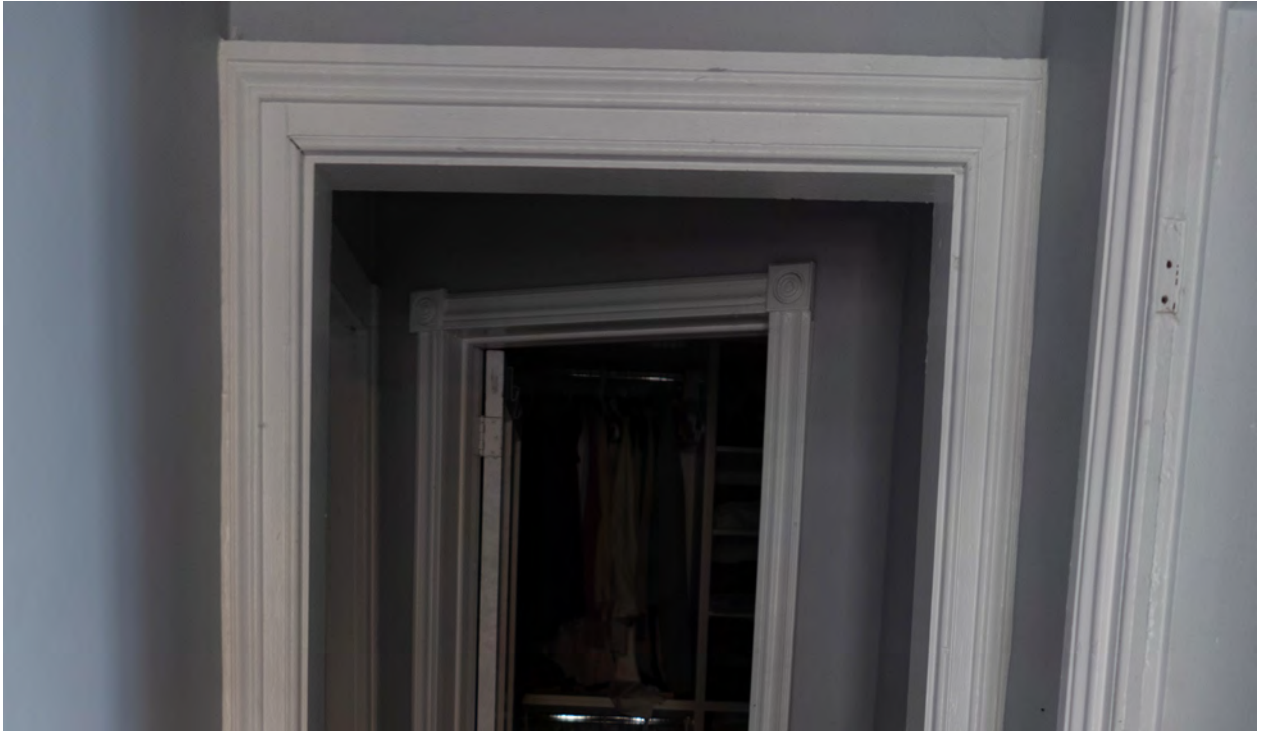
Figure 14: Second floor corridor doorways show historic door casings in the foreground, with later styles visible in the background (CBCollective 2023).

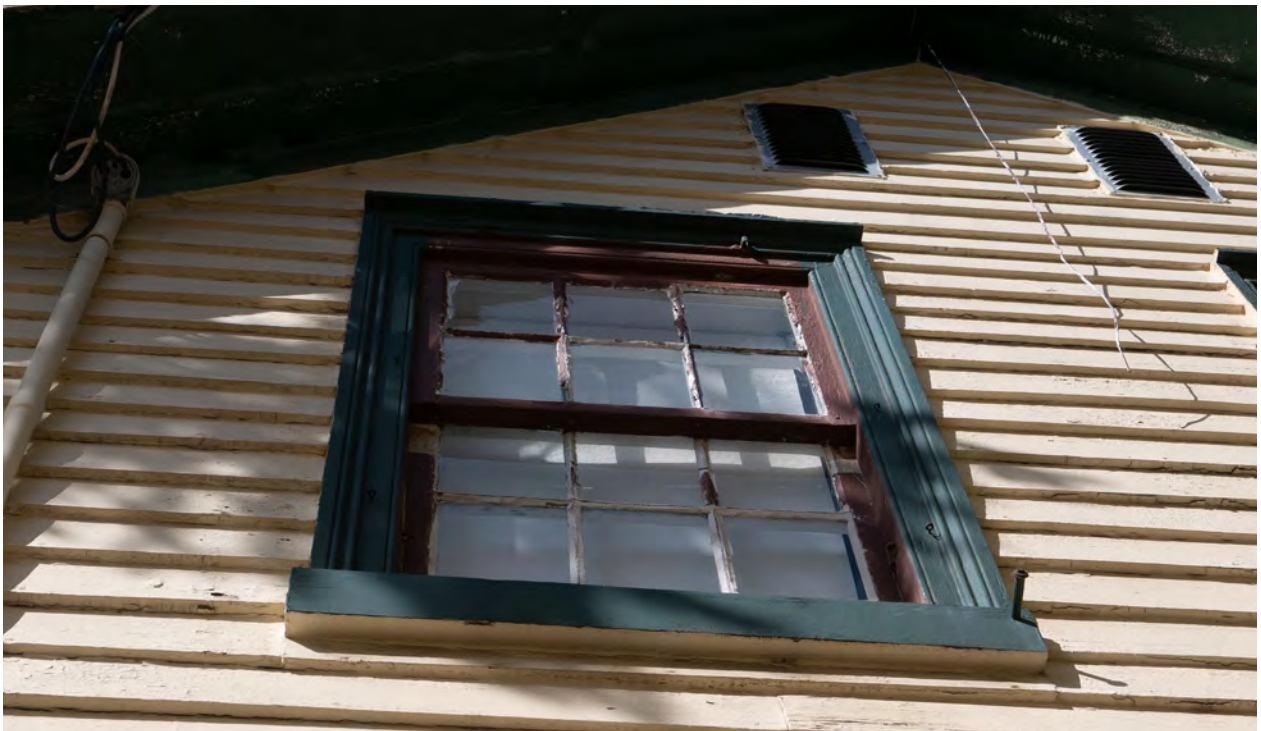
Figure 15: Exterior windows in the west elevation gable show the same moulding profiles and construction, with the addition of a drip ledge above (CBCollective 2023).

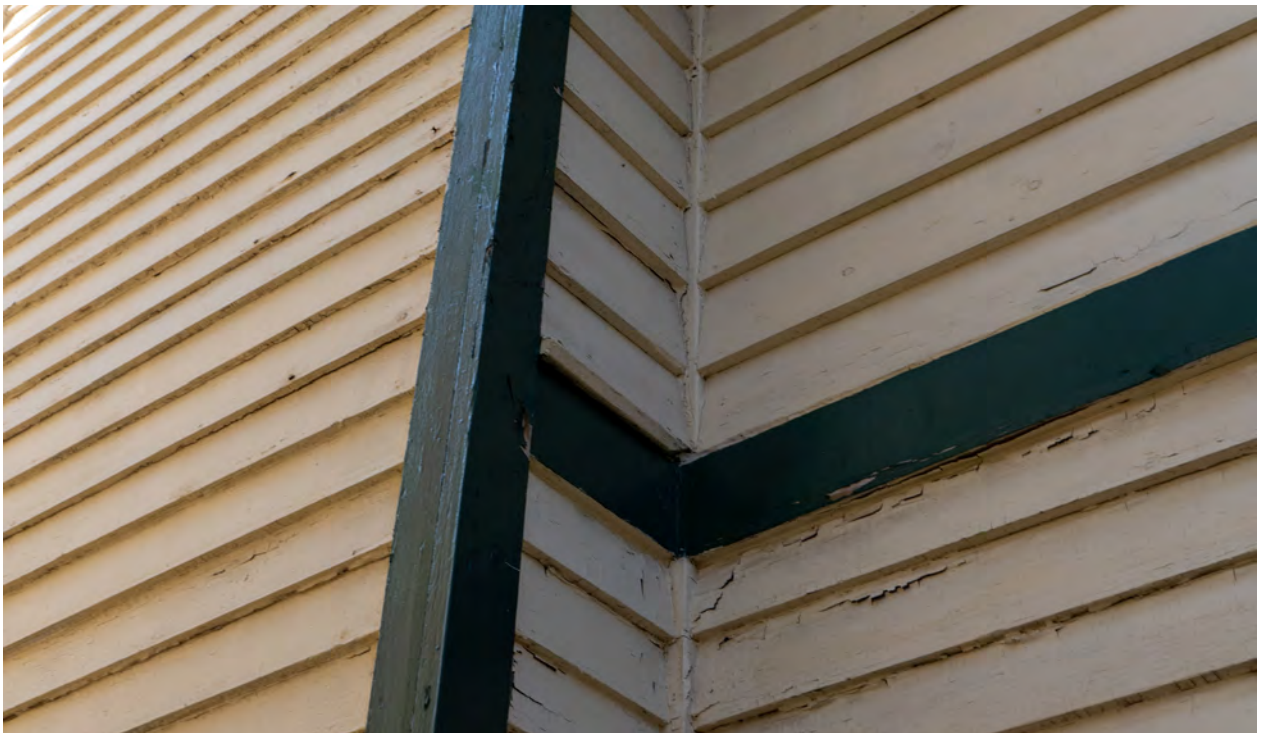
It appears that a ground floor portion of the northern extension on the east side may have been part of the original structure. This is due to consistent materials on the interior and exterior. Specifically the exterior siding matches the dimensions of siding on the southern portion (Figure 17), with window casings, six-over-six double hung sash windows, and water table also matching historic traits on the southern portion (Figure 18).

Figure 17: Photograph showing the main south portion (left), next to the historic ground floor section of the north extension (bottom right) and north extension addition (top right). The bottom right siding matches that of the main south portion (CBCollective 2023).

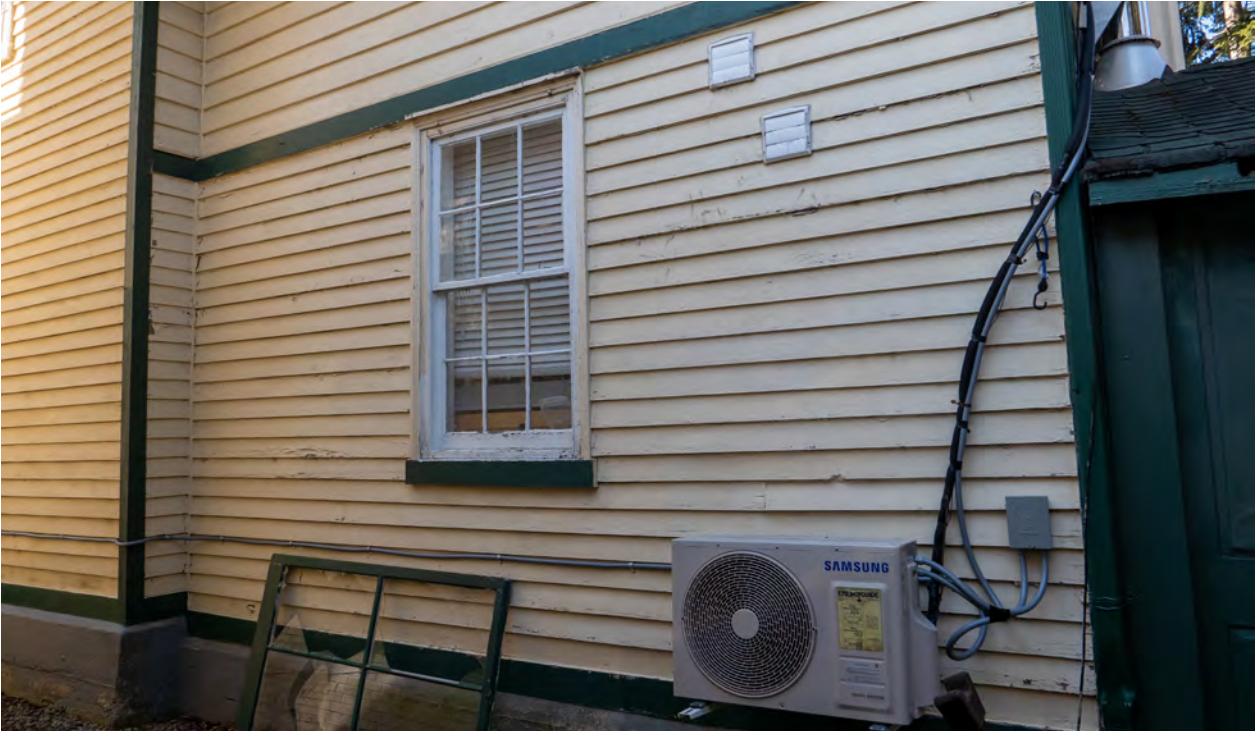
Figure 18: The historic ground floor portion of the north extension, with wooden elements matching those of the main south portion (CBCollective 2023).

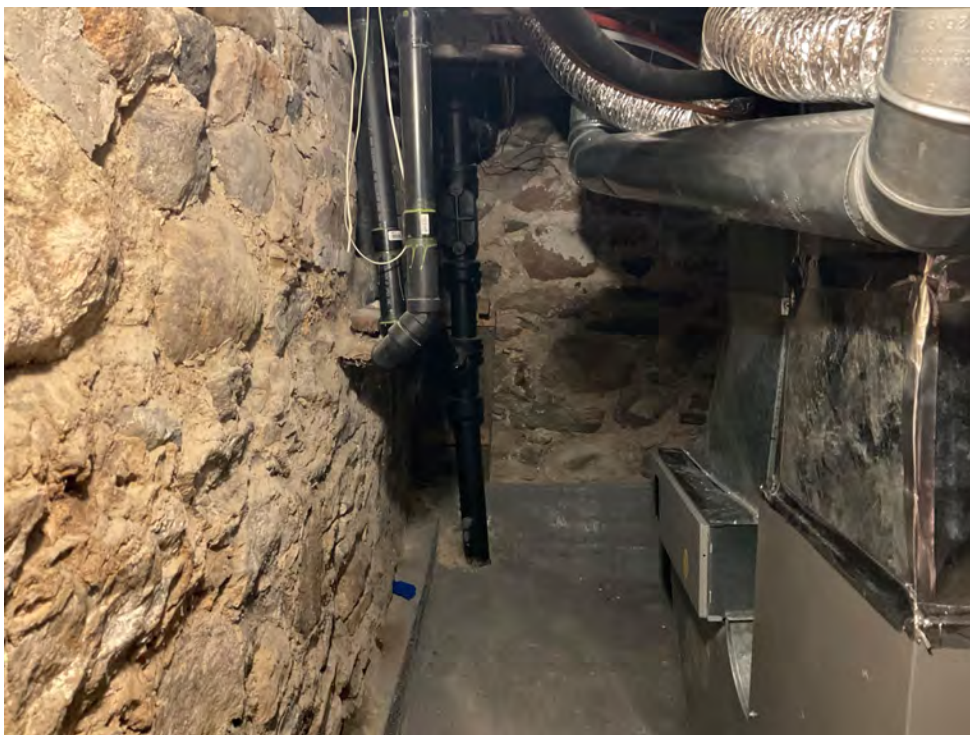
Figure 21: Full Depth Foundation Walls under the main south portion (CBCollective 2023).

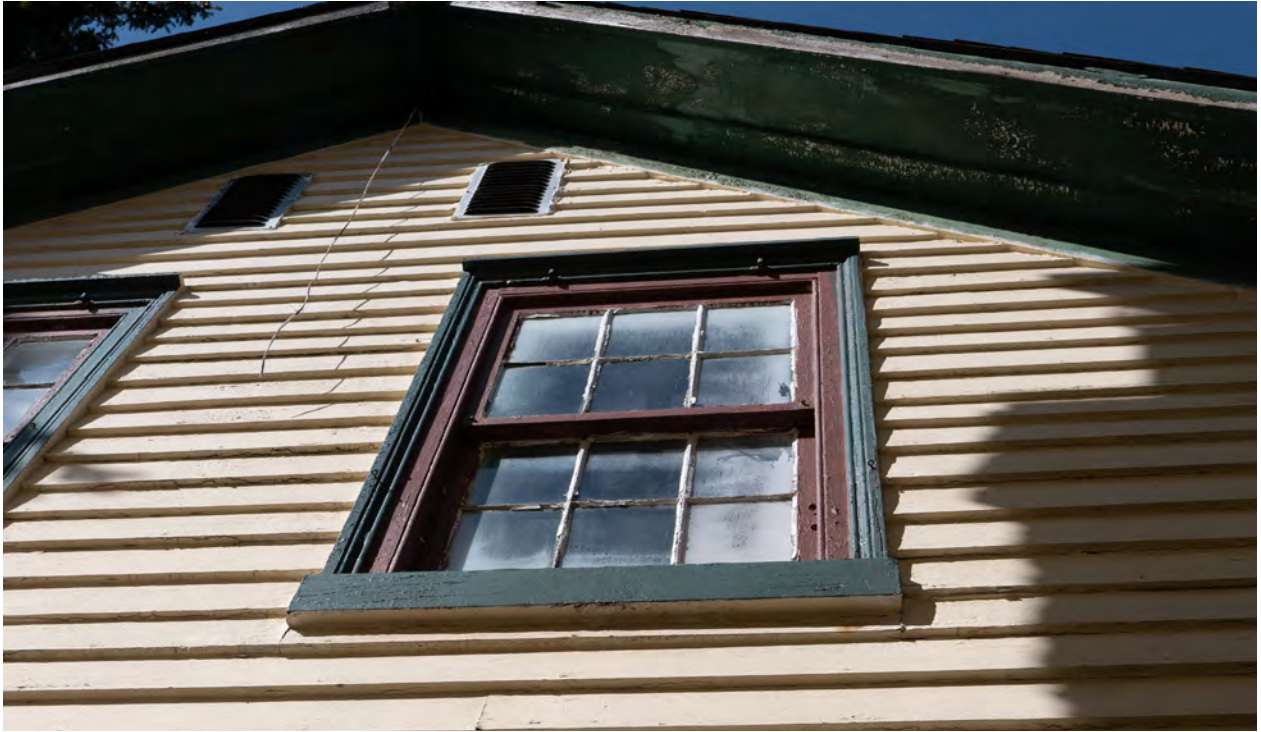
Figure 26: Window architraves shown around an original 6-over-6 window (CBCollective 2023).

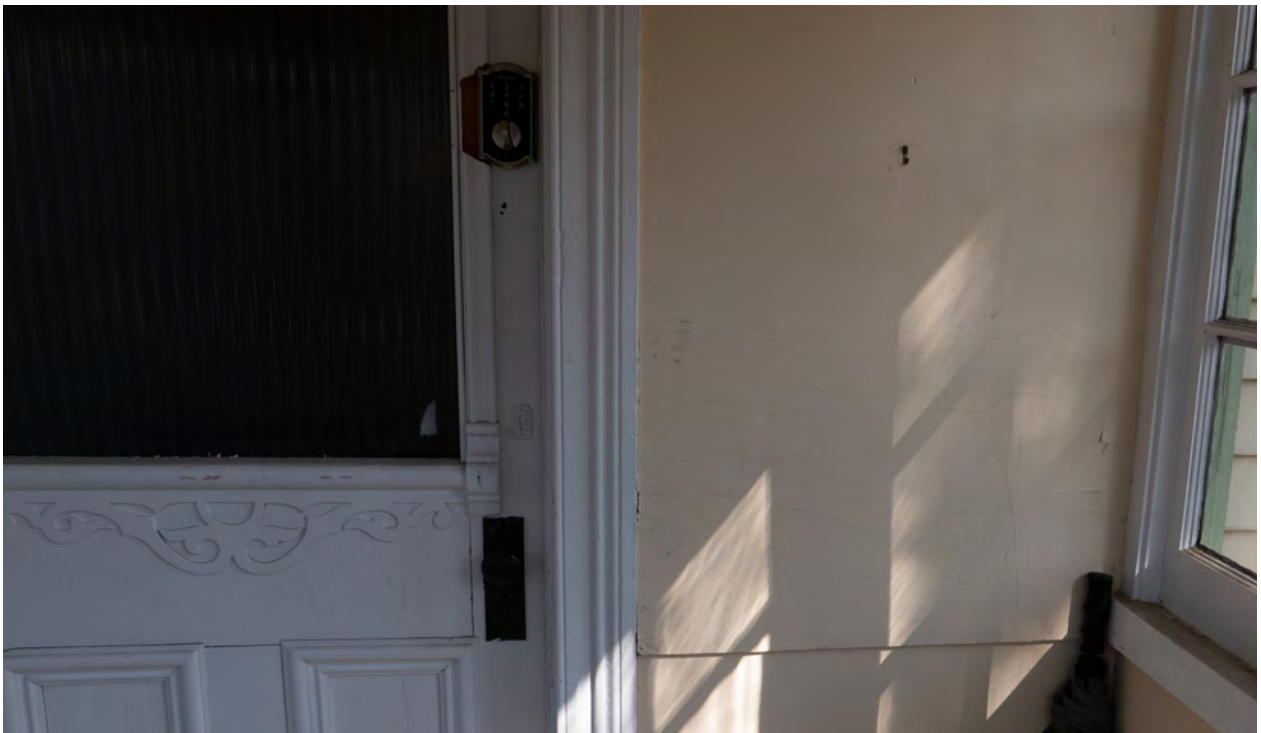
Figure 27: Front door casings display the same moulding profiles as historic windows (CBCollective 2023).

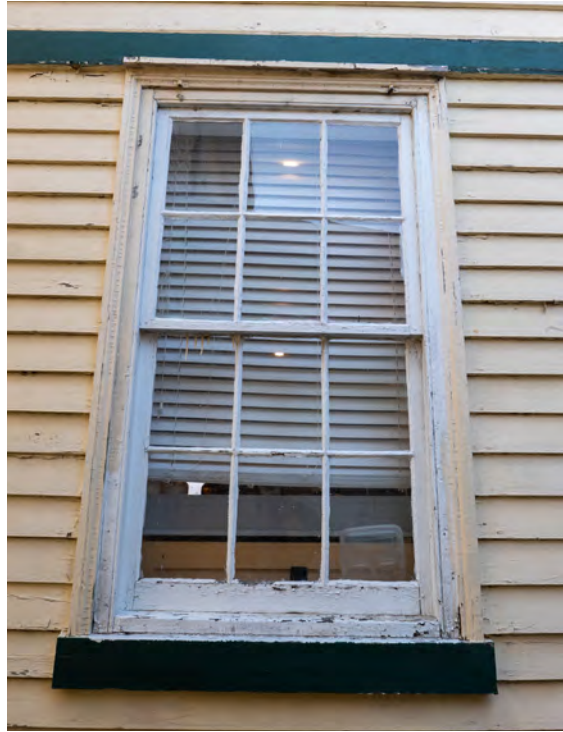
Figure 28: 6-over-6 window with casing on the east elevation of the north extension, showing flat water shedding ledge across the top (CBCollective 2023).

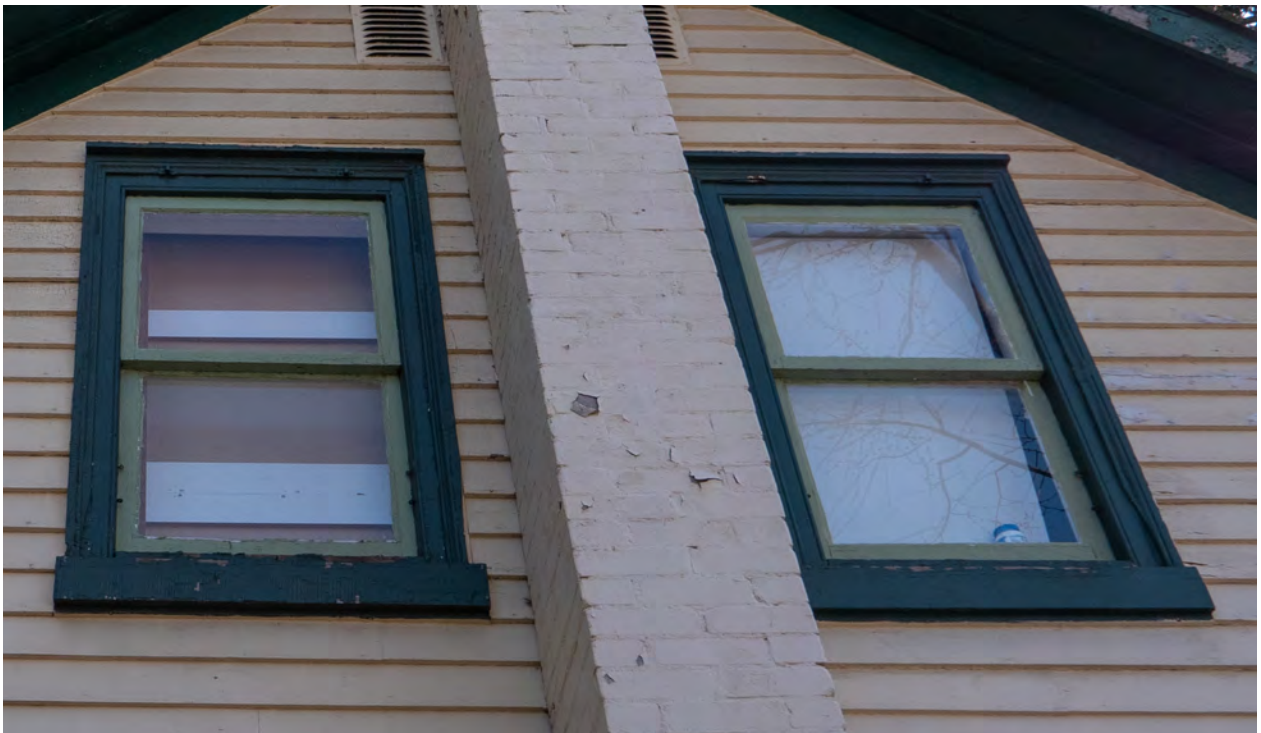
Figure 29: Historic window architraves on the west elevation, showing drip ledges (CBCollective 2023).

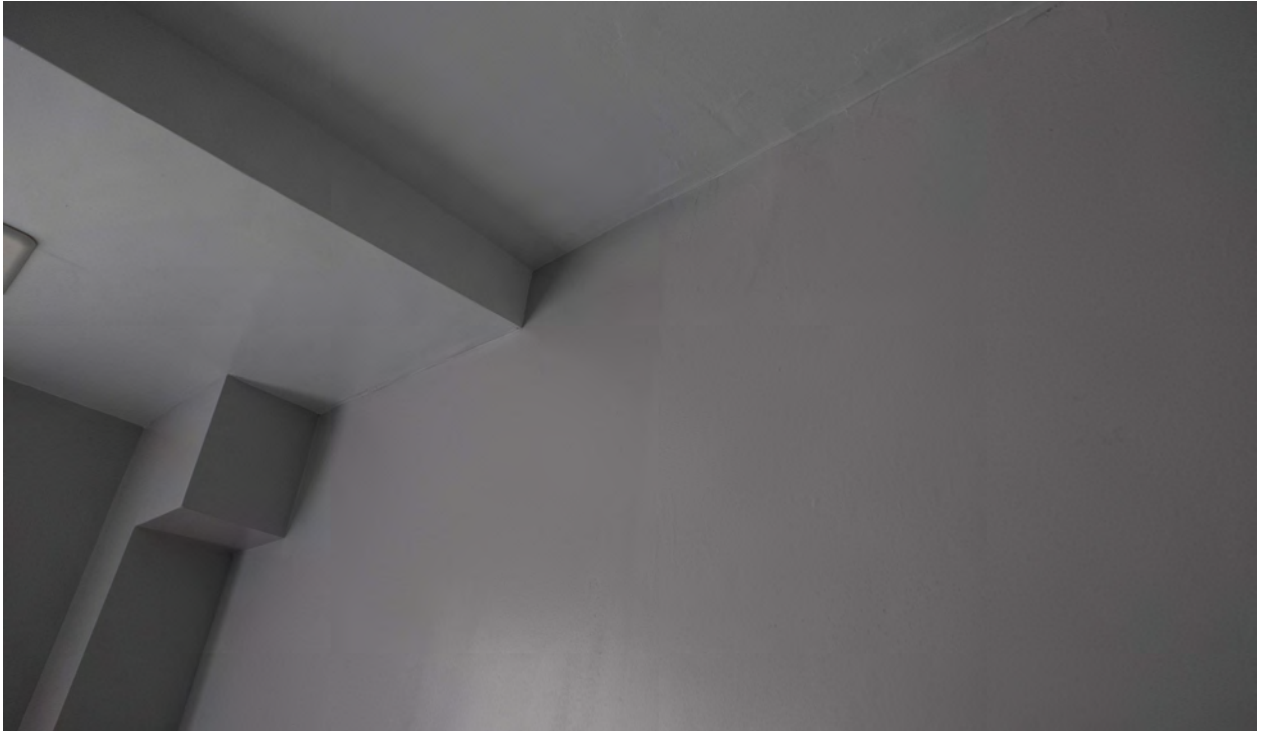
Figure 32: No stenciling was observed in the northwest bathroom of the main south portion, or elsewhere in the house (CBCollective 2023).
