Staff Report for Council Meeting

Report Number: SRCS.20.15

Subject: **SRCS.20.15 – Culvert Emergency Repairs**

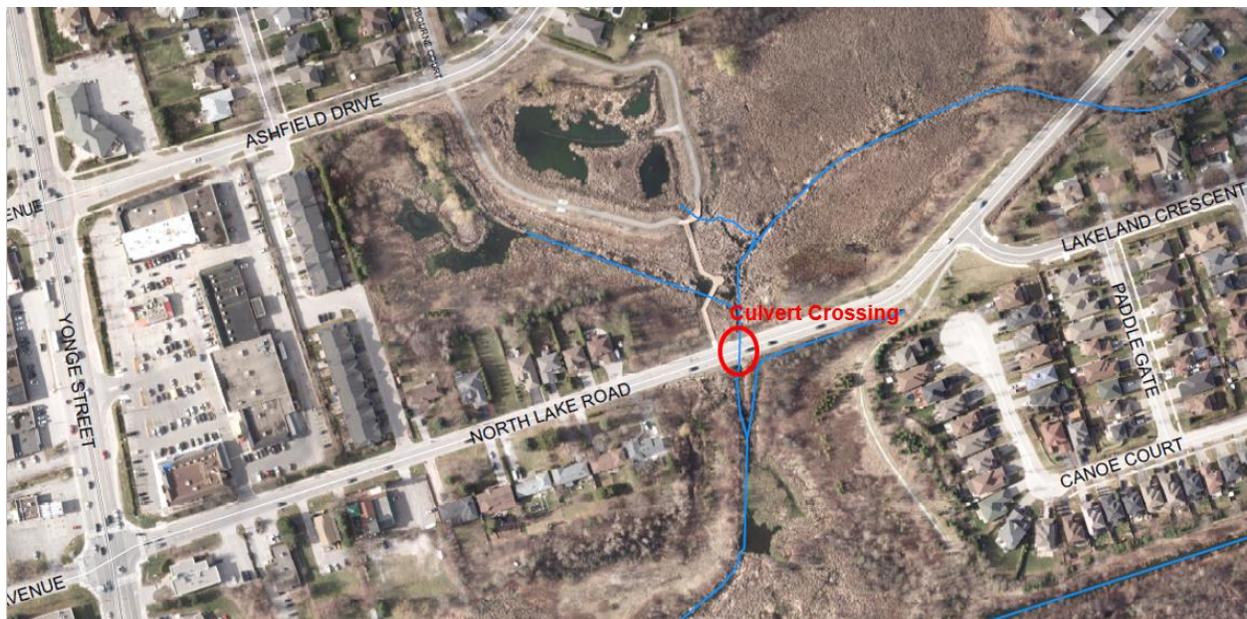
The North Lake Road culvert is a 910 mm diameter corrugated steel pipe (CSP) that conveys drainage from a tributary of the East Humber River. Inspection of the culvert determined that the north portion of the culvert collapsed and undermined the sidewalk and roadway base, resulting in the damaged infrastructure. It was also noted that the south portion of the culvert is severely corroded.

Figure 1 – North Lake Road culvert location

City staff recently observed damage to the sidewalk and traffic lanes on North Lake Road between Yonge Street and Lakeland Crescent, and on Newman Avenue between Bayview Avenue and Wildwood Avenue. Further investigation determined that the cause of the road damage was due to failing culverts. The North Lake Road culvert is located near a connecting trail boardwalk just west of Lakeland Crescent (see Figure 1), and the Newman Avenue road crossing is located adjacent to a natural wetland (see Figure 2).

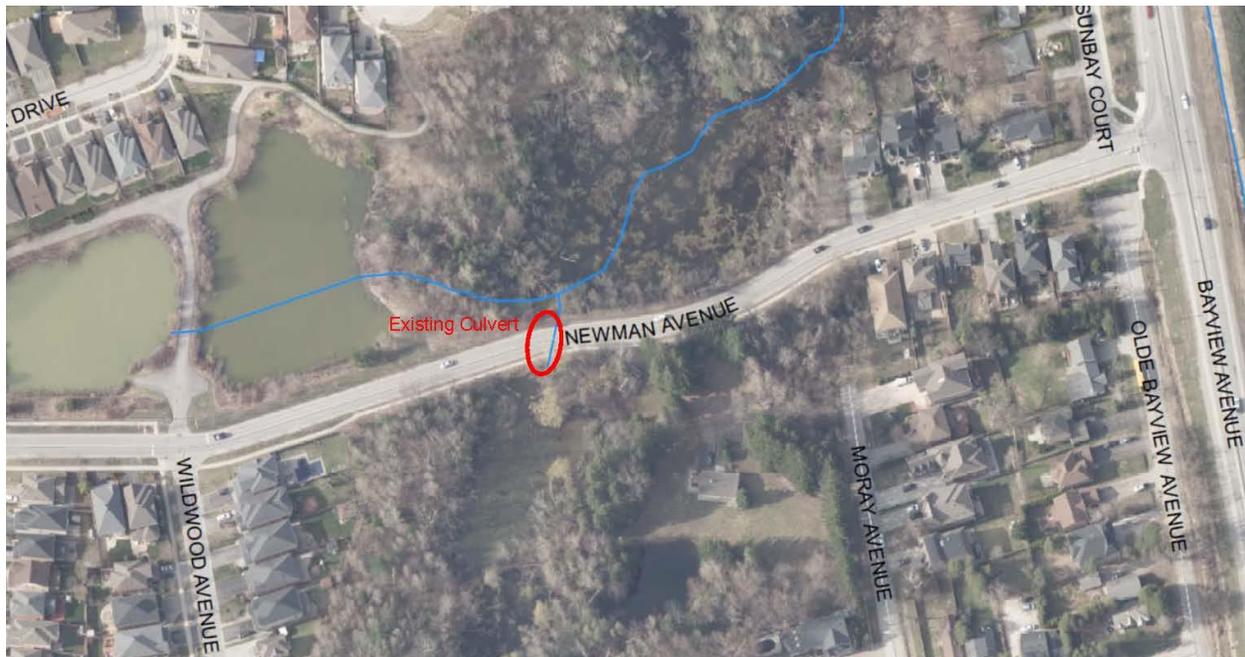
The Newman Avenue culvert is a 450 mm diameter CSP that connects two natural wetland features from the north to the south. Inspection of the culvert determined that the structure was full of debris and collapsed, resulting in the damage to the road and an elevated water level in the north wetland due to the interruption of the natural drainage path.

Figure 2 – Newman Avenue culvert location
