Staff Report for Heritage Richmond Hill Meeting

Report Number: SRPI.22.027

Subject: **SRPI.22.027 - Heritage Permit Application for
376 Church Street South - File D12-07166**

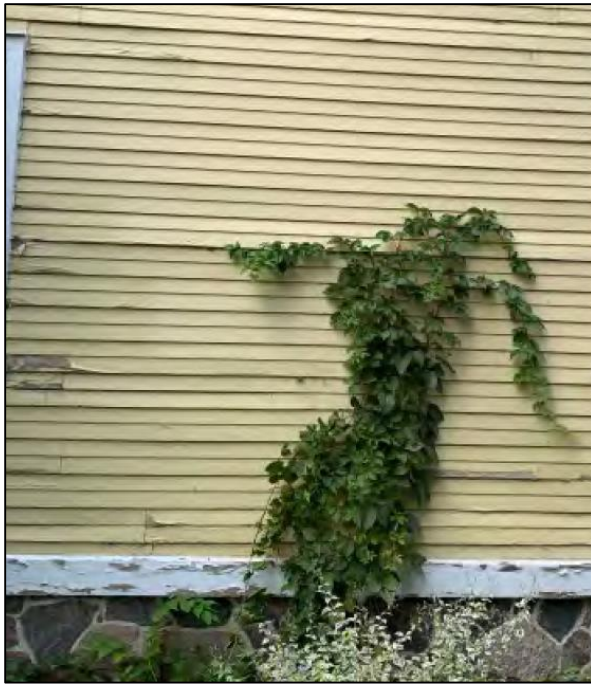
Figures 1 and 2: Photographs of the east elevation showing portions of the wooden siding and skirting board that require repairs and repainting, as well as climbing vines that are to be removed (left), and a door sill that requires repainting.

- Removing the climbing vines from the exterior walls;
- Repainting the wooden siding, repairing where necessary (see Figure 1);
- Repairing and repainting wooden windows, doors and sills (see Figure 2);
- Replacing missing window muntins (see Figure 3);
- Replacing the non-original metal basement door frame on east elevation (see Figure 4);
- Repairing and repainting the wood skirting board and trims (see Figure 1);
- Repairing the concrete steps to the basement entrance;
- Recaulking around foundation openings.

The paint that is proposed to be used will match the existing colours of the Vanderburgh House. Shallow cracks in the wood siding will be filled with a sealant, and areas with deep or extensive damage will be replaced with new clapboard siding that will match the profile of the existing siding. Damaged soffit boards will be replaced with new wooden boards that match the appearance of the existing soffits. Cracks in the skirting board will be patched with sealant prior to being repainted. All openings within the foundation will be recaulked, and cracks in the foundation surface will be filled in and spalled sections will be repaired with a parging coat.

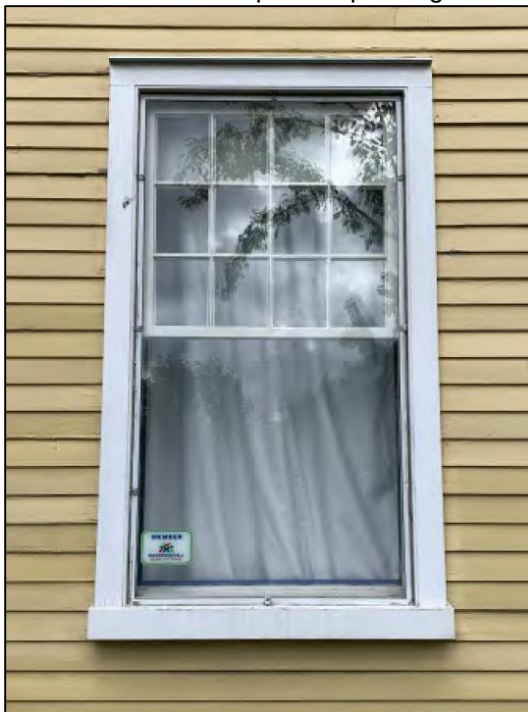
Figures 3 and 4: Photographs of a window with missing muntins (left), and of the basement door with a rusted frame (right).
